Structural Inspection Report

Rose Café, Graves Park, Sheffield
S8 8LJ

PC06414

28/06/22

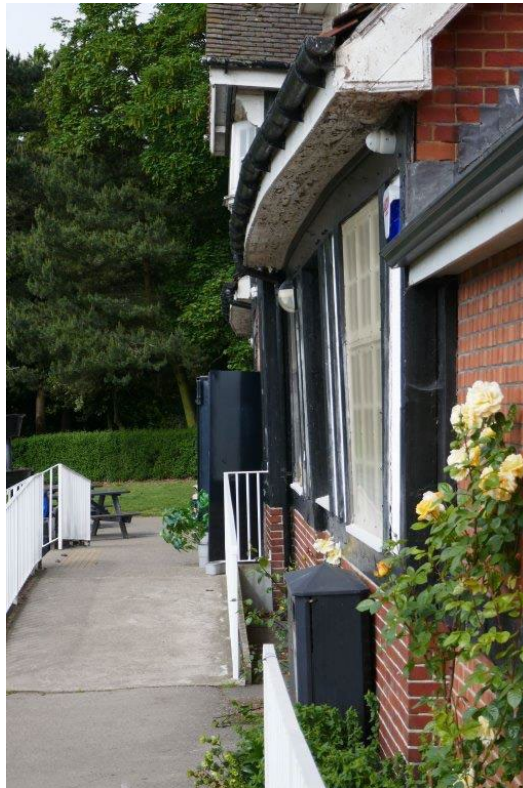
- 3.1.1 Bulging of the soffit beam both sides of the main entrance door, front elevation, to the gable ends – see Photo 1.
- 3.1.2 Roof sag both elevations – see Photos 2 and 3.

- 3.2.1 Leaning of the window frames to the front elevation outwards – obvious visually externally and internally – see Photos 1 and 8.
- 3.2.2 All window frames rotten and rot accelerated by fixing Perspex externally in front of the windows – see Photo 9.

Photo 1 – Bulging of soffit beam and forwards movement of front elevation.

- 5.7** The front elevation requires remodelling to incorporate bi-fold doors and new double-glazed windows which will be formed by a steel skeleton. Nothing to the front elevation is salvageable.

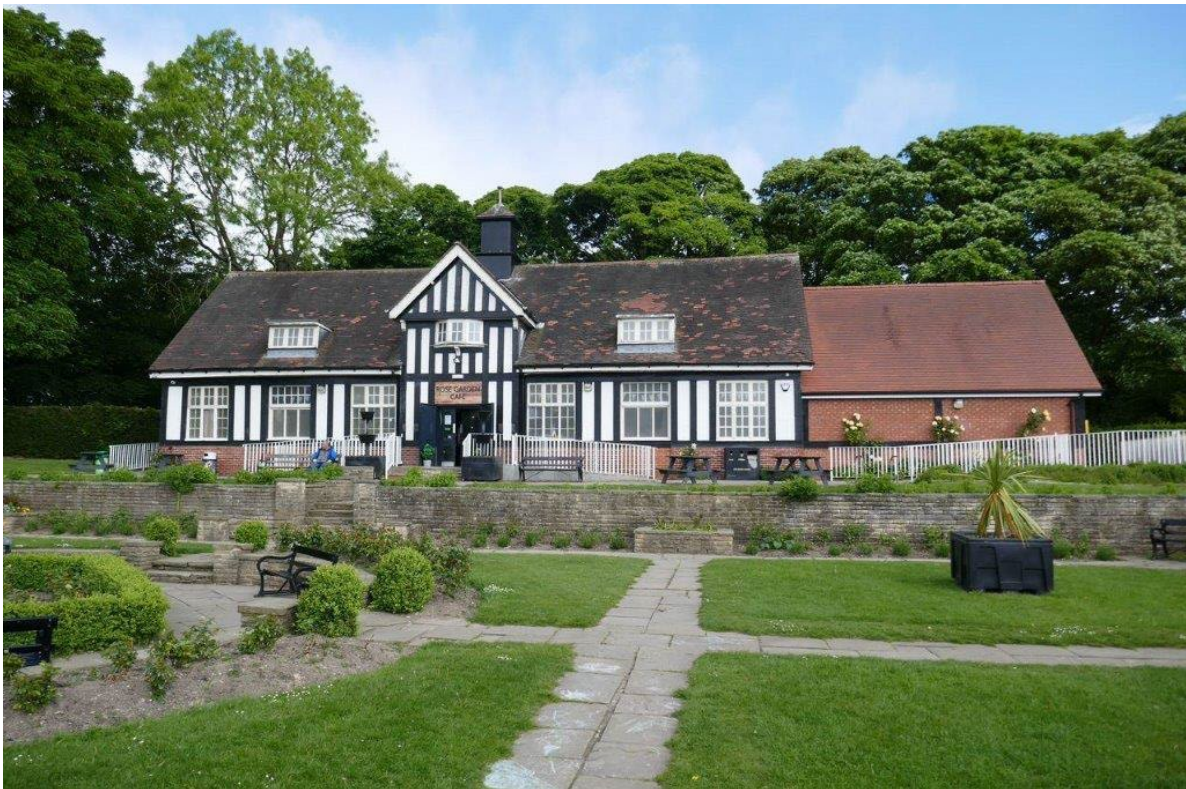
- 3.1.8 Removal of the clock face from clock tower as it was leaning backwards (thought to have been taken to Staniforth Road Depot) – as noted by the café operator – see Photo 2.

Photo 2 – Roof sag front elevation.

- 5.1** The condition or cause of the roof sag may not be known until the roof is stripped. The roof sag is not localised; it seems to be the whole roof on both elevations. In this instance the rafters and possibly the purlins will have split or deflected and could be rotten as a result of the water leaks noted in heavy rain. There is the likelihood that 4 No. structural steel beams will be required, 1 attached to each purlin and bearing into the gable walls, for strengthening. It is also likely that all the rafters will need replacing. There is also potential for bespoke structural timber splice/connection details of the existing trusses. (It has since been confirmed that a survey has taken place in the roof space by an independent consultant which should determine if any of the roof structure is salvageable or not).

- 5.2** Introduction of tie rods at each truss to control future roof spread if possible. This will be dependent on the condition of the trusses as will have to incorporate a shoe detail at wallplate level if the truss feet are rotten and to take the new tie rod.

- 5.5** Every truss end to the front elevation would need to be propped and braced before the roof tiles are removed during the re-roof scheme as it could become unstable.

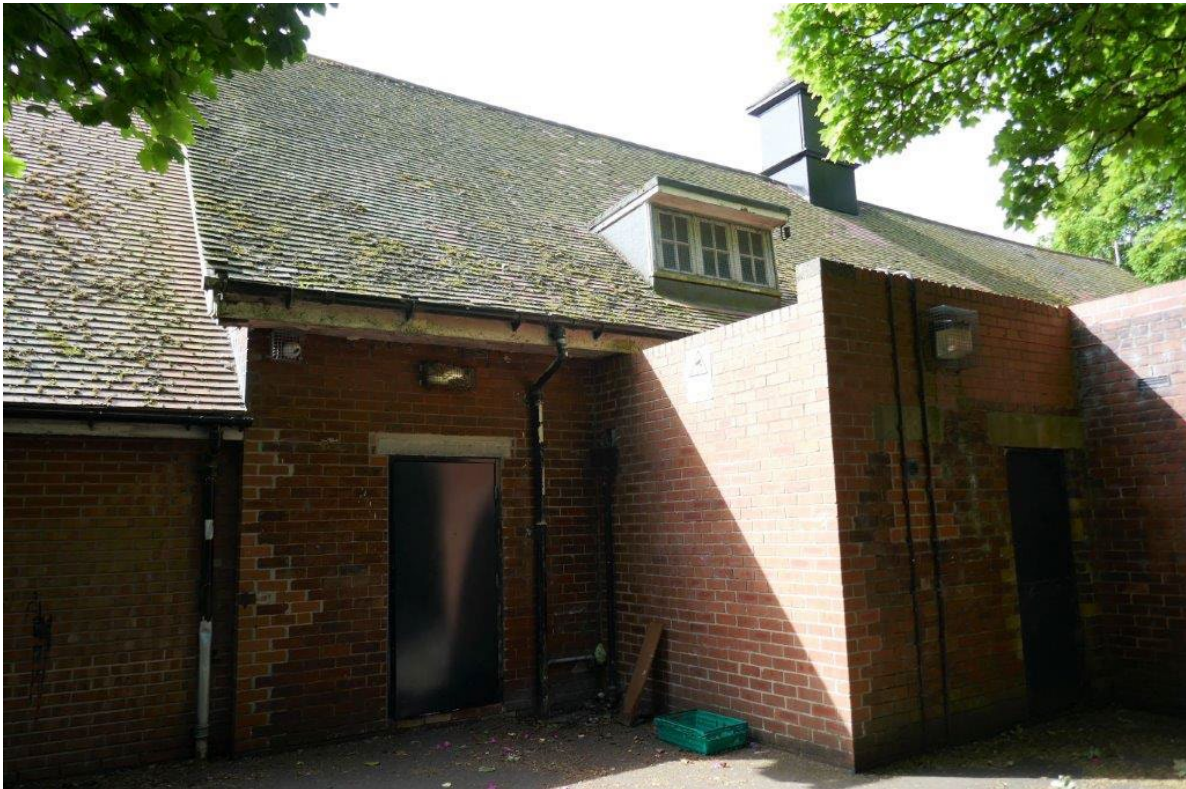
- 3.1.3 Dormer windows leaning backwards both sides – see Photos 4 and 3.
- 3.1.4 Bird entry where soffits missing to rear of café – see Photo 5.
- 3.1.5 Poor detailing box end/soffit front elevation where it meets toilet block gable wall – see LHS Photo 6.

3.4.7 The rear flat roof extension has a skin of brickwork in 2 locations. One skin does not adequately disguise an outside urinal – see Photo 11. This extension is a mismatch of brickwork where doors and windows have been infilled but not using the same colour bricks – see Photos 3 and 12.

Photo 3 – Roof sag rear elevation and Dormer Window backwards lean.

- 5.6** The dormer windows are not accessible and cannot be maintained at present so suggest replacing with rooflights to increase light.

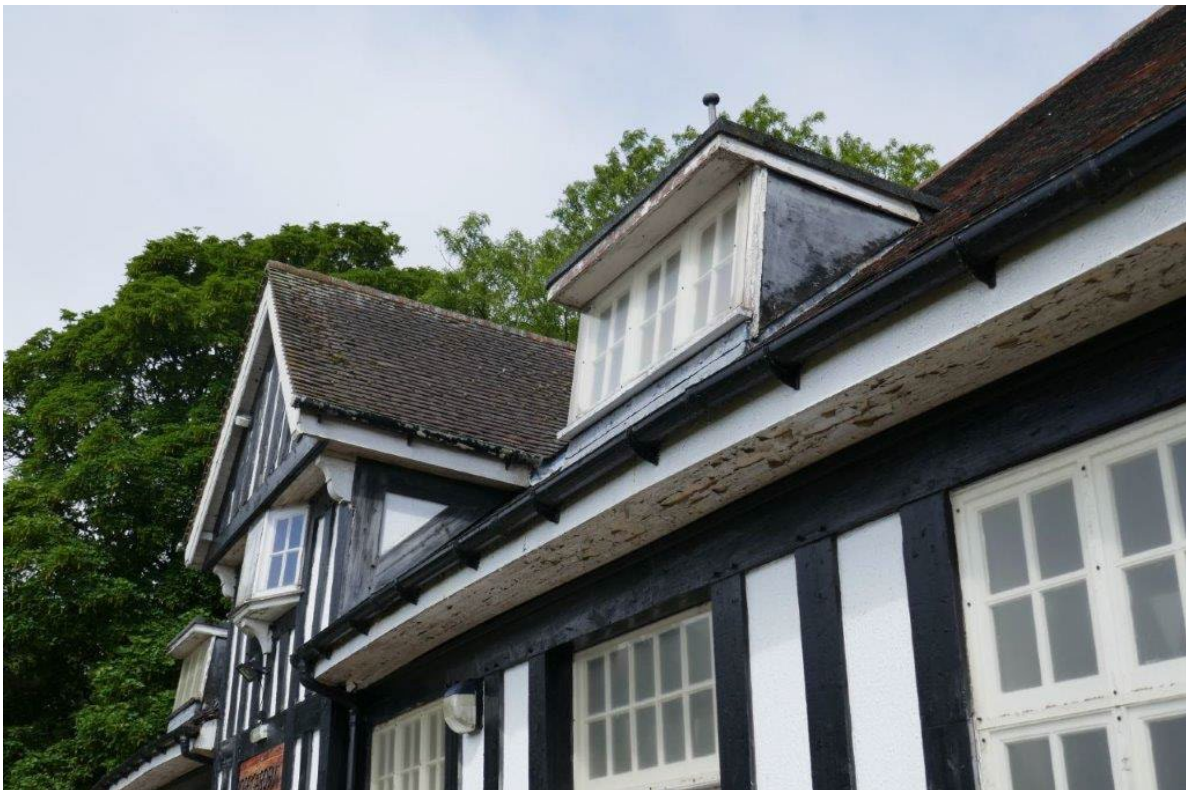
Photo 4 – Backwards lean to Dormer windows Front Elevation.

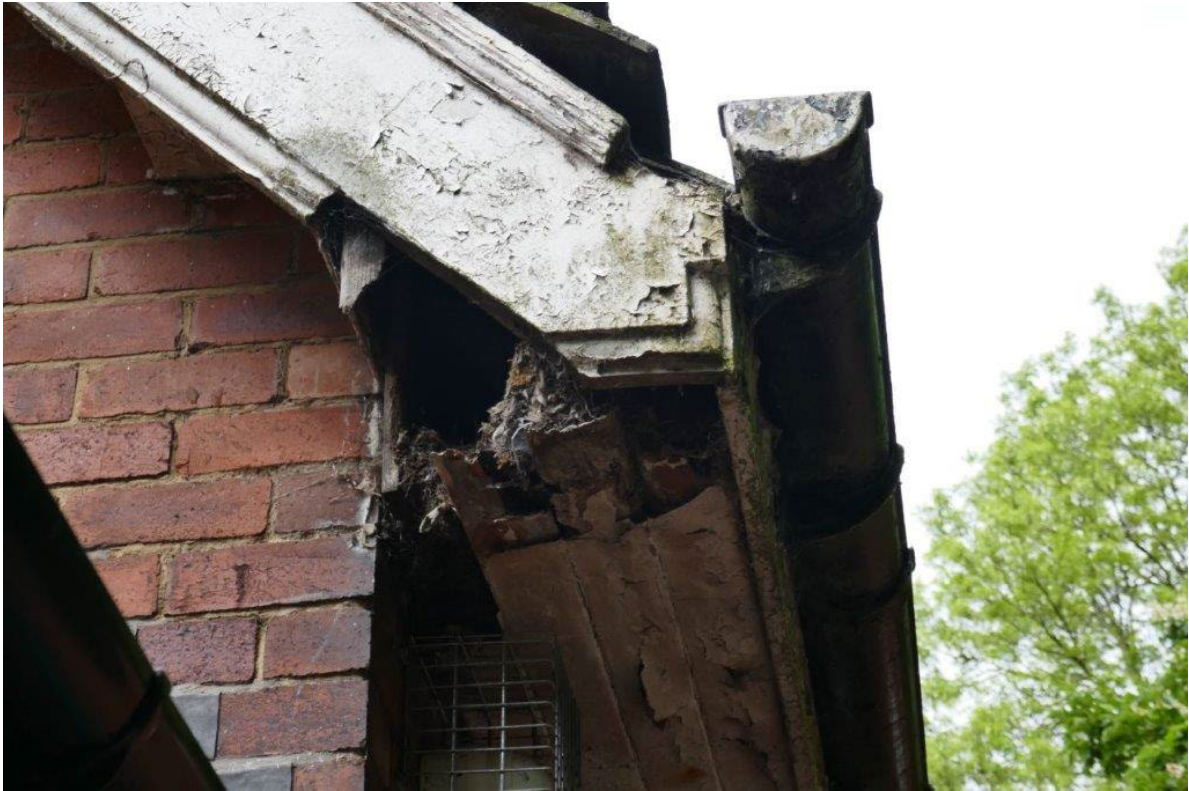
Photo 5 – Bird entry/missing soffit rear elevation.

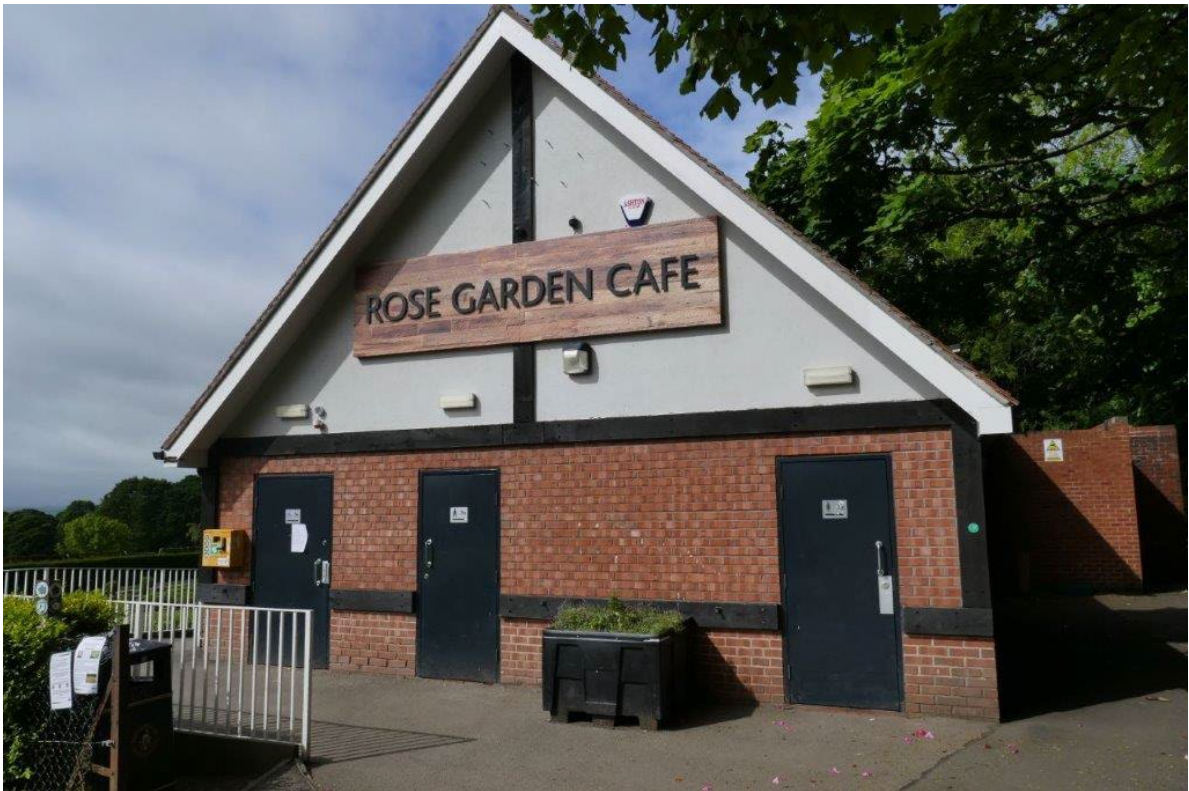
Photo 6 – Poor detailing box end/soffit beam toilet block extension (LHS photo).

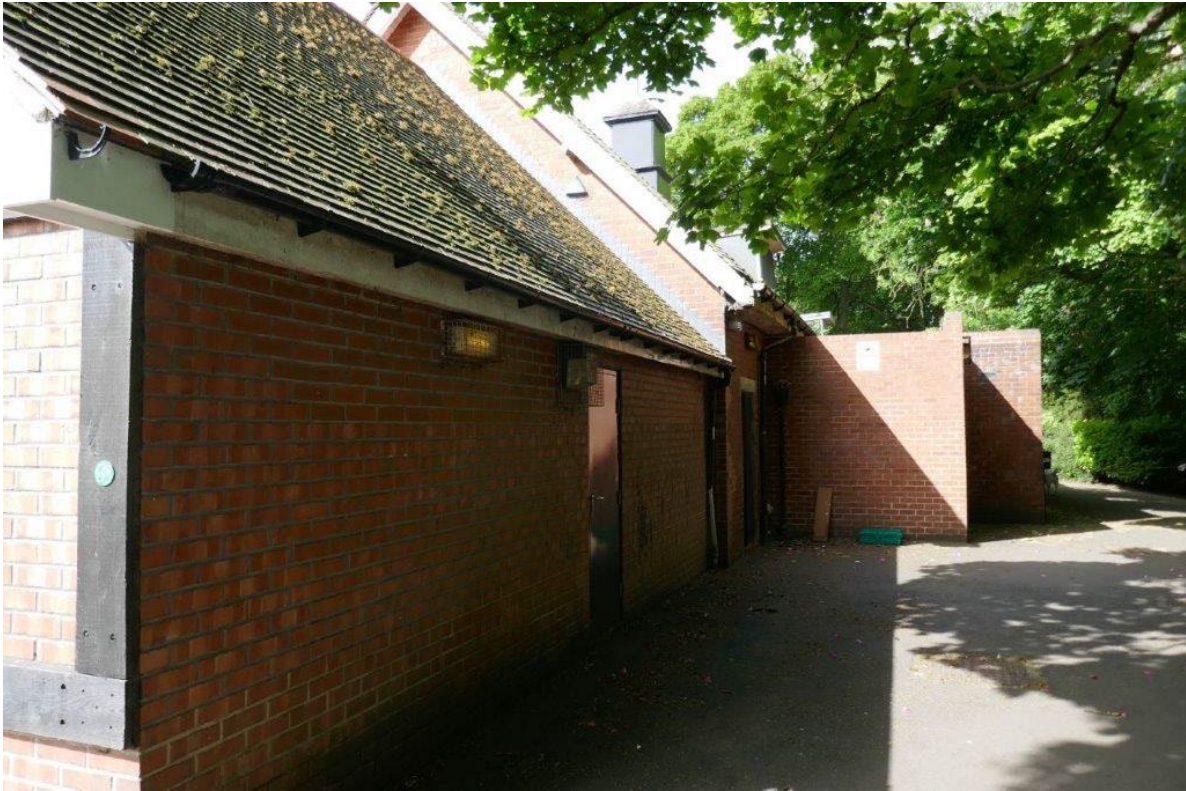
- 3.1.7 Gutters in a poor state and sections to the rear elevation of the building keep falling off as noted by the café. A section was missing from the rear of the toilet block extension at the time of the inspection – see Photo 7.

- 3.1.9 The extension to the rear has a flat roof. Tree saplings and vegetation could be seen growing on this roof. It's condition could not be established due to a low level parapet wall around the flat roof – see Photo 7.

Photo 7 – Missing gutter section rear elevation toilet block.

- 5.4** There appears to be vegetation growing out of the flat roof extension to the rear which will need further investigation with a view to replacing.

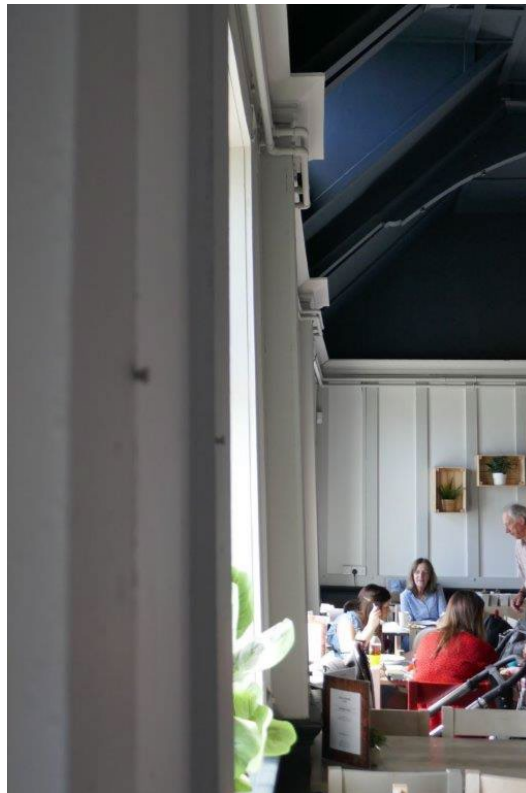
Photo 8 – Outwards lean to front elevation window frames.

- 5.11** The drains will need investigating and renewing if they are blocked or broken.
- 5.12** The existing foundations to the front elevation cannot be used as the structure has considerable lean and rebuilding plumb will eccentrically load them. The existing foundations are likely to be 2-3 engineering brick courses and are unlikely to be capable of taking extra loadings from the roof as a result of heavier tiles; new rafters at closer centres and various other repairs. Structural framing of the front elevation for replacement windows and as a result of the deformation will require new foundations in any case. It is also likely that the remainder of the building will require underpinning unless the foundations present are capable of supporting the new loads.

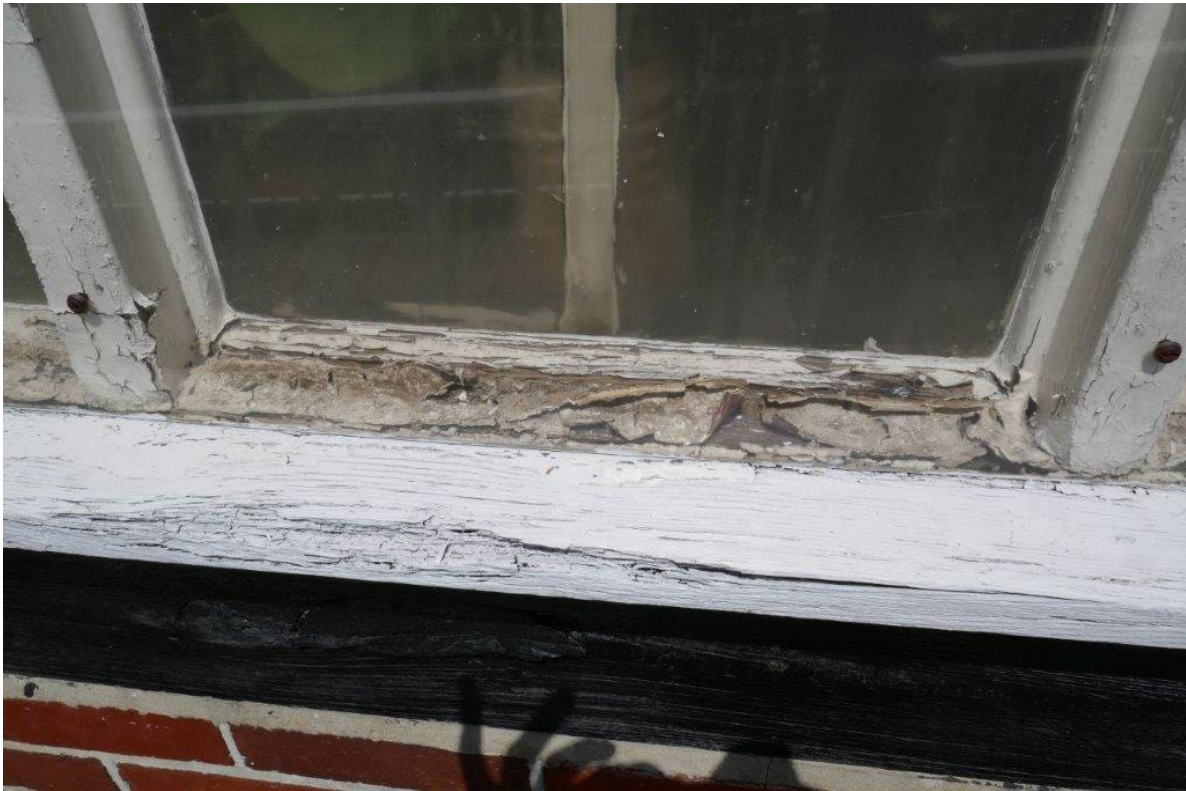
Photo 9 – Rotten window frames exacerbated by fixing of Perspex to front.

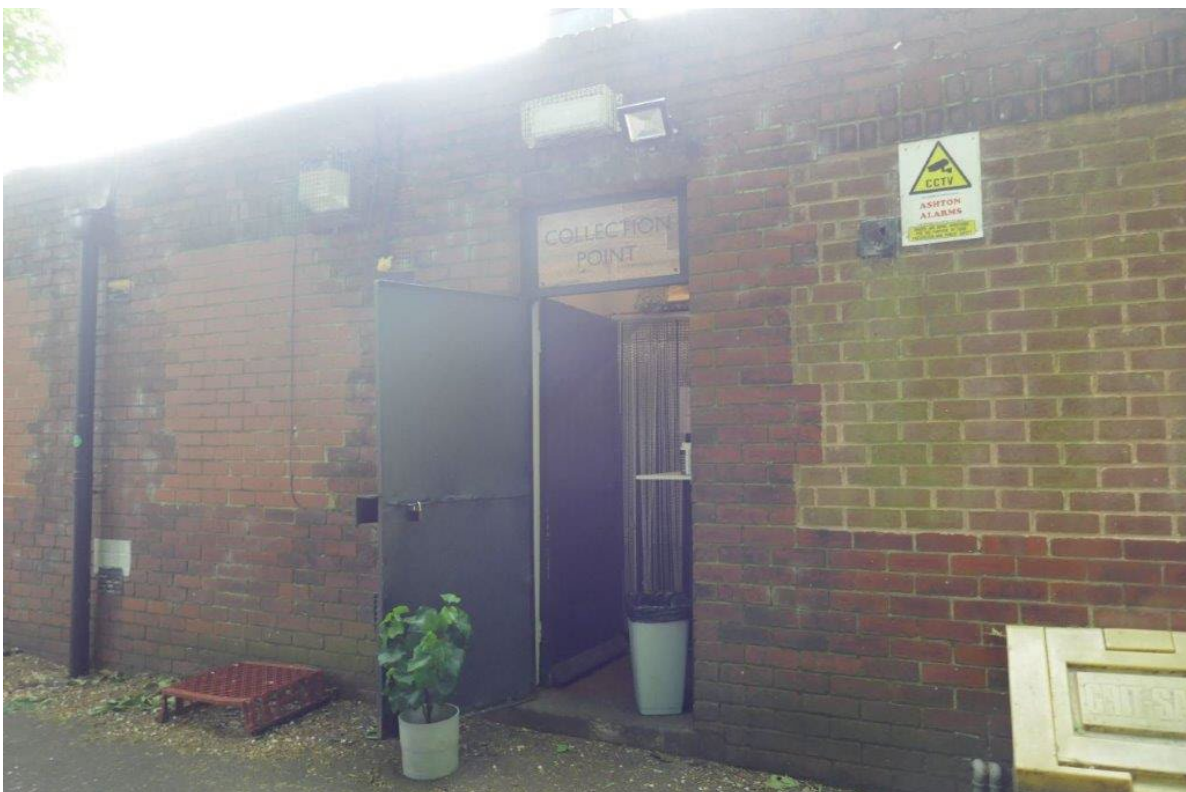
- 3.3.1 Rats had been gaining entry into the cafe through air bricks and vents on the rear elevation. Was resolved by addition of expandable foam in air bricks and service entry points – see Photo 10.
- 3.3.2 Blocked drains to the rear – usually happens every winter – as noted by the Café operator.

Photo 10 – Expandable foam in air bricks and service point entries to prevent rat entry.

- 5.13** Blocking up of the airbricks to prevent rat entry will cause condensation and damp/mould a few years down the line and the expandable foam will need removing if the building is to be refurbished.

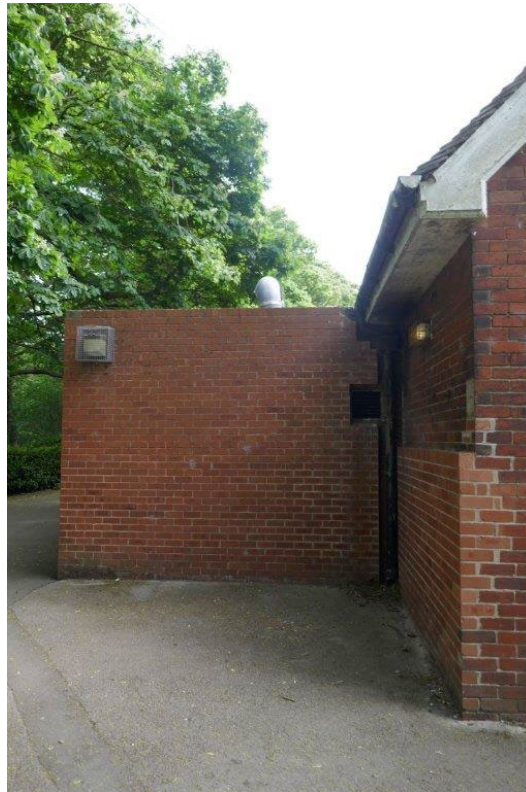
Photo 11 - External skins of brickwork added at a later stage. Extends ½ wall on RHS covering an outside urinal.

- 5.8** The current flat roof kitchen and store to the rear is unsightly due to the brick infilled windows and doors. It is also questionable as to why a skin of brickwork has been constructed in front of the existing wall at the vent elevation and partially disguising the external urinal and if these have been tied back to the existing structure adequately. This could be disguised by external cladding to increase the thermal values, but this could then create the possibility of a blank canvas for graffiti.

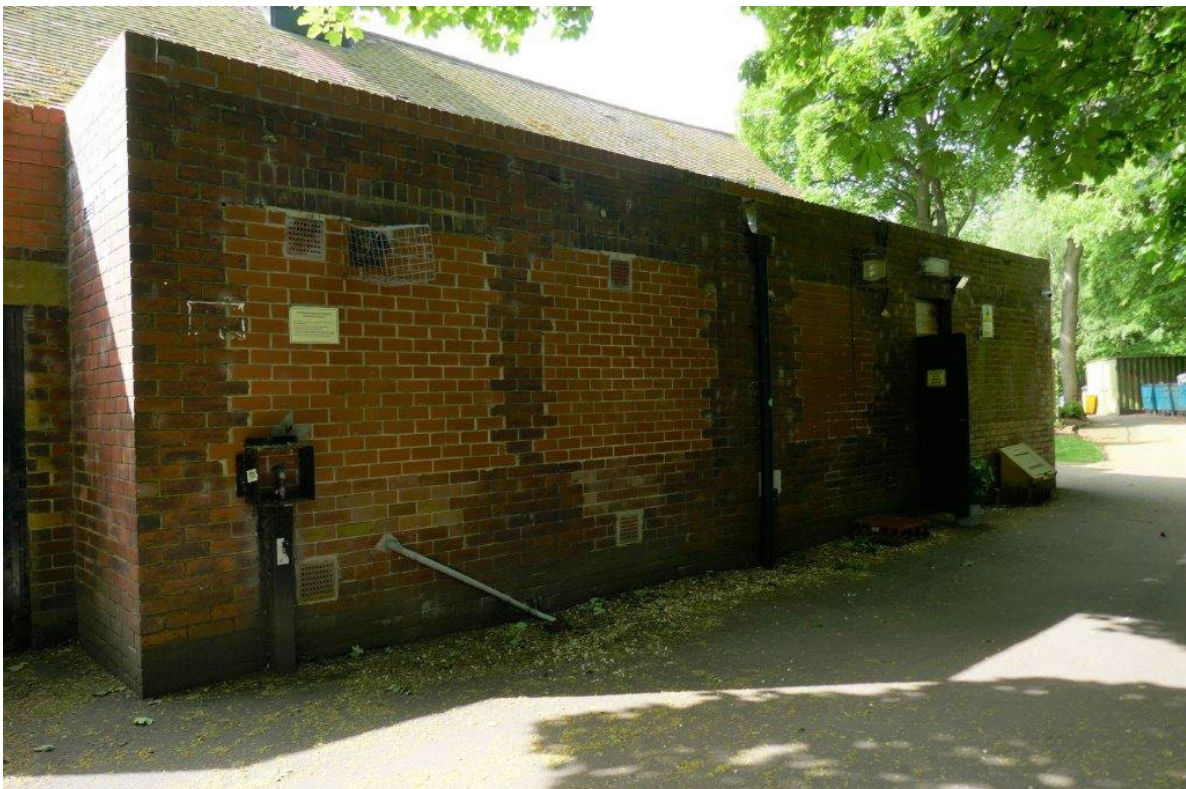
Photo 12 – Infilled windows and doors with different coloured bricks.
