## STRUCTURAL REPORT ROSE GARDEN CAFÉ, GRAVES PARK, SHEFFIELD S8 8LJ

**Client:** Sheffield City Council  
**Project Name:** Rose Garden Café, Graves Park, Sheffield S8 8LJ  
**Report Title:** Structural Inspection Report  
**Document ref:** 00.22225-ACE-ZZ-ZZ-RP-S-0001  
**Date:** 8<sup>th</sup> August 2022

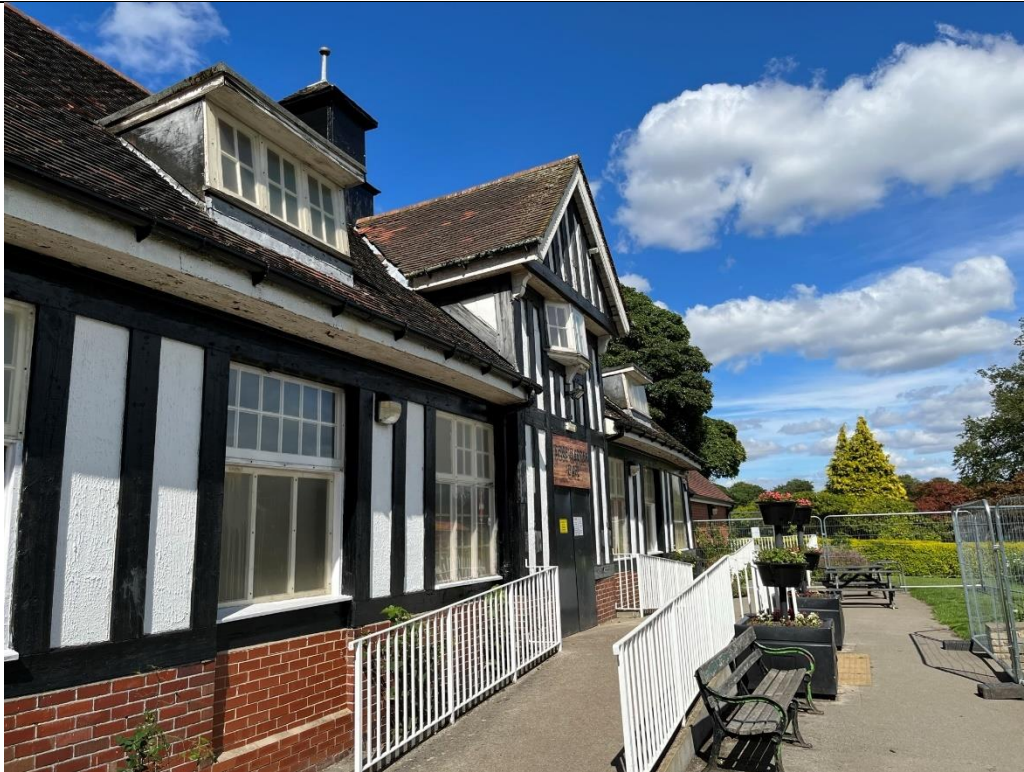
Photo 1  
Front elevation looking east

- 4.1. The front wall of the café was leaning outwards at eaves level. The amount of lean varied along the length of the wall with the maximum amount of lean to the second window position in from each of the gable wall returns. The lean was in the order of up to 150mm at this position over the single storey height of approx. 3300mm, photo 1 & 2.

- 4.4. This movement is considered to be severe in structural terms for the wall thickness and could lead to instability of the wall.
- 4.5. 2 no. original French door openings to the front elevation have been bricked up at low level with what looks like a single skin of masonry and timber to inside.

- 5.7. We would recommend some temporary propping is installed to maintain support to the roof and the front wall to make the building safe to allow for further detailed surveys to be carried out. We also understand that a temporary propping scheme to allow some use of the café area by the public would be considered by SCC, which we suggest would involve propping to each end of the roof trusses with raking props to the external front wall at each pier position.

- 5.8. To provide a more informed opinion of the structural issues we would recommend
  - A measured survey of the façade to accurately plot the position of the façade and allow a structural assessment of this lean to be carried out such as undertaking a point cloud survey.

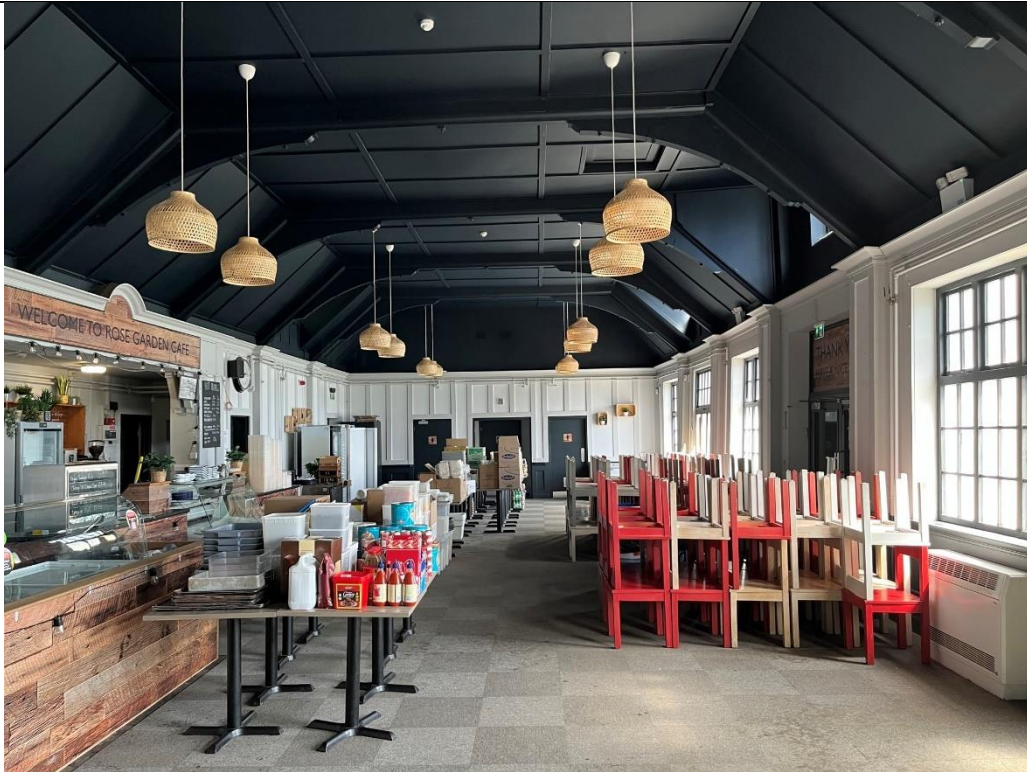
Photo 3  
Internal view to east

- 4.2. The leaning movement was reflected along the wall internally, photo 3 & 4.
- 4.3. The wall appeared to be masonry, an approx. 325mm thick pier at roof truss positions with an approx. 225mm thick infill wall between piers.

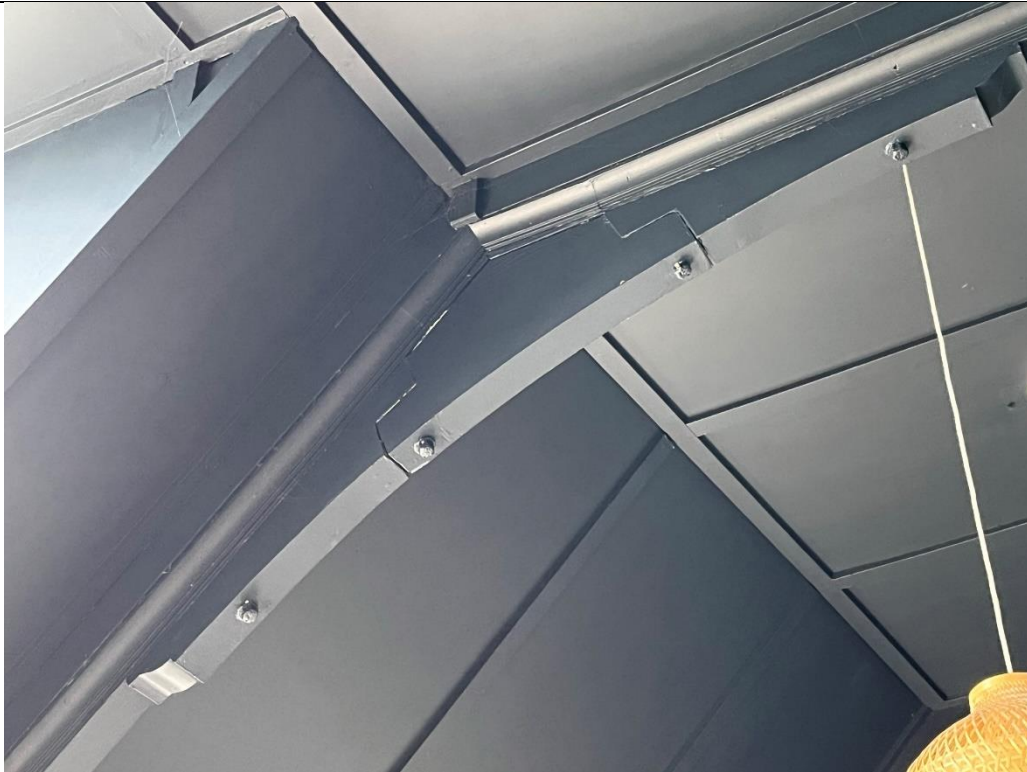
Photo 5  
Typical roof truss detail to ceiling level

- 4.8. Some smaller opening up of timber joints to the roof trusses was noted at ceiling level, photo 5.
- 4.9. This would suggest some structural defects may be present to the timber roof trusses, such as splitting, opening of joints, rotten timber or movement of the roof associated with the movement of the front wall, or both.

- Determine wall construction and thickness and foundation to front wall.
  - Providing access to allow close up inspection of the condition of the roof trusses in the ceiling space and the truss bearings, this could involve removing roof coverings locally. The CDS SCC report also refers to evidence of pigeon entry to the roof space.

- Carry out a specialist timber and damp survey of the roof structure.
- 5.9. It is likely that a detailed structural assessment of the front wall will show it to be unsatisfactory in structural terms and require rebuilding or permanently buttressed and/ or replacement with a framed structure and require new foundations.

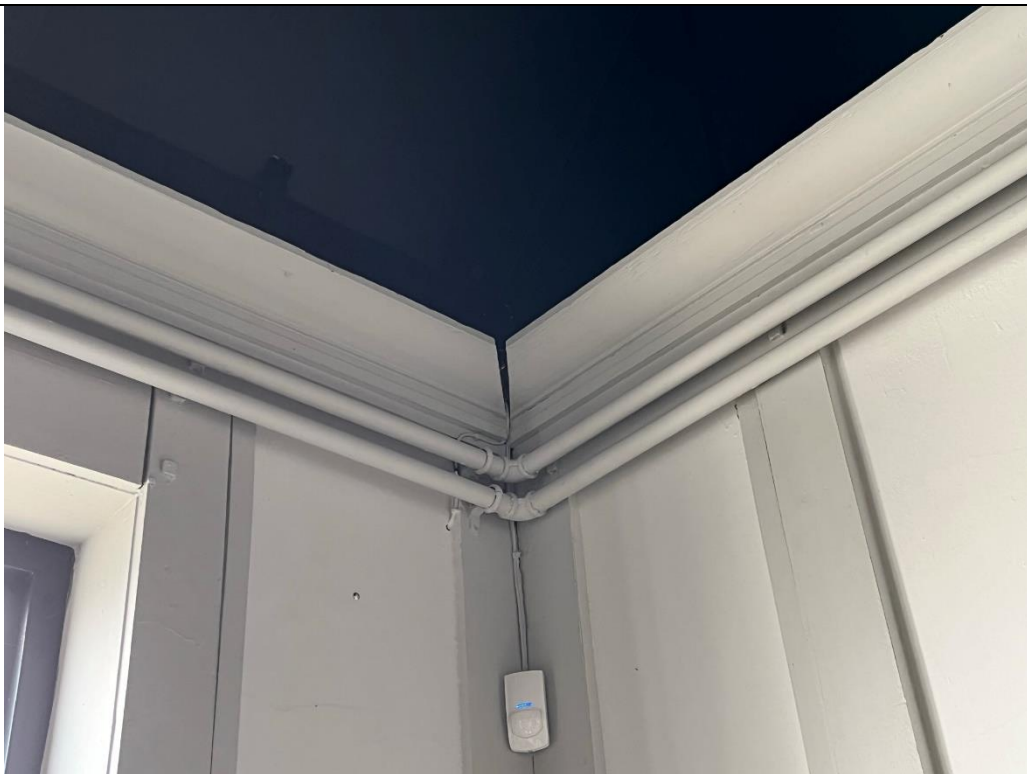
- 4.10. Some gaps between the timber finishes to the top of the wall internally were noted, photo 6.

Photo 6  
Opening of timber finishes attached to bowing wall, with electric cable in gap

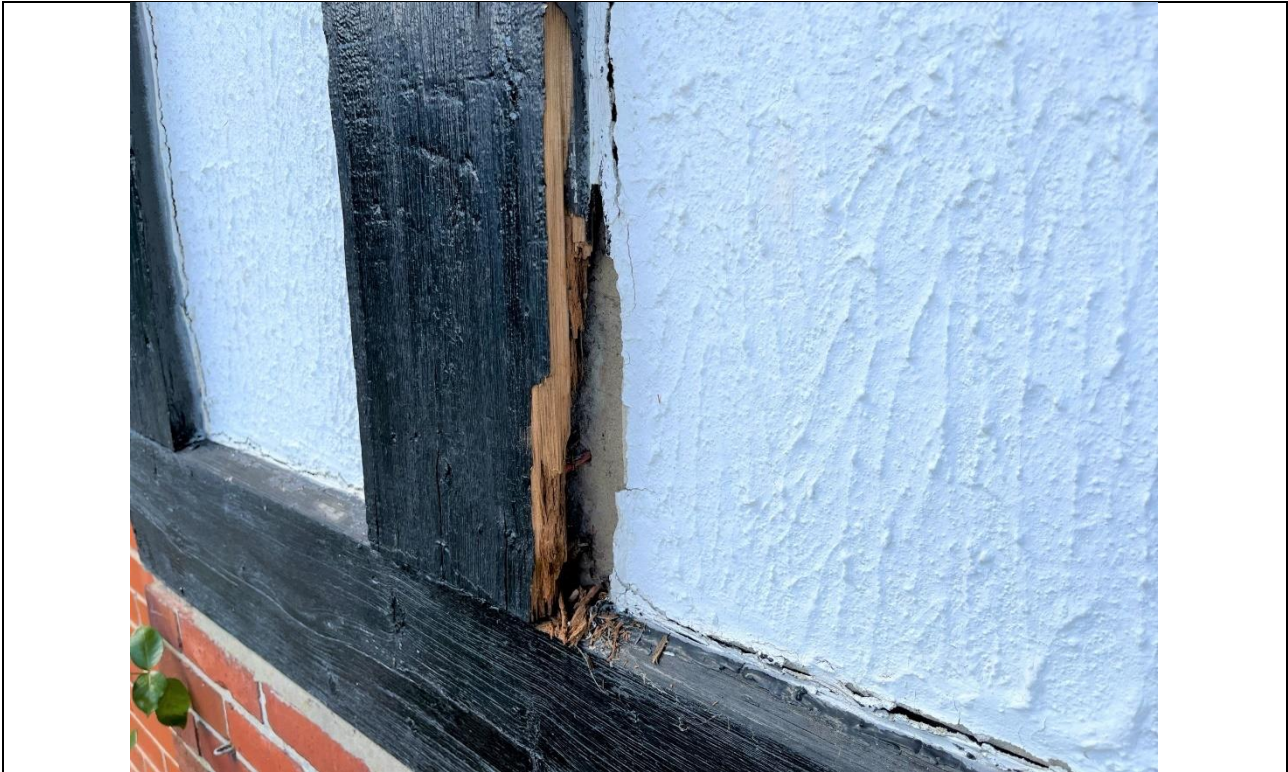
Photo 7  
Timber cladding fixed to front wall

- 3.3. The front wall is noted as a timber frame in the closure report and it would appear that timber cladding is fixed to the face of the front elevation to give a mock Tudor appearance, photo 7. Some intrusive investigation would be required to confirm the existing wall construction.
