Street Tree Appraisal Report

Resurfacing roads and footways whilst retaining street trees

December 2021

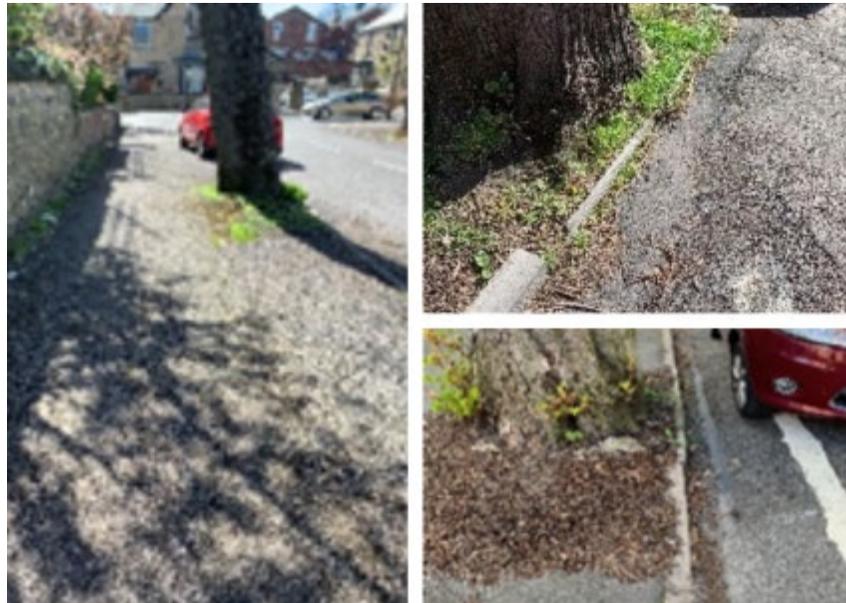
- The photo on the left shows a 25m section of the footway up to the road junction which to date has not been resurfaced;
-

- The photo on the top right is the tree located adjacent to a speed cushion. Narrow edging has been installed to replace previously missing kerbs;
- The photo on the bottom right shows' edgings installed in place of kerbs.

- Regarding the tree located adjacent to the speed cushion, the edgings are effective and currently there is no evidence of movement, therefore no further action is required apart from continuing to monitor through regular inspections;
- Further investigation is required on the other tree (see bottom right) due to potential rooting into the carriageway and to prevent damage to tree roots during any resurfacing work. The likely depth and intrusion into carriageway may result in minor deviation of kerb line with a lining solution or a build out to be considered;
- Tree pits to be constructed in the footway where required followed by footway resurfacing (photo on the left).

Whilst the use of edgings is considered a temporary measure, there is no evidence of movement to date, therefore recommend accepting a compromise to contract standards to be agreed which may apply to both trees. The aim is to minimise disturbance of the other tree, to identify root intrusion into the carriageway and implement an acceptable solution based on previous experience and good practice.

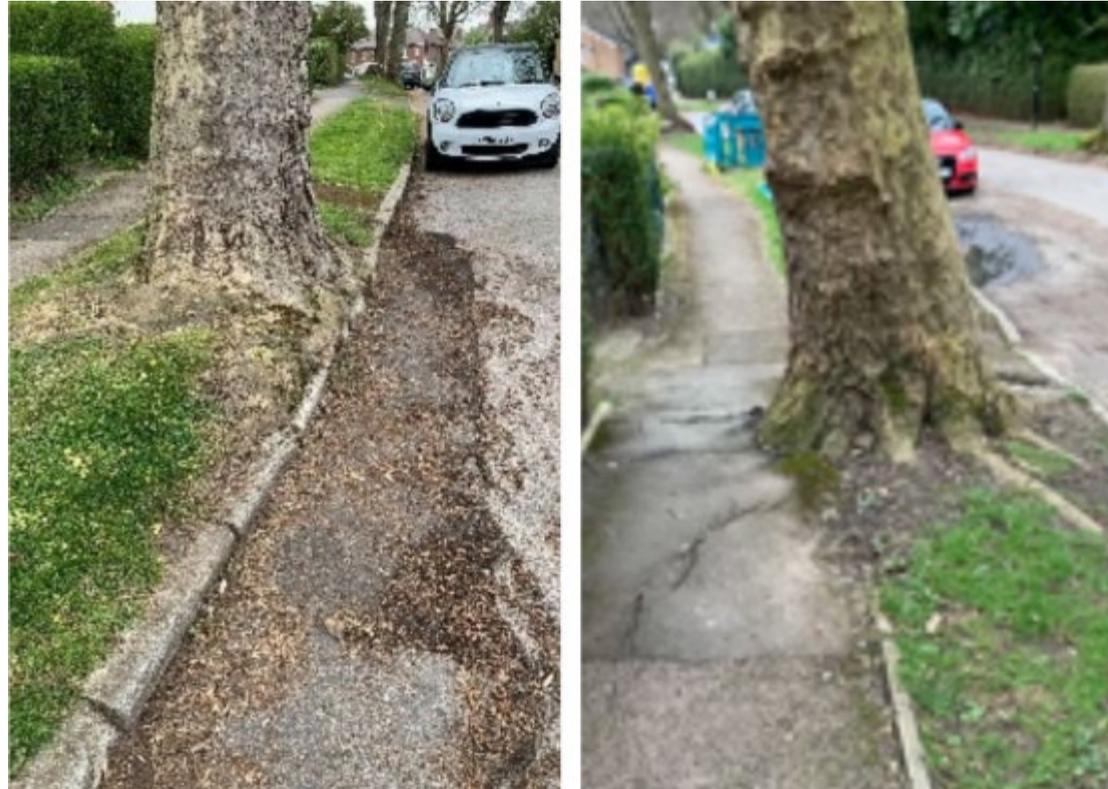
- Several carriageway defects exist which to date have prevent the conclusion of the required resurfacing work;
- Those previously identified outside 37 and 25 have been addressed, though footways remain outstanding.

- Photo on the left outside property 22: tree buttress roots have displaced the kerbs with a significant root between the kerbs extending into the carriageway. The remaining kerbs have been absorbed by the tree.
 - Photo on the right outside property 25: the defects associated with the kerb line have been concluded previously, however the footway has been narrowed and surface is uneven and in poor condition due to the tree roots.
-

- The options available to address the displaced kerbs and rooting into the carriageway are limited as removing the existing kerbs is likely to result in significant damage to the tree which is in a fair condition overall;
- Therefore, the option is limited to the installation of a built out, 600mm in width. Bollards are not considered to be a requirement, therefore minimising impact on the street scene;
- The footway requires 60mm reconstruction throughout the length of the street and in proximity to the trees, hand excavation is required. Regarding the tree outside 25, removing historic asphalt patching will enable the new surface to be laid to rectify the ramping, but in retaining the tree there is a compromise to the current width of the footway where no restrictions exist on the footway on the opposite side of the street.

To ensure the trees are retained and a permanent solution implemented, the construction of a build out is recommended, accepting that for the tree outside 25, a reduction in footway width will be required.

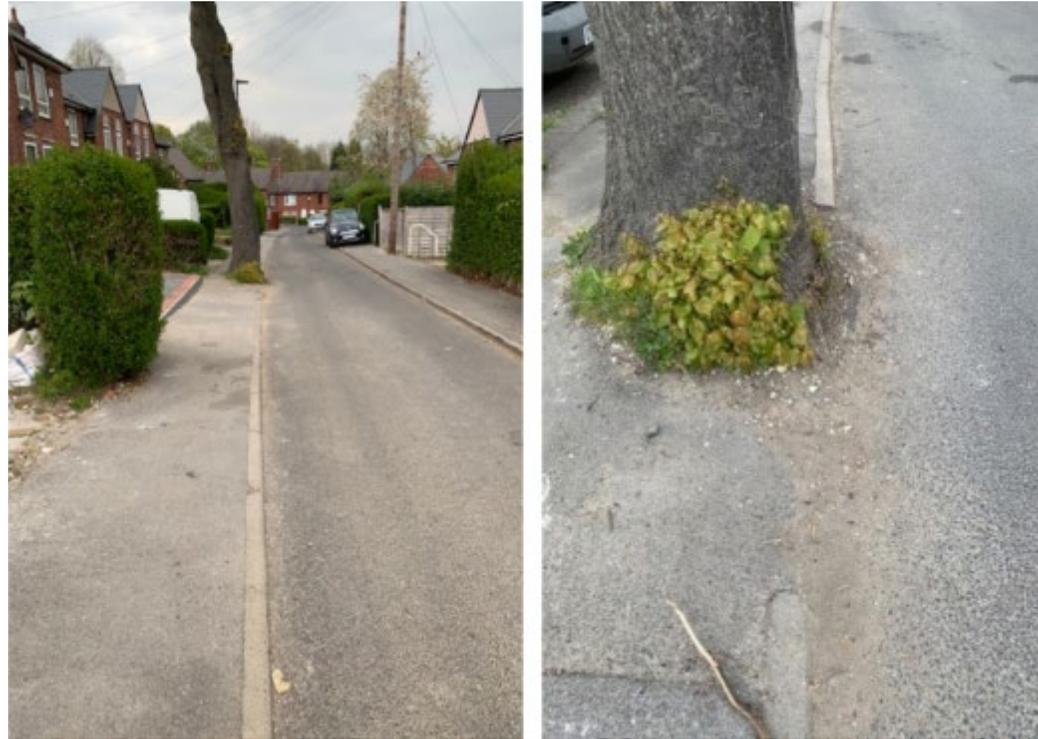
3.3 Aldfield Way

- Aldfield Way is a residential street with a single lane carriageway and one mature tree located in the footway. The footway width has been compromised by the tree, with no safe passage between the tree and its' boundary to the stem, and there is ramping of the footway due tree roots;
- The carriageway and footway resurfacing works have been completed and remain in good condition.

- The photo on the left shows the location of the tree and its' impact on the footway;
- The photo on the right shows the impact of the tree with several kerbs missing and narrowing of the footway.

- Road safety view (June 2021): as a historical layout with a single isolated tree, with alternative crossing points at Edensor and Fairbank Roads available with a low upstand on the kerbs, the road is accessible for impaired highway users. Therefore, the recommendation is to retain the tree with no alterations to the highway required;

As per the road safety view quoted above, as a historical layout with a single isolated tree, with alternative crossing points at Edensor and Fairbank Roads available with a low upstand on the kerbs, the road is accessible for impaired highway users. Therefore, the recommendation is to retain the tree with no alterations to the highway required.

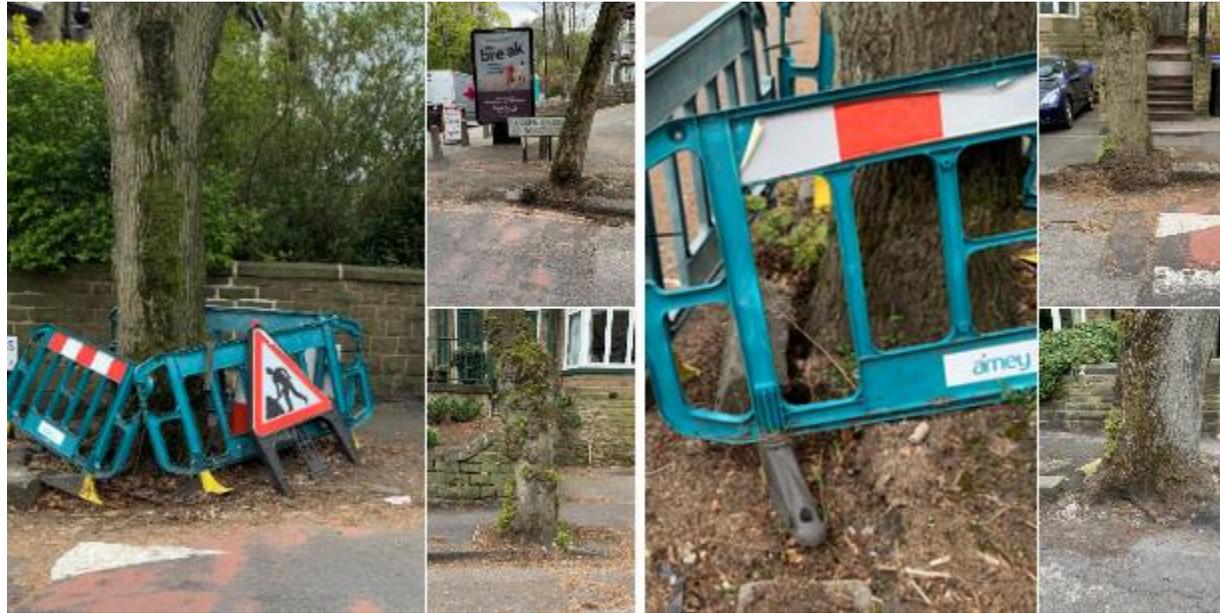
- The photos show the extent of the damage to the footway including displacement of kerbs, and kerbs which are missing, replaced by the tree stem and buttress roots. There is clear evidence of roots extending from several trees into the carriageway which will need to be investigated further. Based on current experience this is unlikely to exceed 500mm;

- Two trees are located at the junction with Ecclesall Road South. Both have displaced and missing kerbs with pedestrian barriers in place due to the extent of damage on the footway. The other shows a missing kerb only;

- Damage from the remaining trees varies, from displaced kerb, to no kerbs at all and roots encroaching into the carriageway, with footway surface defects and ramping needing to be addressed;

- In addition to the defects listed above, the tree outside number 67 leans into the carriageway but there is no other defect present.

To address the current kerb defects and rooting as shown in the outline design drawing below:

For the remaining two (2) trees where buildouts are not recommended, they can be retained using alternative materials, a relaxation of current standards, introducing the use thinner kerbs or edgings where feasible, minimising buildout and the impact on the junction with Ecclesall Road South.

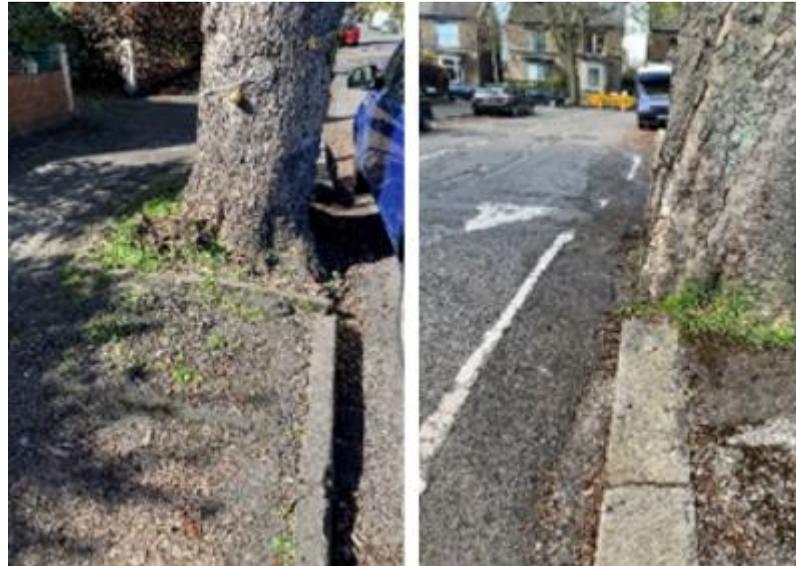
3.5 Chippinghouse Road

- Previous remedial works have addressed several defects associated with the trees and the carriageway. However, there are two (2) trees where kerbs are displaced and there is rooting into the carriageway. The carriageway resurfacing remains outstanding;
- Footway resurfacing has been completed apart from the sections surrounding the remaining trees to be addressed;
- On the opposite side to the speed cushion a tree of similar scale exists where the displaced kerbs have been replaced with edgings. There is no sign of movement therefore no further action is considered necessary.

- Photo on the left outside property 181: the tree has displaced the kerbs with evidence of roots extending into the carriageway. The footway edgings are raised and footway surfacing around the tree has yet to be completed;
- Photo on the right outside the Butler Hotel: as above the footway remains outstanding in proximity to the tree. The tree has displaced the kerbs which are now missing and is located adjacent to the speed cushion section in the carriageway.

- The tree buttress roots, and stem fill the gap of the kerb, therefore by way of compromise, leave the kerb out. It does not impede the resurfacing work and there will be no impact to the tree, therefore no excavation is required. Lining to be applied to the speed cushion to highlight the tree and missing kerbs similar to Rundle Road. It is a wide residential street with on street parking and considered low risk;

First option as above, accept the missing kerbs. It is a no cost option with no impact on the outstanding carriageway resurfacing and minimises the impact to residents and the current street scene.

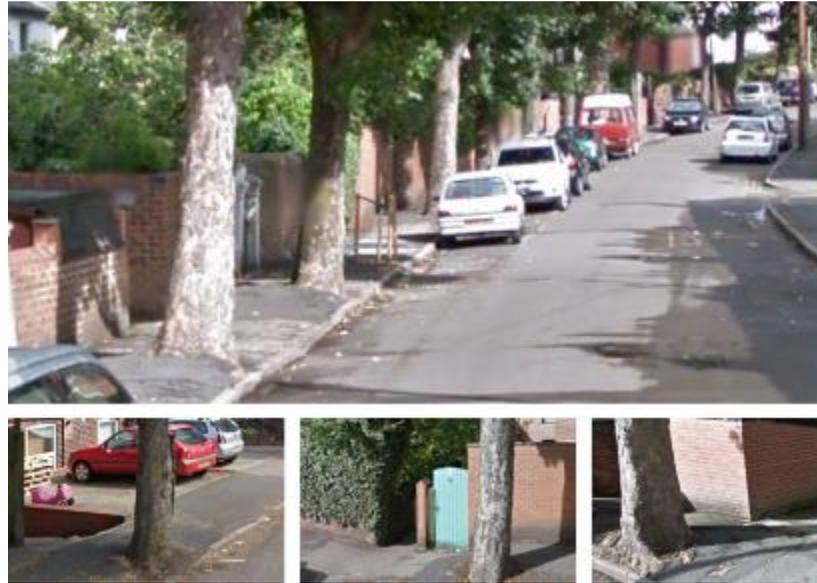
- The trees are in a narrow footway which runs adjacent to the rear of the properties. There is minor kerb displacement only. The key issue is the uneven footway due to roots, the narrowing of the footway conflicting with adjacent steps to a third-party property with implications on one tree, and another where there is significant water run-off into a third-party property and carriageway ponding that needs to be addressed.

- **Top photo:** shows a number of trees and the extent of the footway narrowing. However on the opposite side of the road there is safe passage for all users where access is restricted;
- **At the bottom left:** a narrow footway and adjacent access step to the third party property where there is a heightened risk for the footway users due to the restriction of the footway and its condition;
- **Bottom middle photo:** there is a significant gradient and profile of the footway which creates run-off of surface water into an adjacent property. The carriageway is also in a low spot where ponding occurs;
- **At the bottom right:** tree roots are evident across the footway causing an uneven surface and potentially restricting access to the driveway for the resident.

- Replacement of the tree in the bottom left photo to allow the footway to be reconstructed, providing a greater and sufficient width to allow safe passage and avoid the third-party steps, reprofiling the surface of the footway to reduce surface water run off on to third party property;

- Replacement of the tree in the bottom middle photo to allow footway to be reprofiled, lower kerbs to reduce the surface water run-off into the neighbouring property where evidence on site indicates this to be significant;

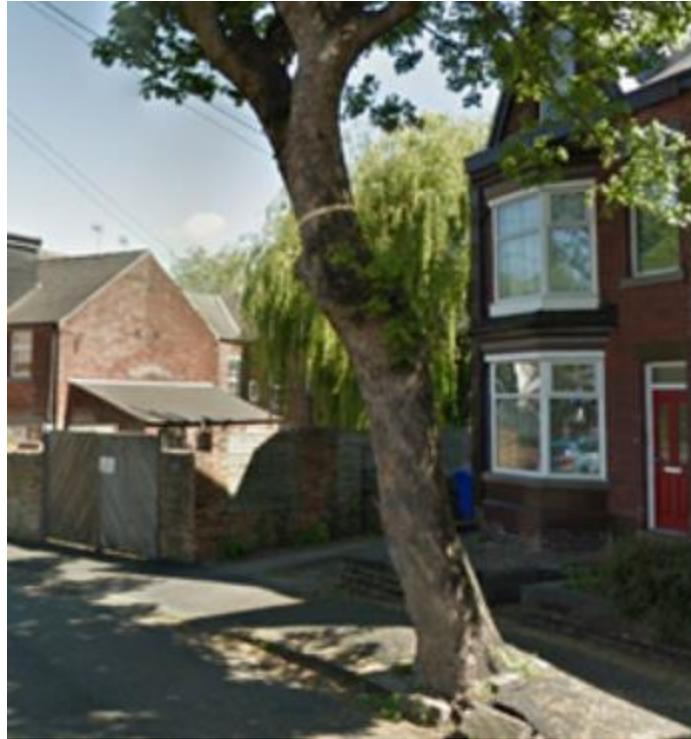
- The footway has previously been resurfaced however several tree pits need to be extended due to current damage evident from roots with ongoing monitoring and inspections;
 - Carriageway resurfacing remains outstanding due to the tree outside number 3 which to date has remained unresolved.
-

- The above photo shows the tree outside number 3. The kerbs have been replaced with edgings previously but the footway is raised due to the tree. The key issue is that the tree leans into and encroaches over the carriageway by approximately 2m. The tree is in a fair condition with no visible defects.

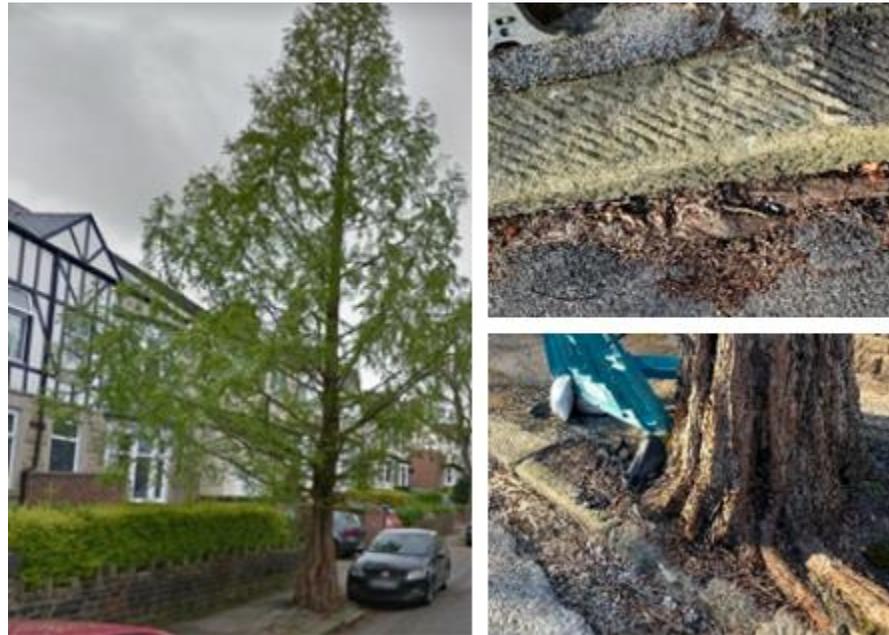
exposed roots and around one tree, safe passage is difficult. The roots extend 4m to 5m along the channel on either side of the tree (see photo top right), with kerbs displaced or missing, the footway disrupted and difficult for users to use.

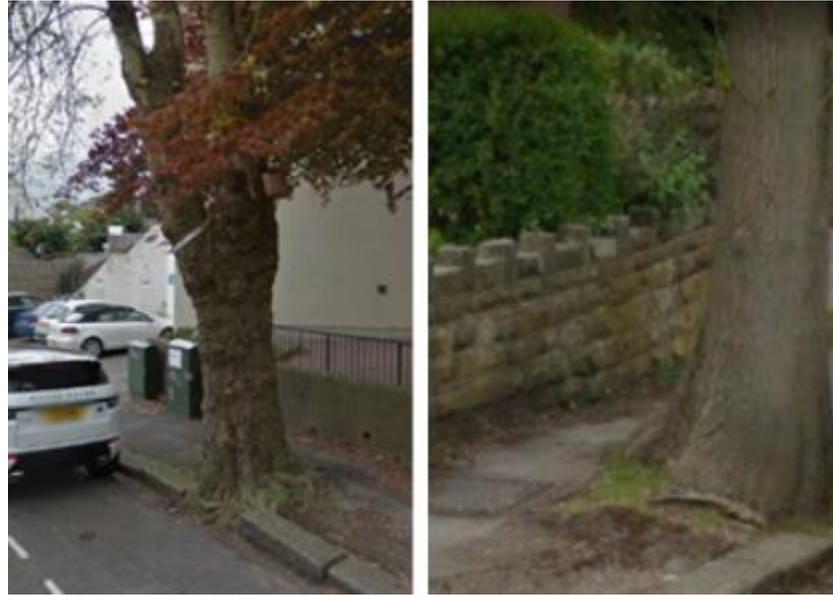
- On the left: on the junction with Ecclesall Road South, a mature Plane tree is located with kerbs missing and buttress rooting encroaching into the carriageway. The footway is narrowed due to the tree and uneven due to root damage;
-

- On the right, there are a further six (6) trees causing damage. One of the six located outside 45 is a mature Ash tree. Other species include Alder, planted at a similar time as the Dawn Redwoods. The damage is significantly less but there is cracking and raised areas along the footway.

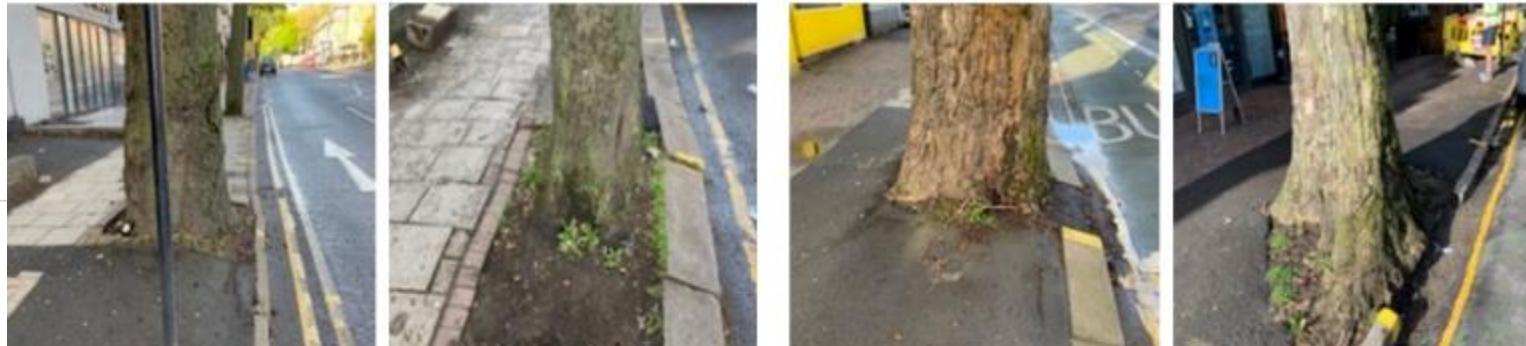
- The photos are a sample of the current defects present along the road, including locations where several footway defects have previously been resolved. For example, by removal of the flagged footway surface and replaced with an asphalt surface in 2019 which is now cracking due to movement and presence of tree roots;

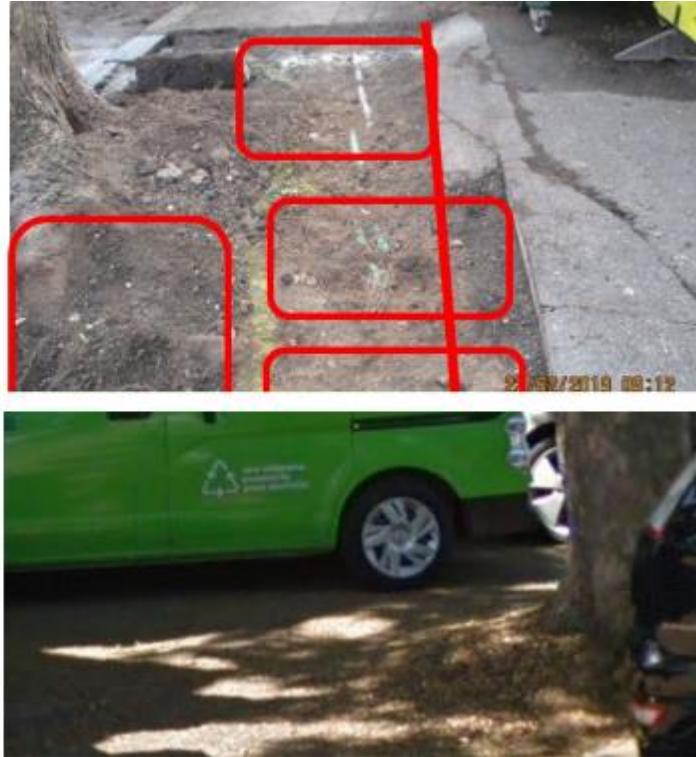
- Top photo: excavation of the footway in February 2019 revealed significant shallow rooting (red boxes indicate main areas). The red line indicates the limit of the adopted highway;
- Bottom photo: due to roots present in the footway, pedestrians are required to walk on the adjacent property to pass the tree.

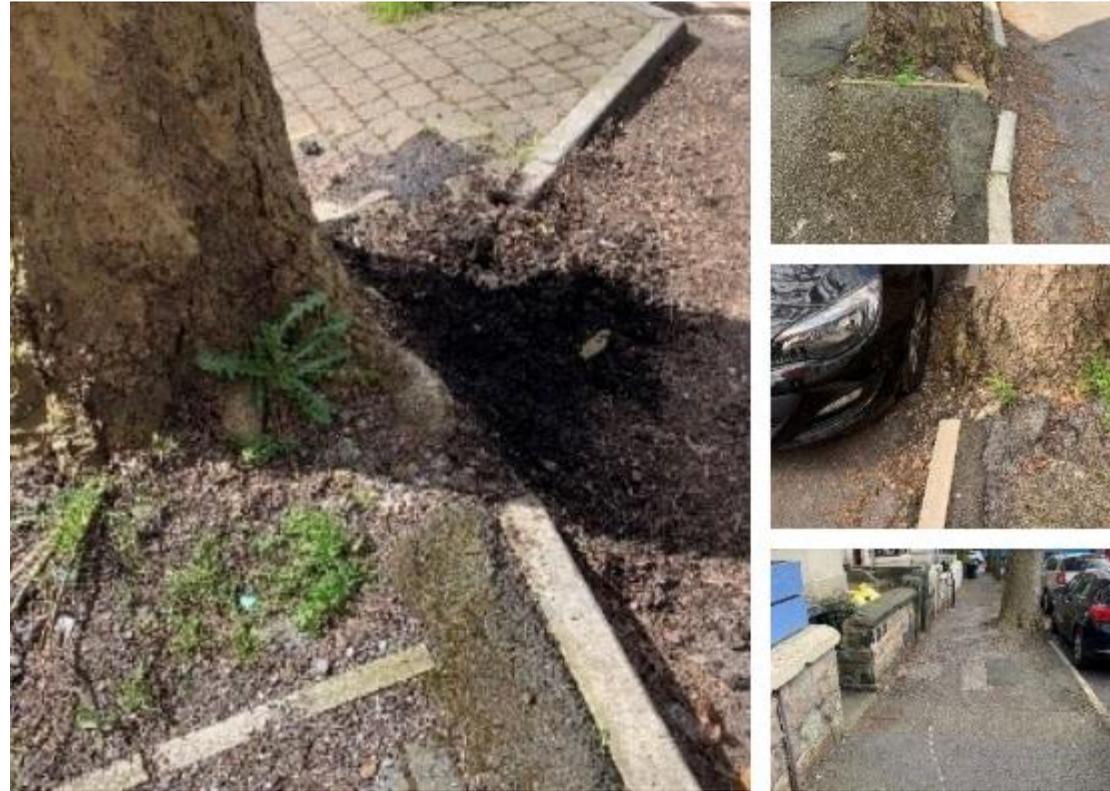
3.11 Gatefield Road

- The works outstanding from the early investment stage is a 40m approximate section along Gatefield Road to the junction of Abbeydale Road of both footway and carriageway due to three (3) trees where kerbs are missing, tree pit edgings are raised necessitating reconstruction;

- Photo on the left shows the displaced kerbs on the footway build out at the junction of Abbeydale Road;
- Top & middle left photos show the trees on either side of the road where the kerbs have been displaced due to the stem and buttress roots being in the kerb line. Reinstatement or use of thinner kerbs is not possible;
- Photo bottom right shows where the section of footway surfacing remains to be completed.

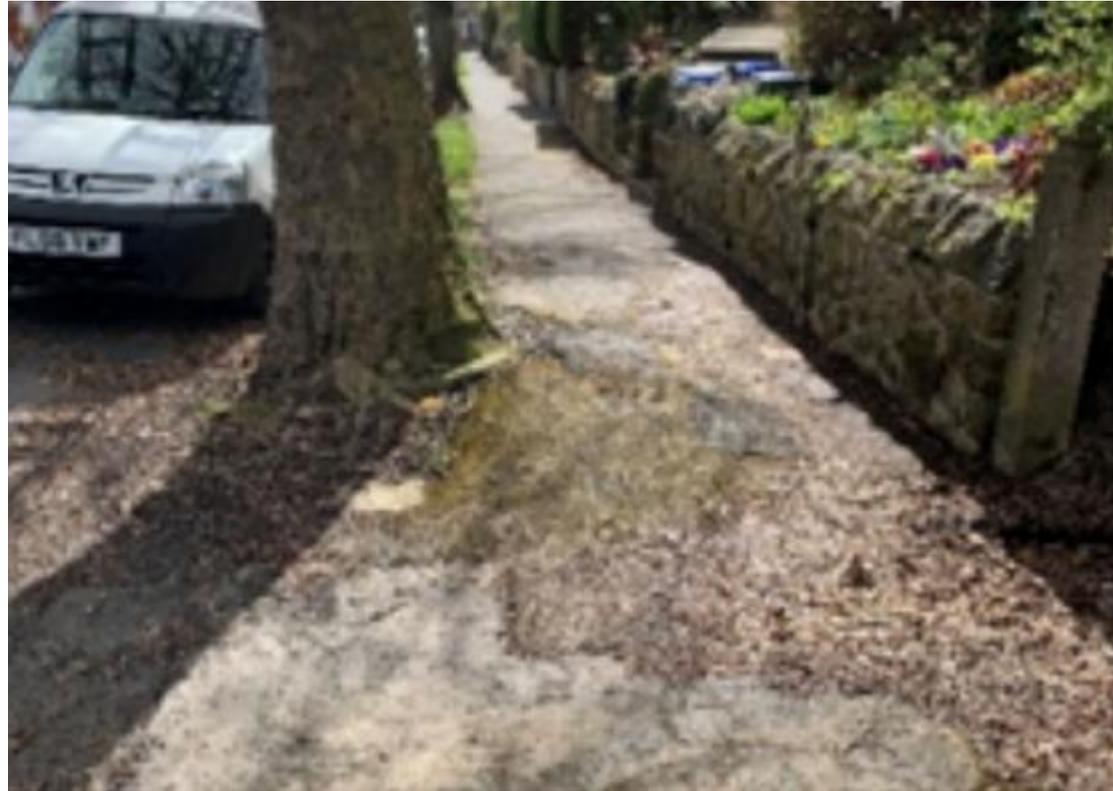
- Carriageway and footway resurfacing work has been completed during the early investment stage, however outside property number 21, the kerb line is missing with the tree buttress roots filling the void created and a footway patch either side of the tree remains to be completed;

- The photo above shows the tree and location of the missing kerbs plus outstanding footway patches to be resurfaced which will conclude all necessary work on the street.

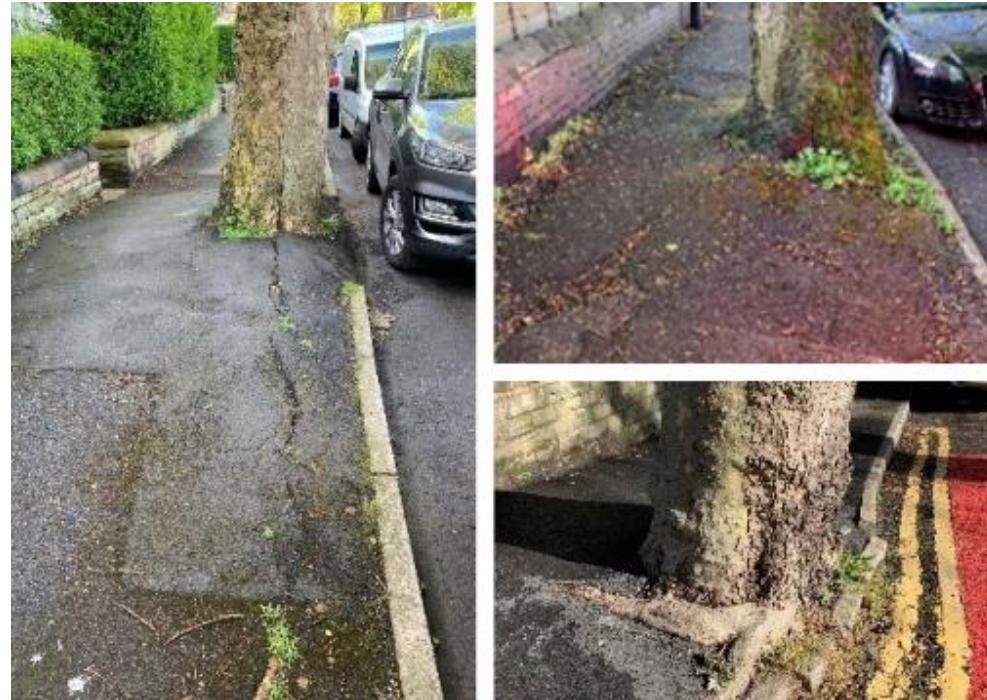
- Previous remedial works undertaken on the initial nine (9) trees identified for replacement resulted in a number successfully retained with thinner kerbs and footways addressed through the removal of historic asphalt overlays;
- However, several defects remain at the junction with Psalter Lane and outside number 155. Carriageway and footway resurfacing remains outstanding.

- **Photo on the left:** outside property 155 where the kerb has been displaced due to the extent and size of roots and cannot be reinstated. An asphalt inlay was constructed in the place of the kerb as a temporary measure. The pavement patch completed at the same time has failed 2 years on creating an uneven surface, further investigation have been undertaken in August 202, summary provided below:
-

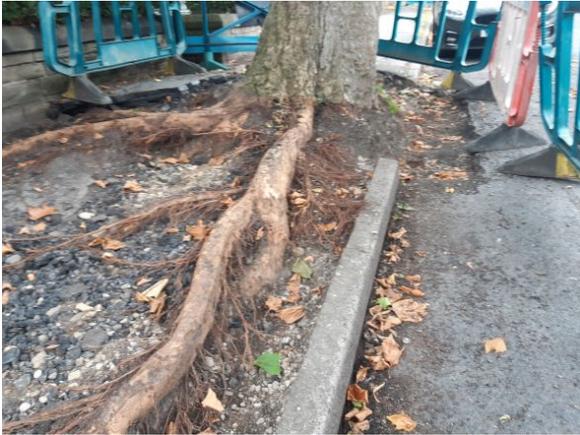
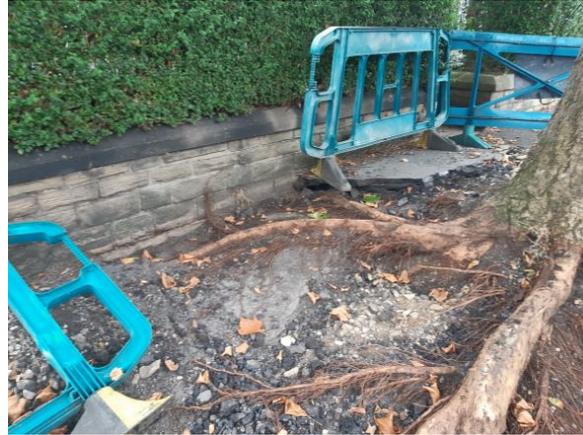
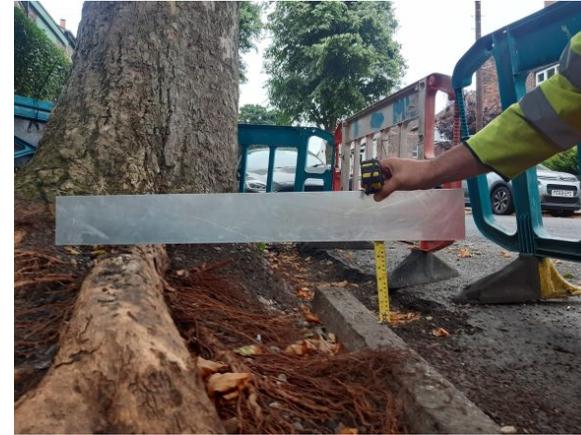
Tree Outside 155 Hunter House – Site Investiagtion

The photos above show the extent of the roots running along the footway, up to an under the private boundary wall causing damage. The upstand of the roots above the footway / kerb face is 180mm.

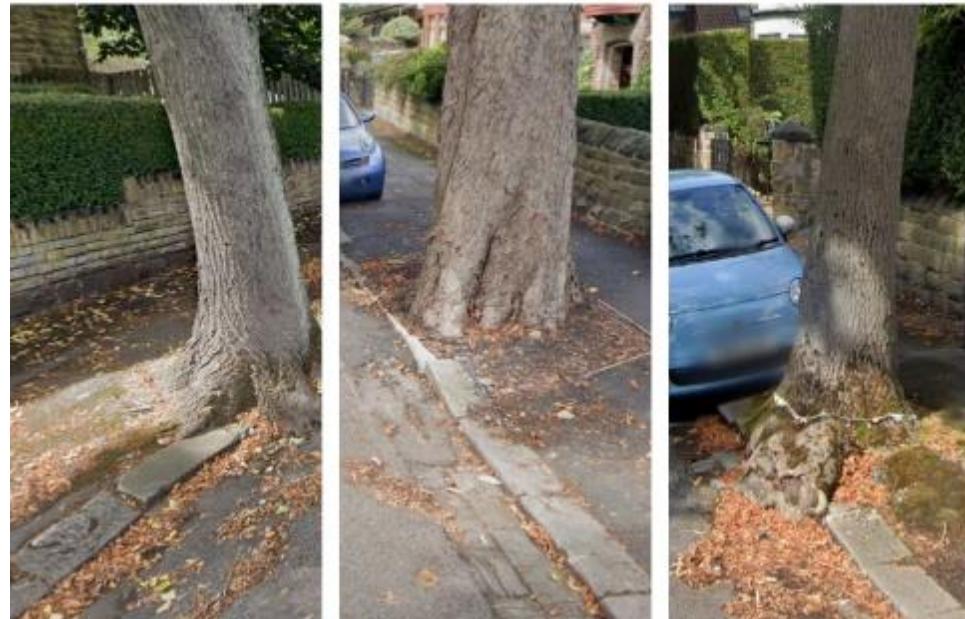
- Extensive uplift of the footways and kerb displacement with rooting into the carriageway;
- Extensive site investigation was undertaken in May 2021 to inform the proposals outlined below. The following images show the extent of the damage that is evident, with displaced kerbs, extensive rooting into the carriageway and the image far right show previous remedial works undertaken which addressed the footway and kerb but did not address the rooting in the carriageway which impedes successful resurfacing of the street.

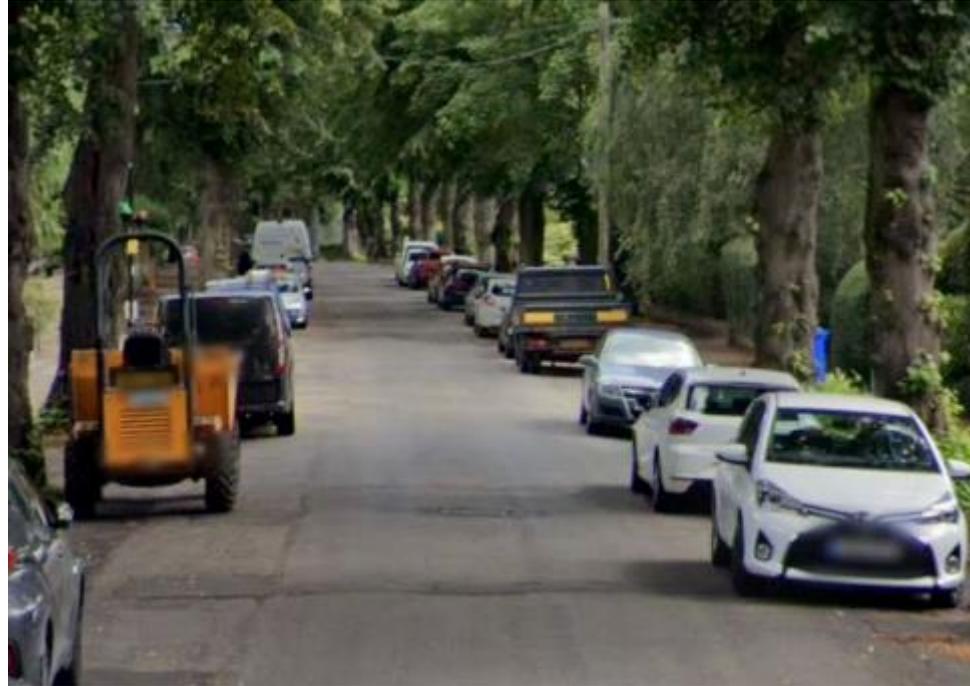
3.15 Kenwood Park Road

- In the early investment stage, fifteen (15) trees were identified for replacement out of the total tree population. In May 2021, further investigations were undertaken on what is a wide, residential, heavily tree-lined street. The number of defects associated with the trees and the carriageway far exceed 15, with multiple kerbs missing or displaced and tree roots extending into the carriageway.

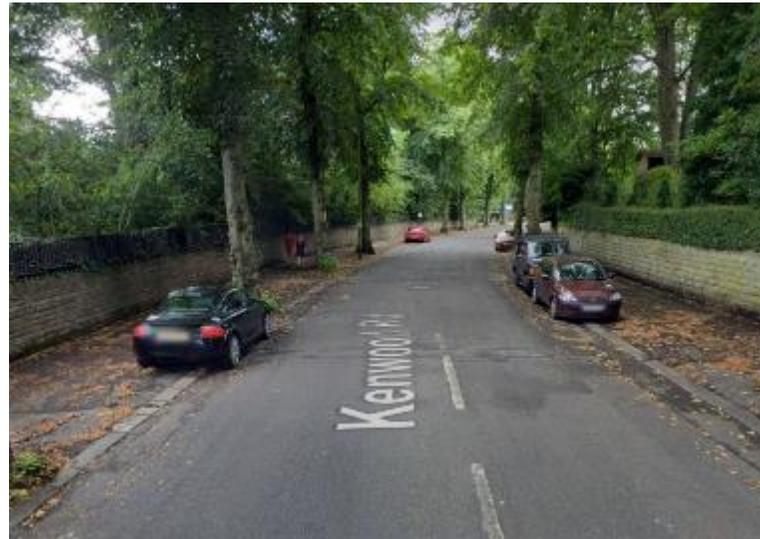
- In the early investment stage, seven (7) trees were identified for replacement. Over recent months, further investigations have been concluded, highlighting a greater number of defects associated with the street trees;
- Most of these defects are being corrected at the point of investigation or require minor deviations to the kerb. However, several trees leaning into the carriageway are a risk to high sided vehicles and need to be addressed.

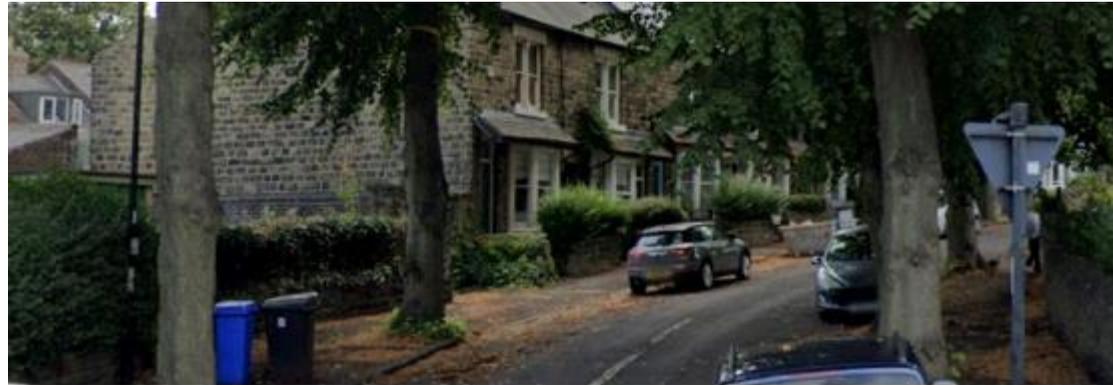
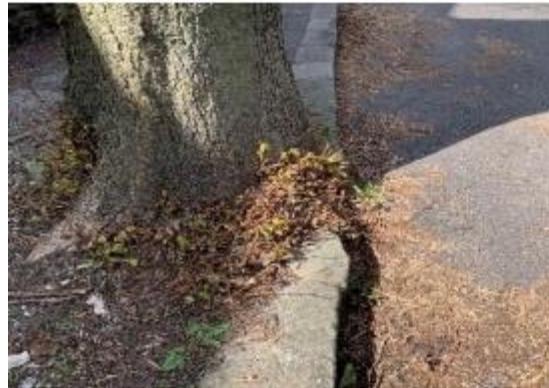
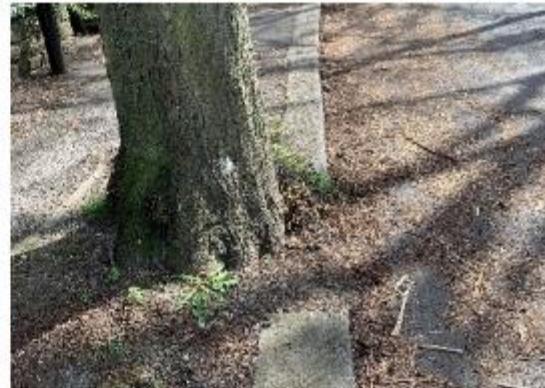
- On entering Ladysmith Avenue from Machon Bank Road there are several Lime trees on both sides of the carriageway where kerbs are missing, and the buttress roots extend into the edge of the kerb line or into the carriageway;
- This is replicated along the length of Ladysmith Avenue, where the trees are of a similar age and size. Eight (8) out of the ten (10) trees present have displaced kerbs or kerbs are missing. The footway overall has minor defects.

- Top photo shows the trees as you enter Ladysmith Avenue from Machon Bank Road;
- Photo bottom left shows the missing kerbs on the first tree on the right as you enter Ladysmith Avenue;
- Photo bottom right shows the tree on the left as you enter Ladysmith Avenue, again with missing kerbs.

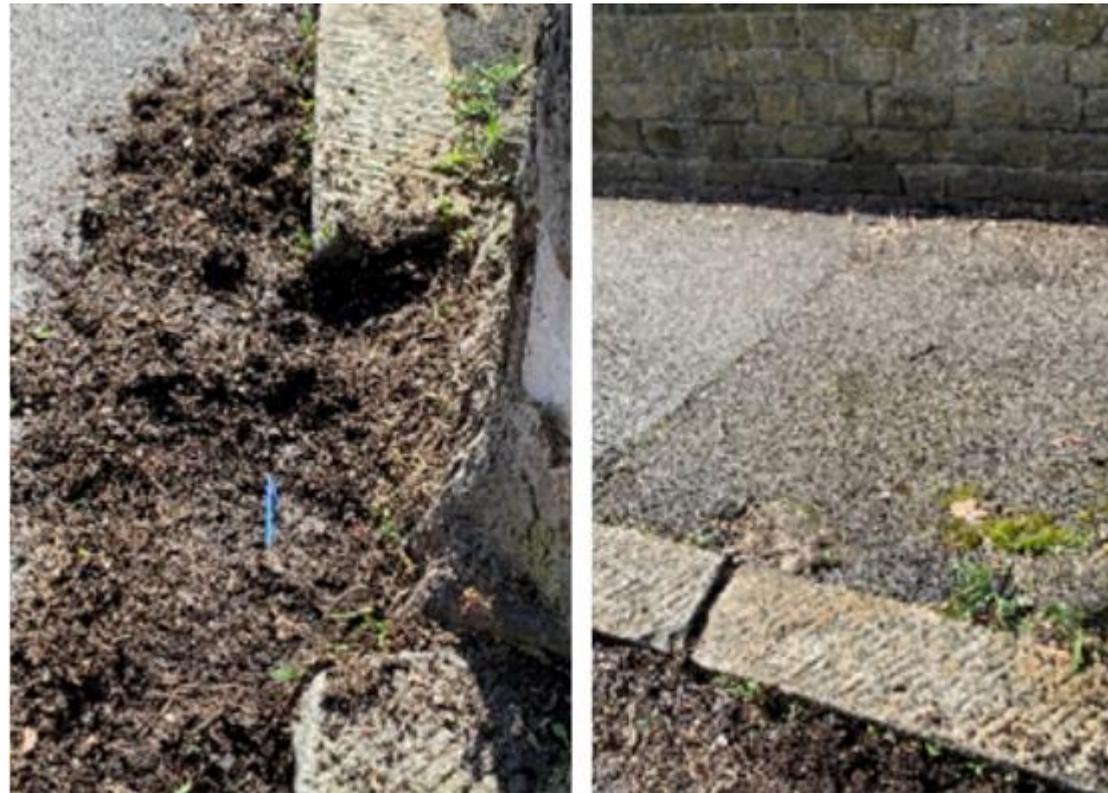
- **On the left:** The kerbs have been displaced by the buttress roots, with roots in line with the outer edge of the kerb line. This prevents the kerb from being reinstated and pruning a root of that size is not feasible;
 - **On the right:** the footway has some minor ramping and roots present.
-

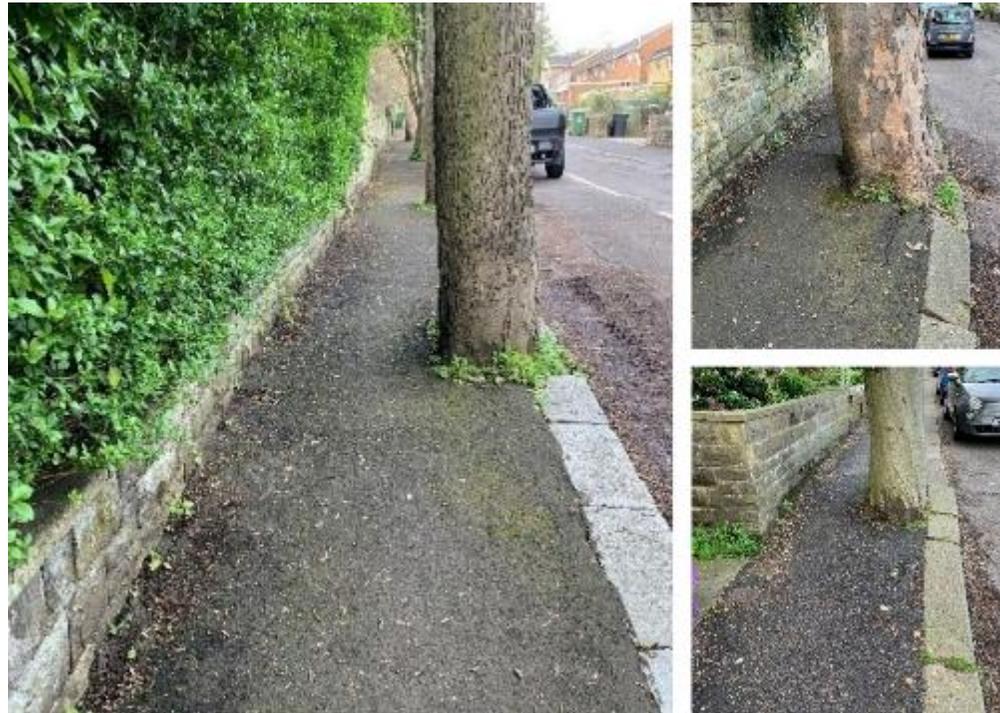
- **Left photo:** the kerb has been replaced with edgings, however there is evidence of roots extending into the carriageway;
 - **Top right photo:** the kerb is no longer present, and the void is filled with the tree buttress root. There is no visual evidence of roots extending into the carriageway that will impede resurfacing work;
 - **Bottom right photo:** kerbs have been displaced by the tree but remain in-situ.
-

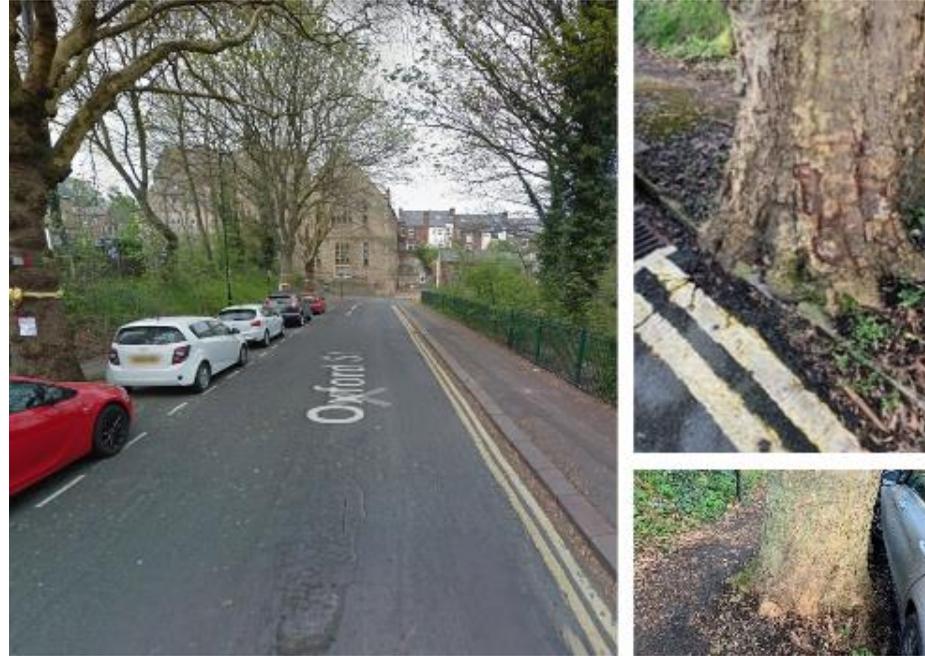
Section One

- The photos on the right show the current condition of the kerbs which are displaced and missing due to the presence of the trees, mature Planes, which are in a fair condition;
- Parking is a premium in the area as shown in the photo on the left, with two trees located inside parking bays and another on the outer edge inside the double yellow lines.

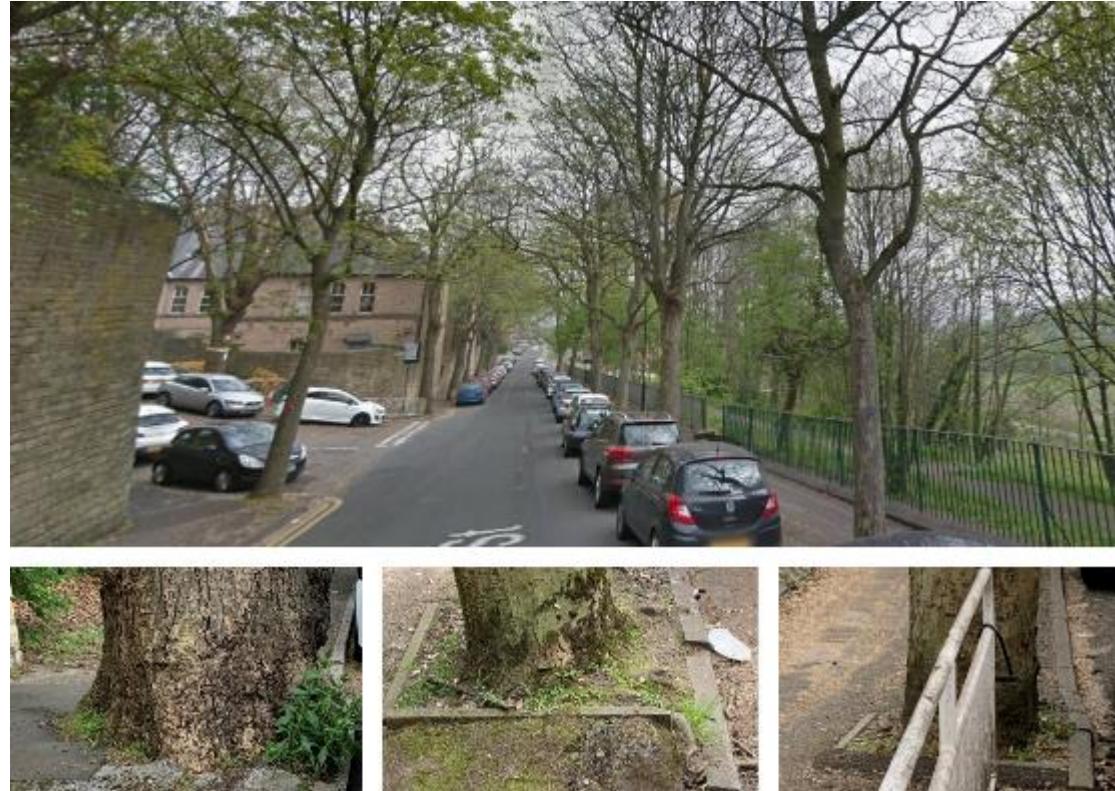
Section two:

The photos above show the common defects that exist along the length of the road, from minor kerb displacement, raised tree pit edgings and footway defects that need to be addressed.

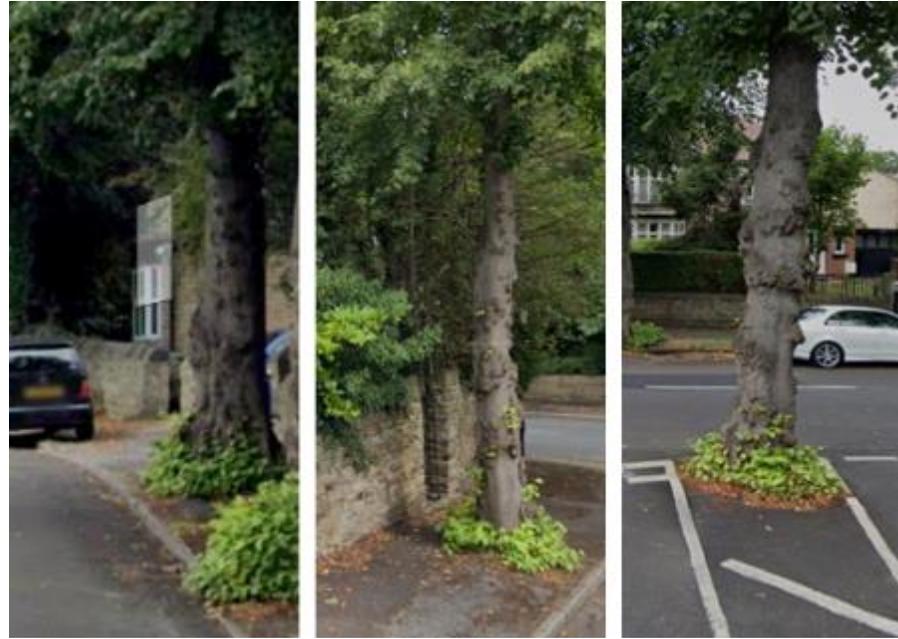
- On the left, the photo shows the extent of the narrow footway due to the trees and epicormic growth; the middle photo is the tree located at the junction of Moncrieffe Road;
- The photo on the right shows the tree located in the junction of Ryle Road and Montgomery Road.

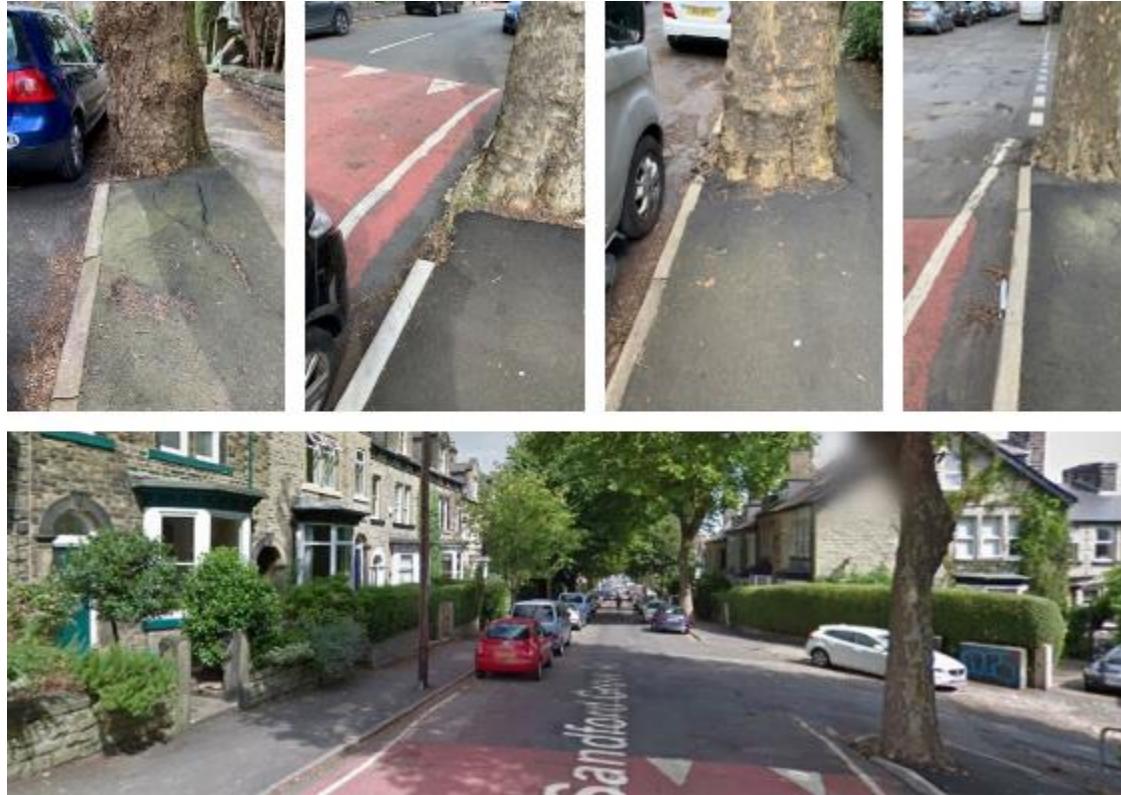
Top right photo: located on the junction of Marden Road, the kerbs have been displaced with an asphalt infill in place. There is no visible evidence of rooting into the carriageway. Both footway and carriageway resurfacing remain outstanding;

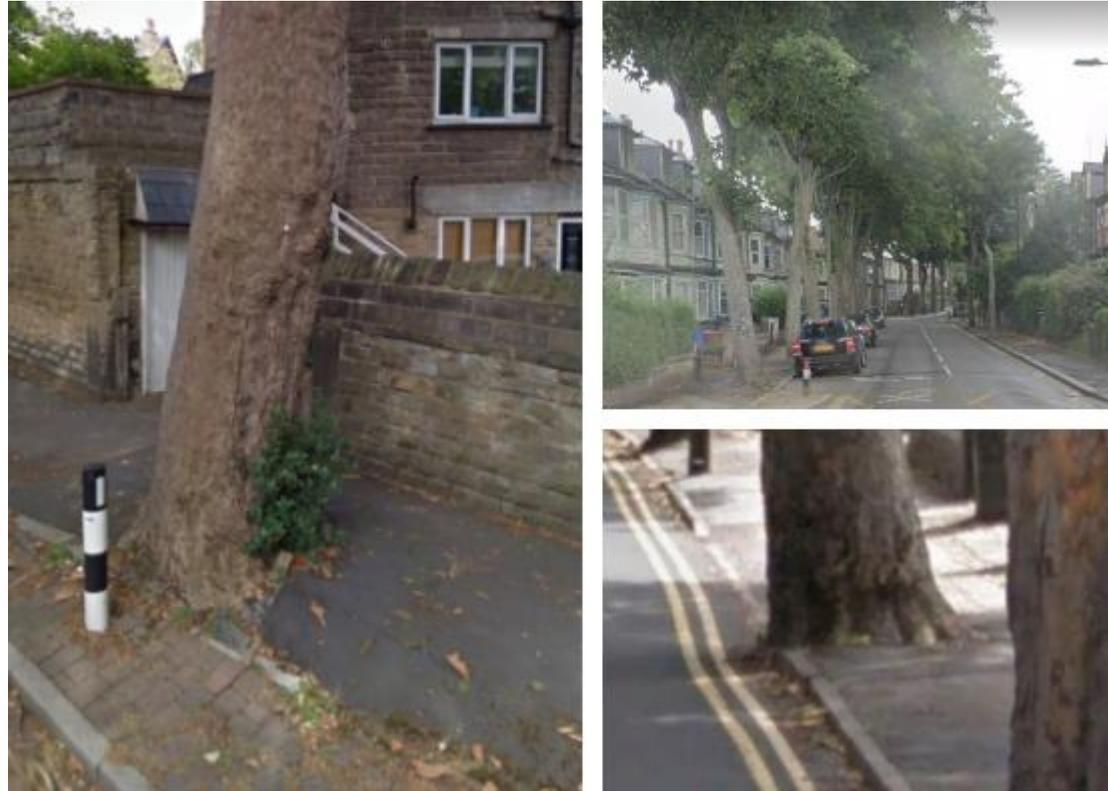
- Top right photo shows the overall tree coverage along Sheldon Road affecting both sides of the carriageway;
- Bottom right photo shows several trees where kerbs are missing and narrowing of the footway;
- Photo on the left shows a restriction of safe passage along Sheldon Road due to the tree.
