Street Tree Appraisal Report

Resurfacing roads and footways whilst retaining street trees

December 2021

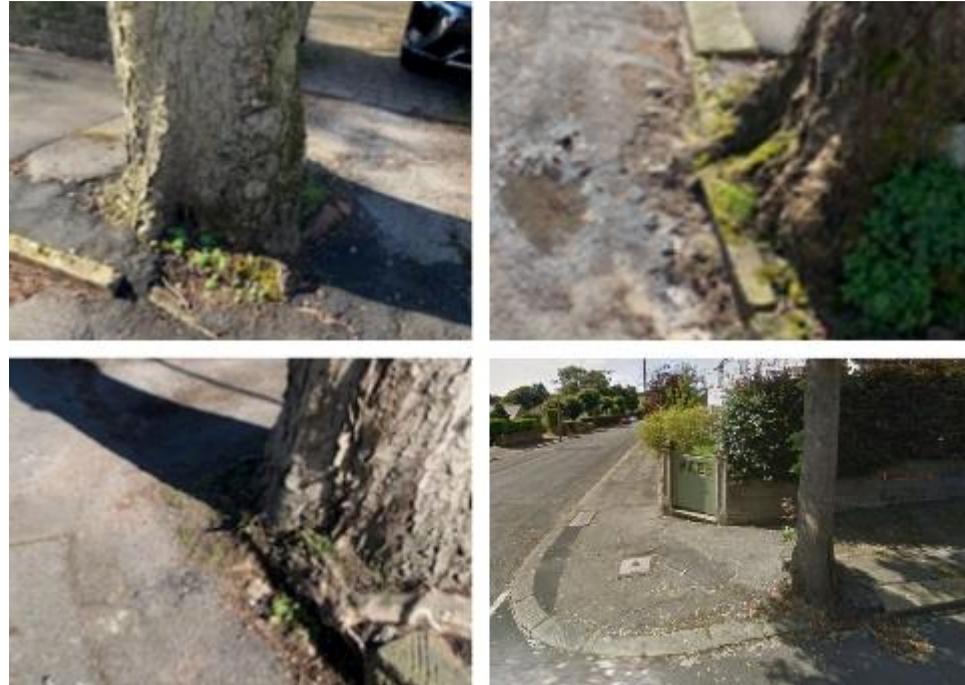
- **Top left outside 17:** access to the property is currently achievable but may be problematic in the future;
- **Top right outside 29:** major stem encroaching into the highway with kerbs displaced and edgings used previously;
- **Bottom left outside 18:** major stem encroaching into the carriageway;
- **Bottom right:** missing kerb although tree is in a fair condition at the junction of Mylnhurst Road.

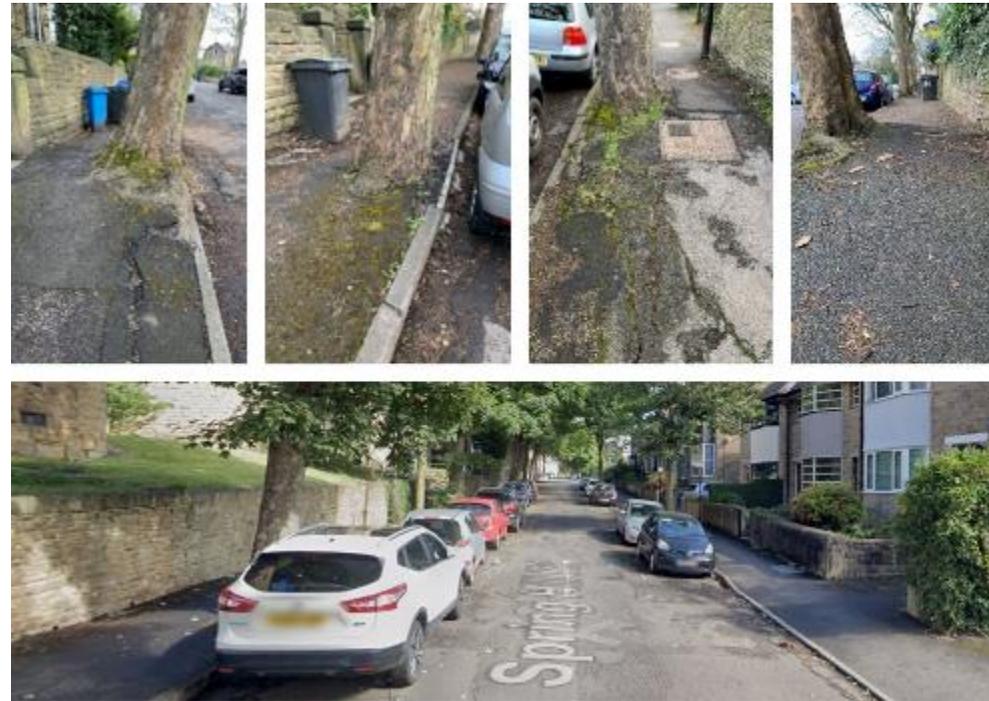
- **Top left photo:** shows defects in the footway and missing kerbs with previous patches evident to address the failing surface;
- **Middle left photo:** a short-term solution of installing edgings to replaced previously missing kerbs;
- **Middle right photo:** shows the extent of footway damage with ramping near a utility cover and associated chamber;
- **Bottom right photo:** there is significant ramping of the footway due to tree roots present.

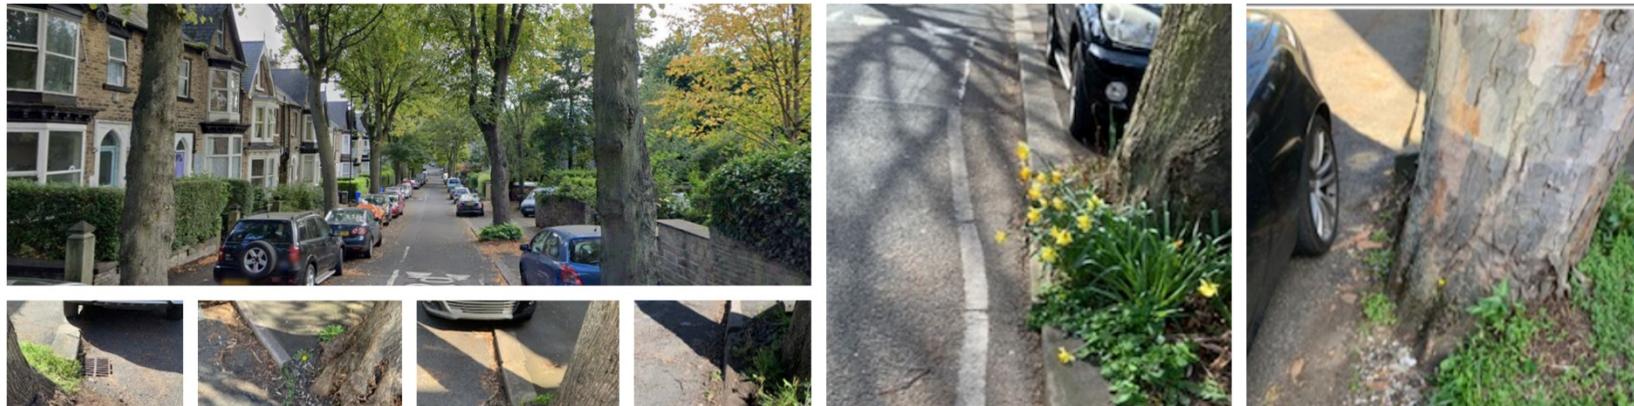
The photos above are a sample of the issues to be addressed such as missing kerbs and tree buttress roots extending into the carriageway. Out of the thirteen (13) trees of concern, up to eight (8) trees along the length of Steade Road are impacting on the kerb line, with kerbs either missing or displaced and with roots potentially extending into the carriageway. Overall, the footway defects consist of minor ramping and cracking due to tree roots.

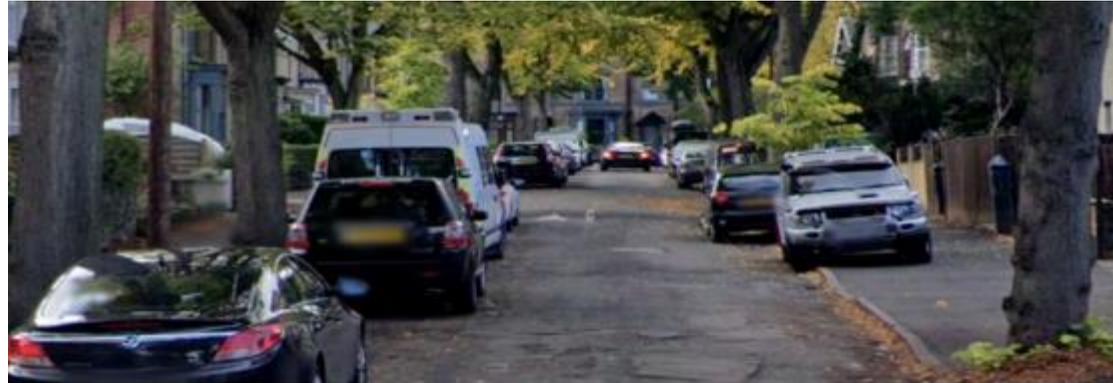
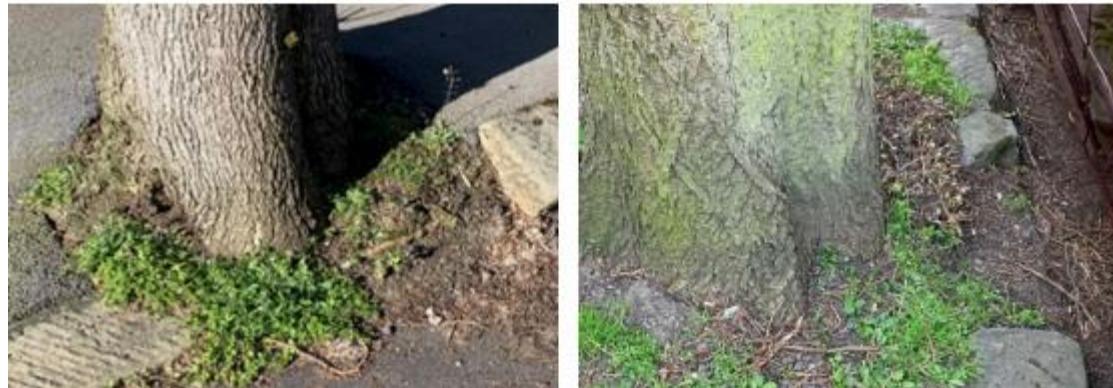
- The photos above are a sample of the issues identified on the street resulting from the presence of mature trees which are in fair to good overall condition;
- Neither the footway nor carriageway have been resurfaced to date.

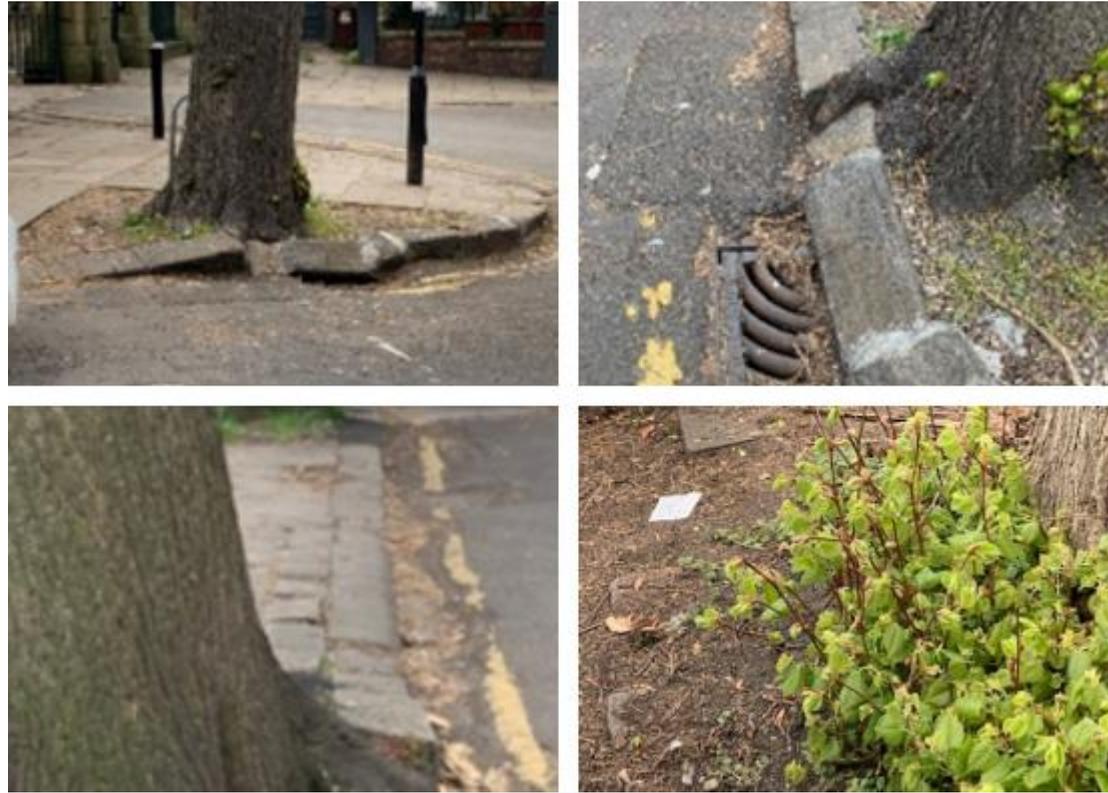
- Above photos of the tree located at the park entrance where kerbs have been displaced and there is significant root in the kerb line. The gully has also been buried by the displaced kerbs;
 - Photos below show the damage to the footway due to the presence of tree roots which have raised the flag stones. To rectify the trip hazards, the flag stones have been lifted and replaced with an asphalt surface path.
-

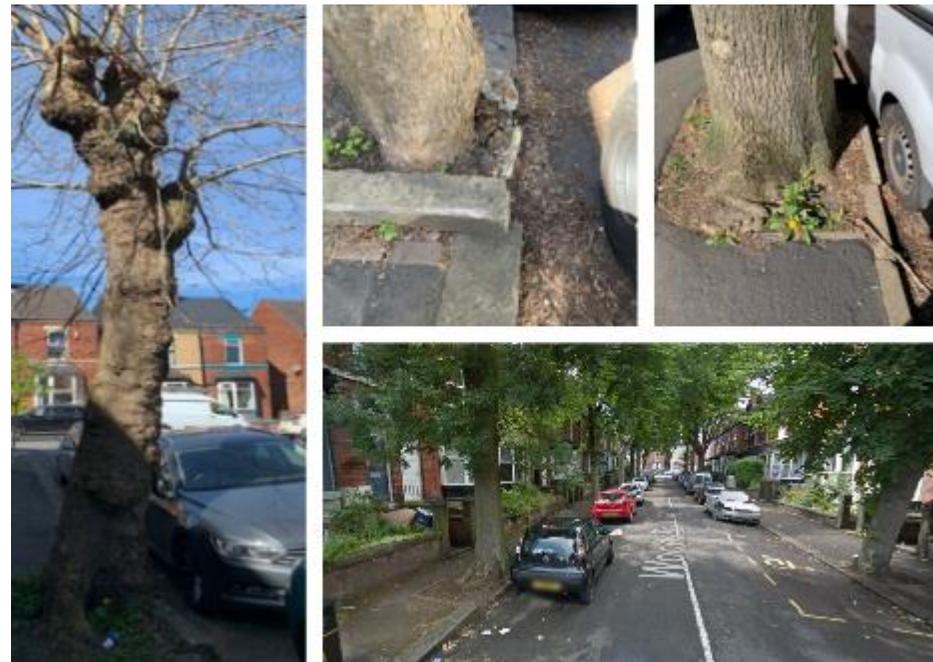
- **Top right photo:** a sample of the condition of the kerb line in the vicinity of the six (6) Ash trees along the road;
- **Top left photo:** an example of other defects along the road caused by trees other than Ash. Displaced or missing kerbs or where previous remedies have failed such as the installation of edgings outside numbers 66, 67, 71 and 82;
- **Far left photo:** outside number 19 is a mature Plane tree that has been topped. Its' form is poor, and the kerbs have been displaced.
