# **REPORT ON WESTERN ROAD**

## Report on Western Road:

## REPORT ON WESTERN ROAD – TREE PROPOSALS

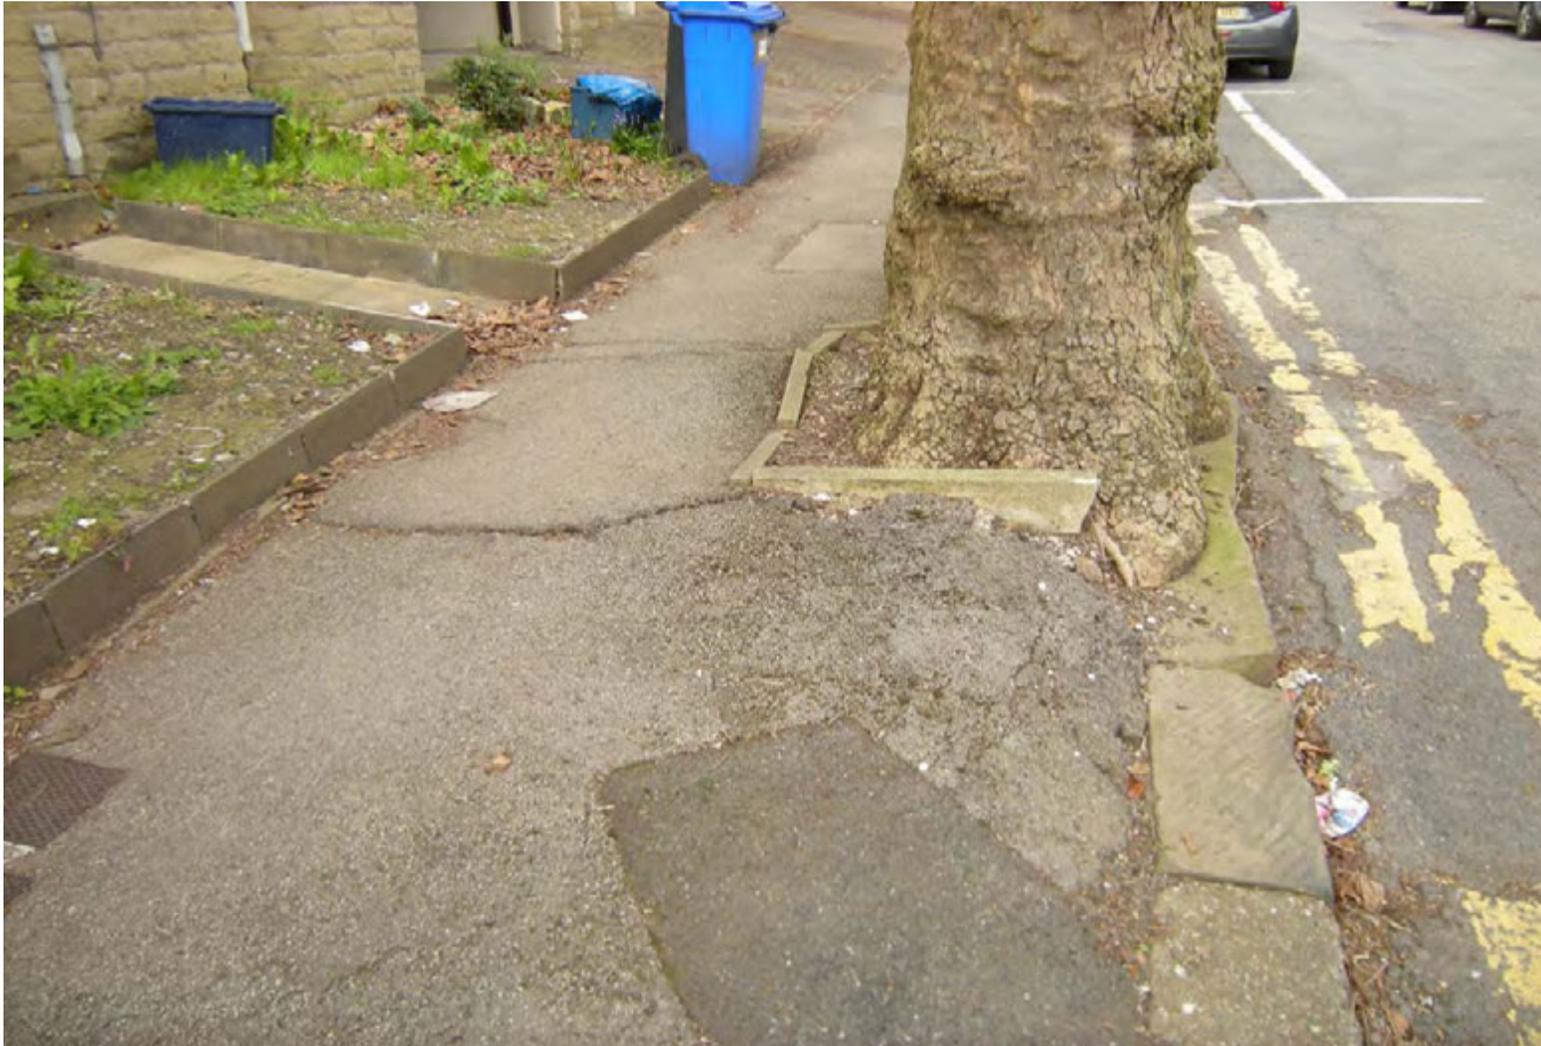
**Outside No 47: SA. Recommend Replacement: ITP in Agreement:**

Kerb Displaced by buttress, footway already ramped by shallow root disturbance causing backfall, also roots tracing into the adjoining property.

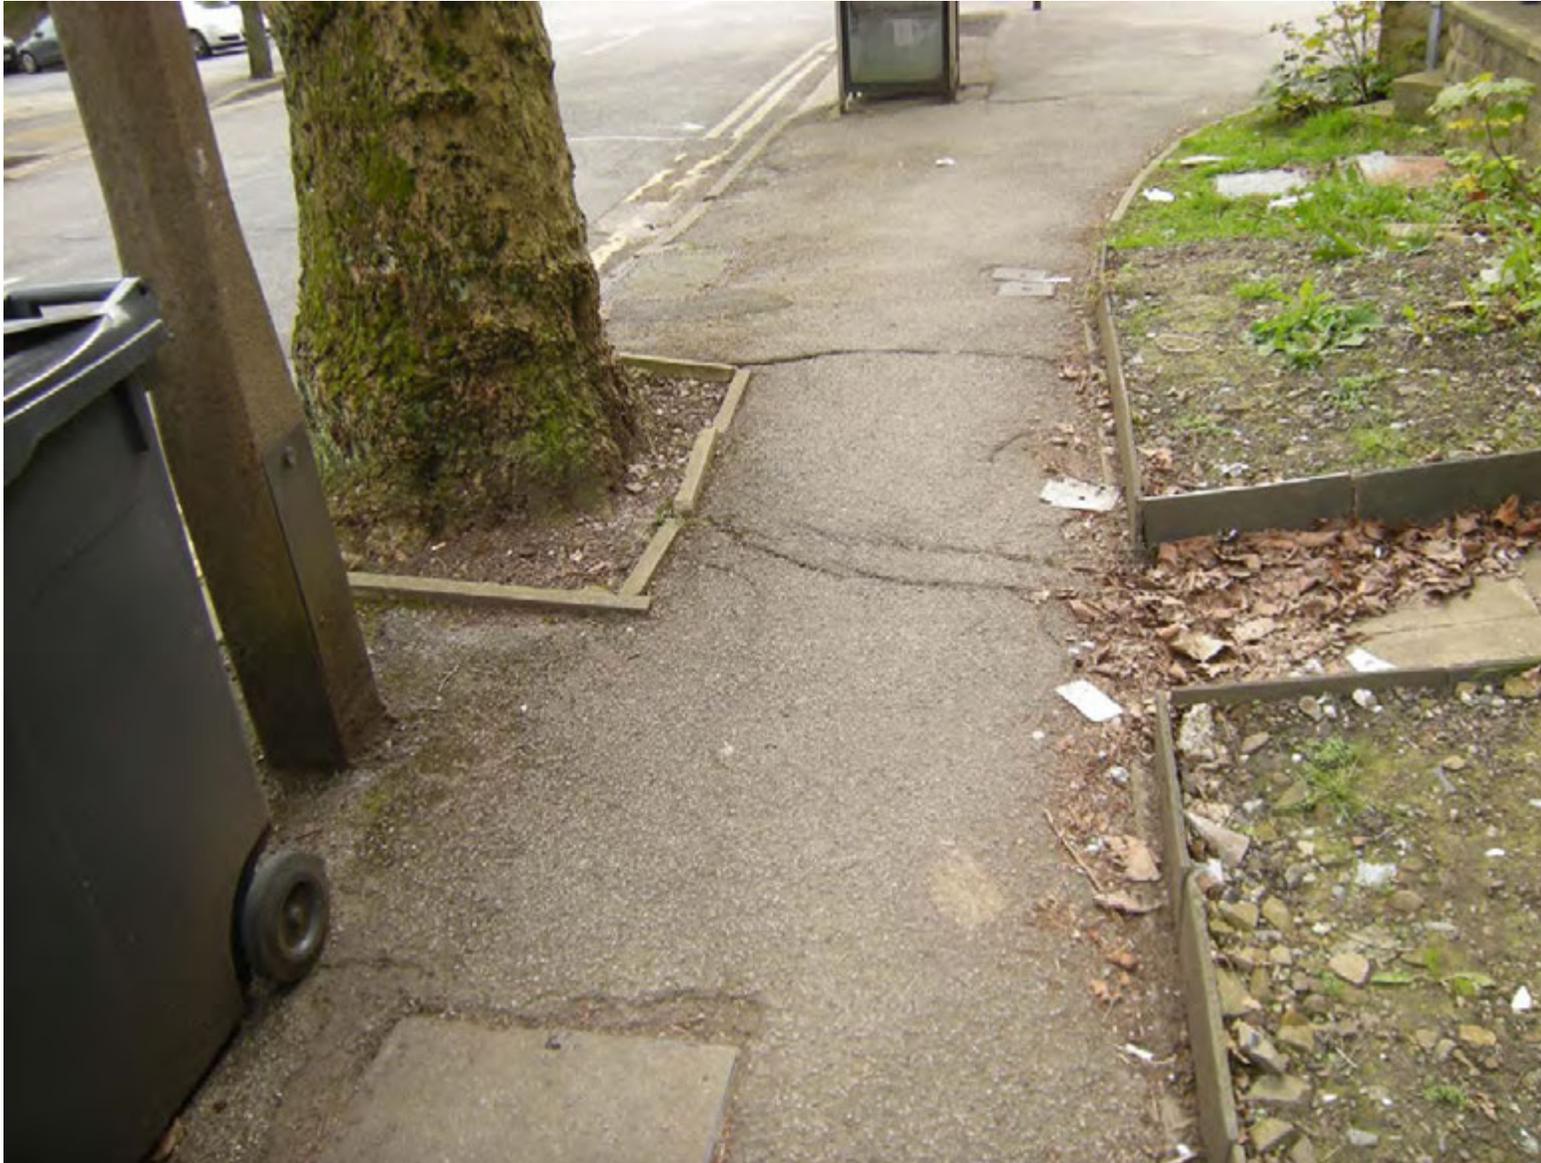
O/S 47 Additional showing roots tracing to forecourt area.

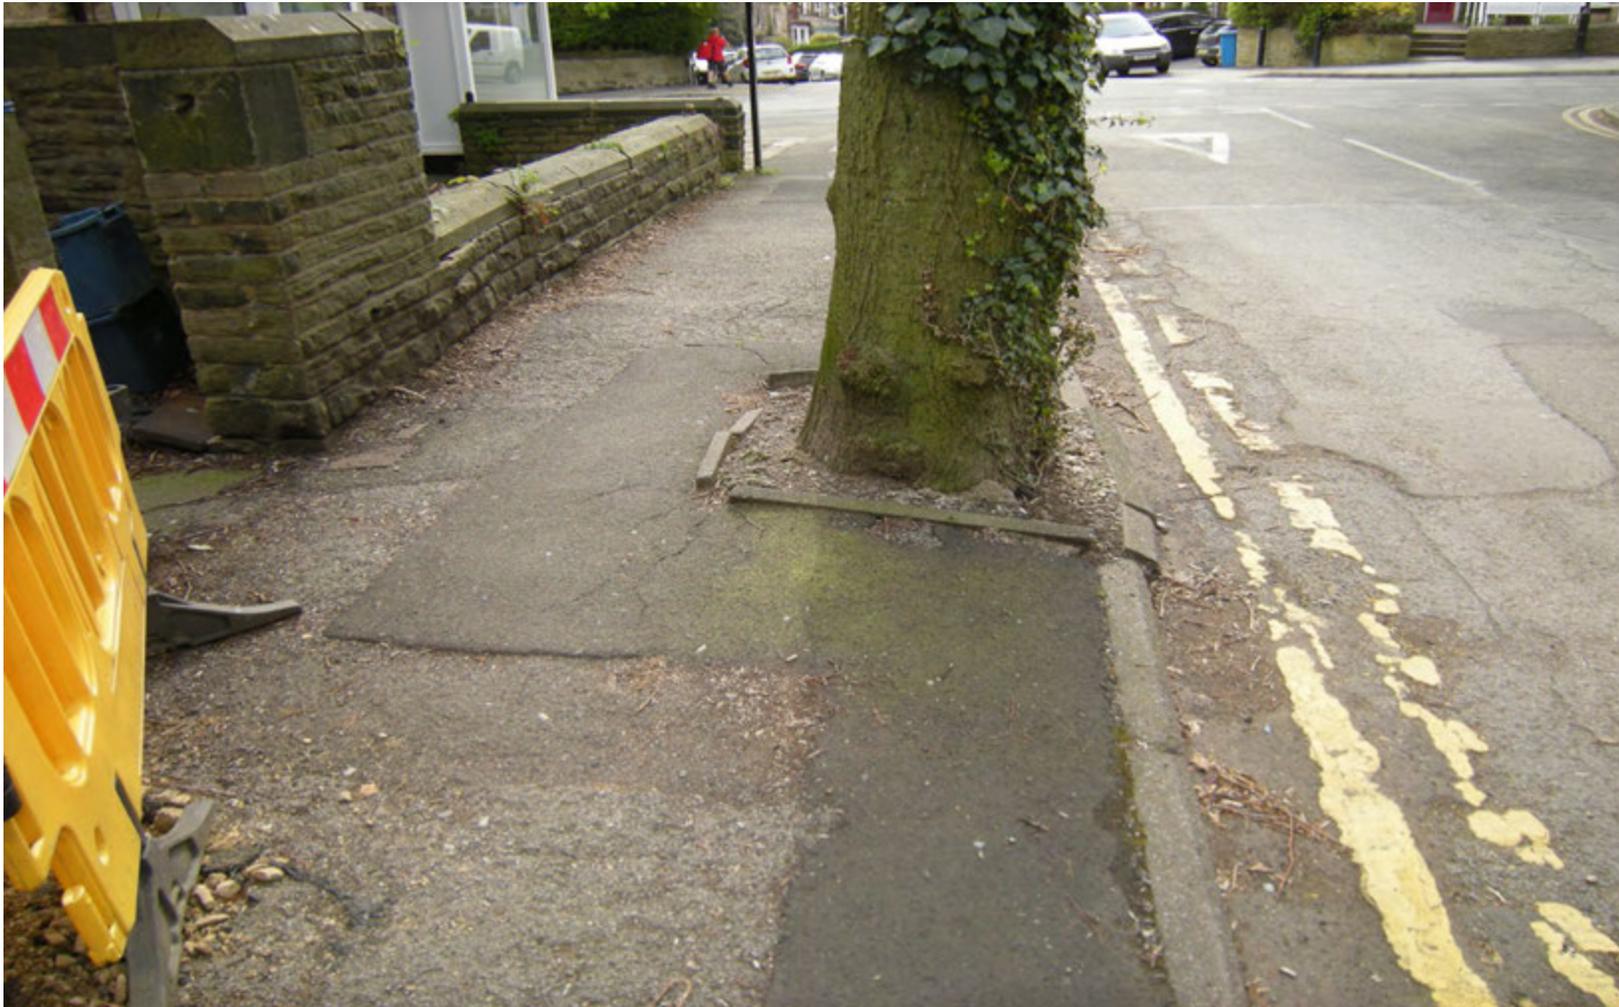
**Opposite No 47: SA. Recommend Replacement: ITP in Agreement:**

**Kerb Displaced by buttress, footway already ramped by roots outside vehicular access point and disturbance by roots tracing to private property. Evidence of wall distortion also by roots tracing to third party boundary wall.**

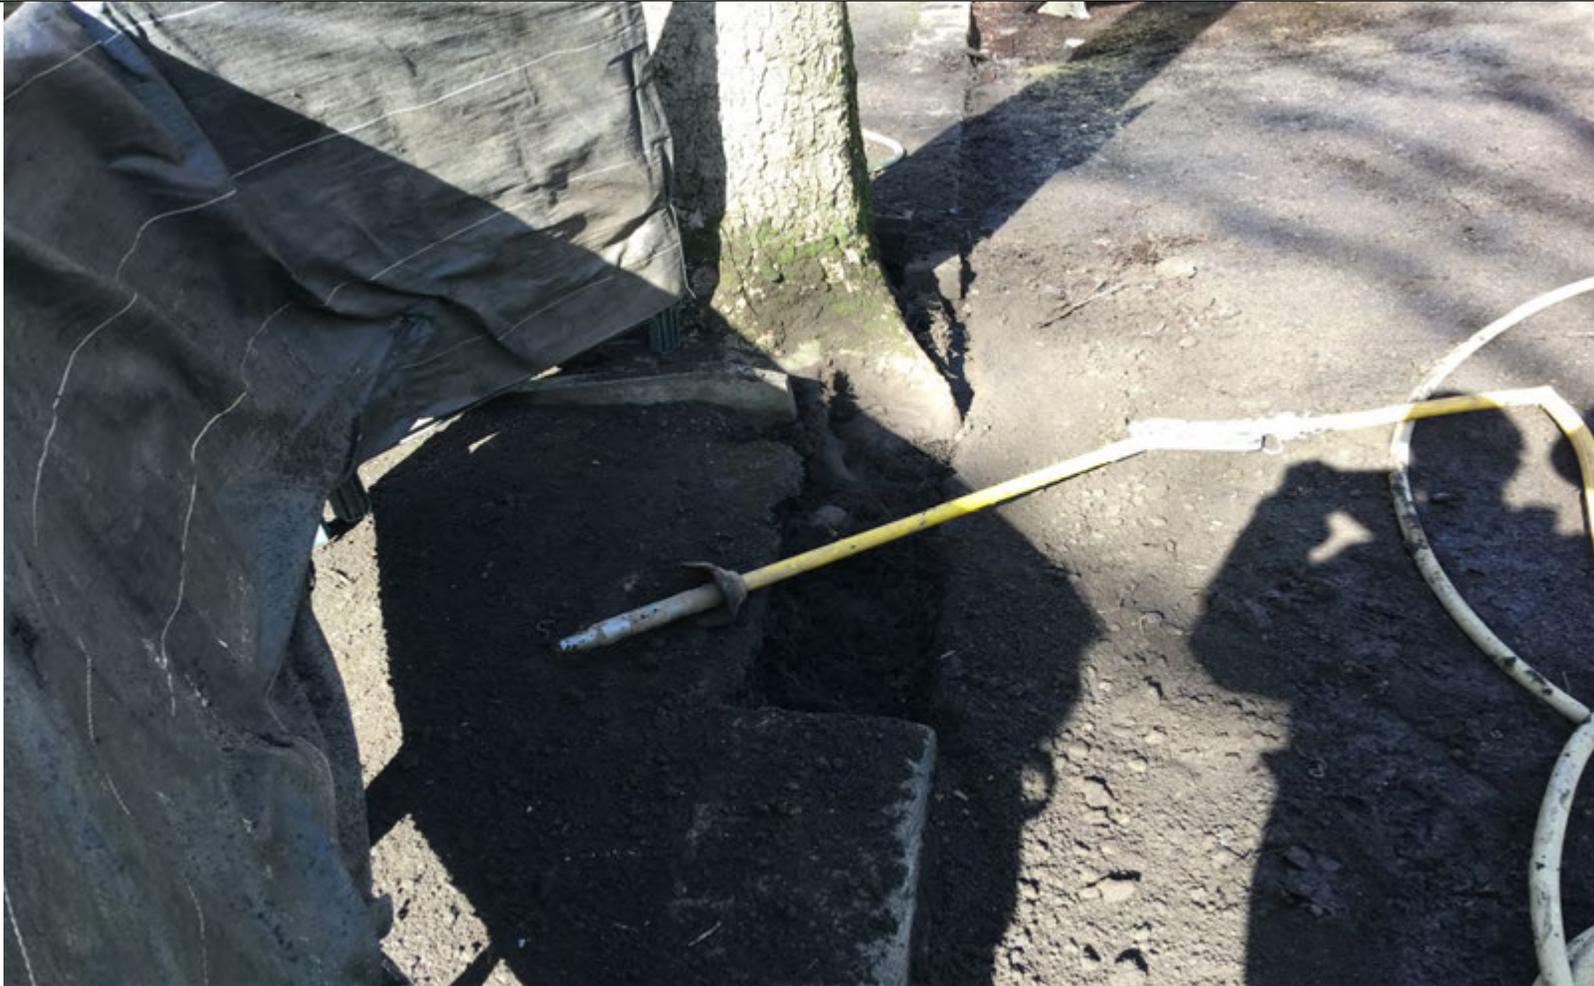
**Outside No 53: SA. Recommend Replacement: Airspade In Agreement**

Cannot install full or half kerb due to buttress which was suggested by ITP. Risk of vehicle strike damaging existing wounds allowing entry of pathogens: Independent Airspade report recommends replacement.

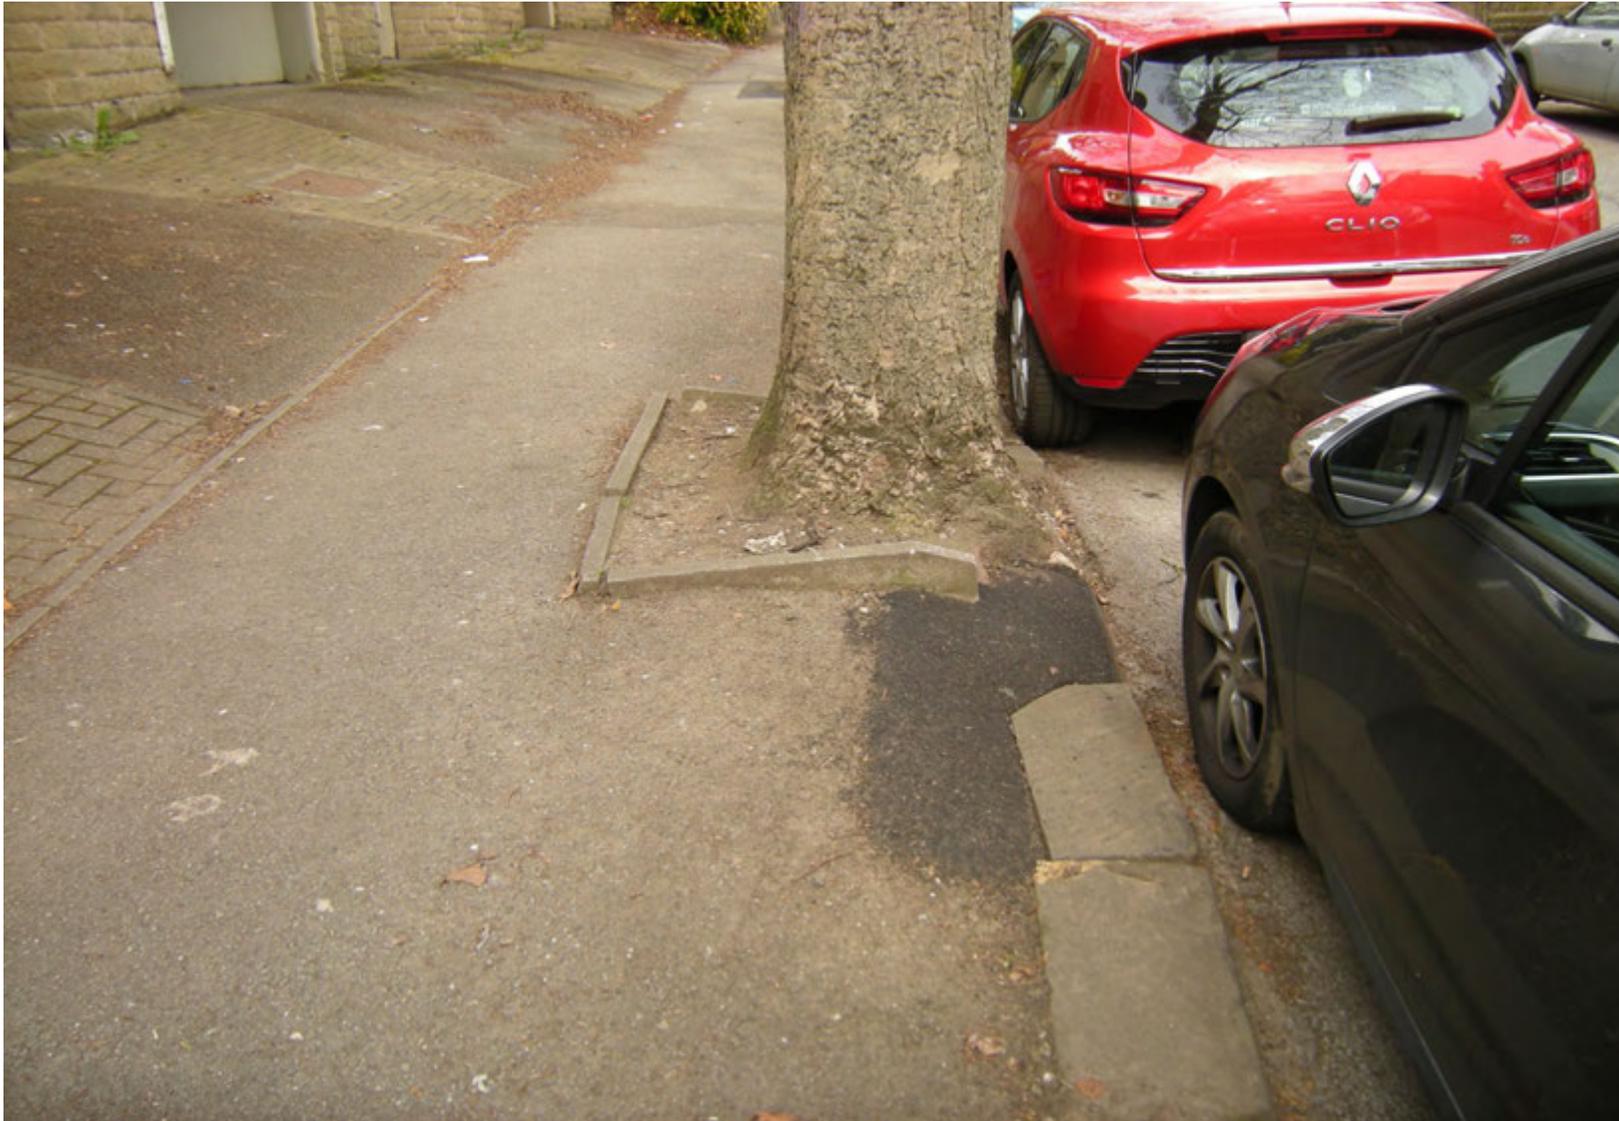
**O/S No 53 Additional:**

**The root continues to grow into the carriageway and will get damaged when surfacing is completed. Proceed as planned with replacement**

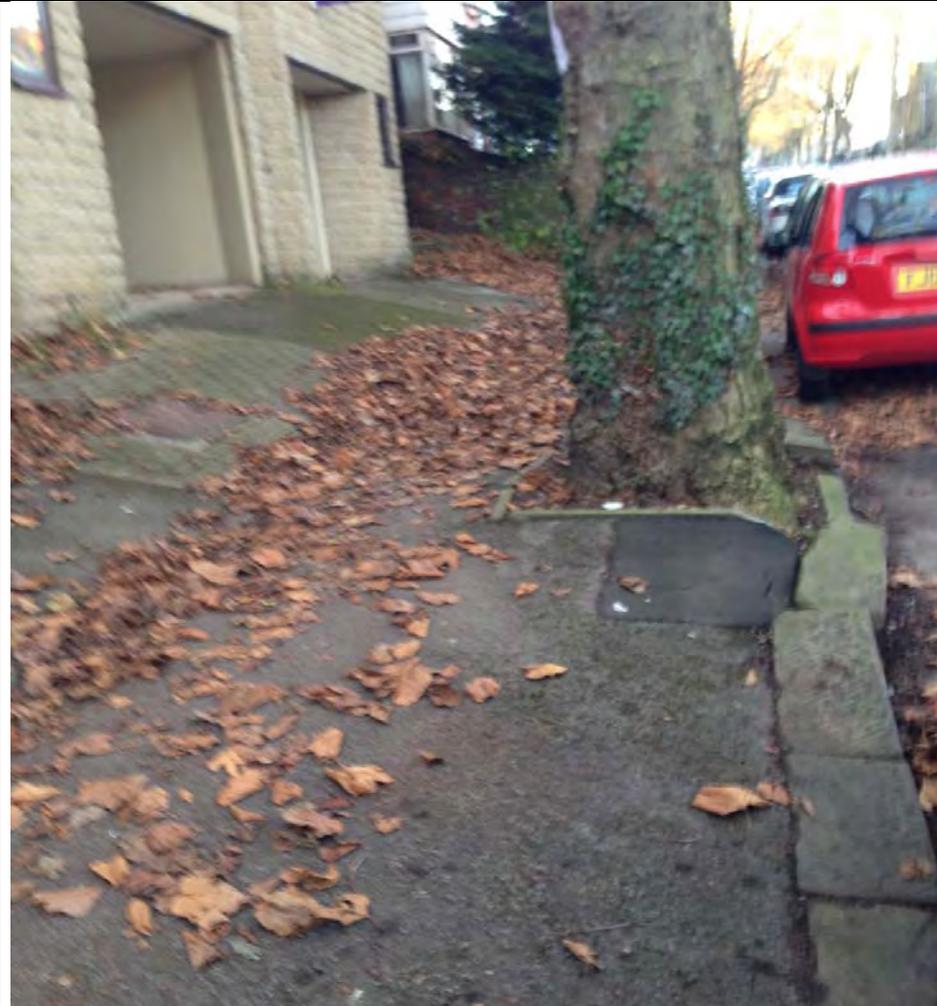
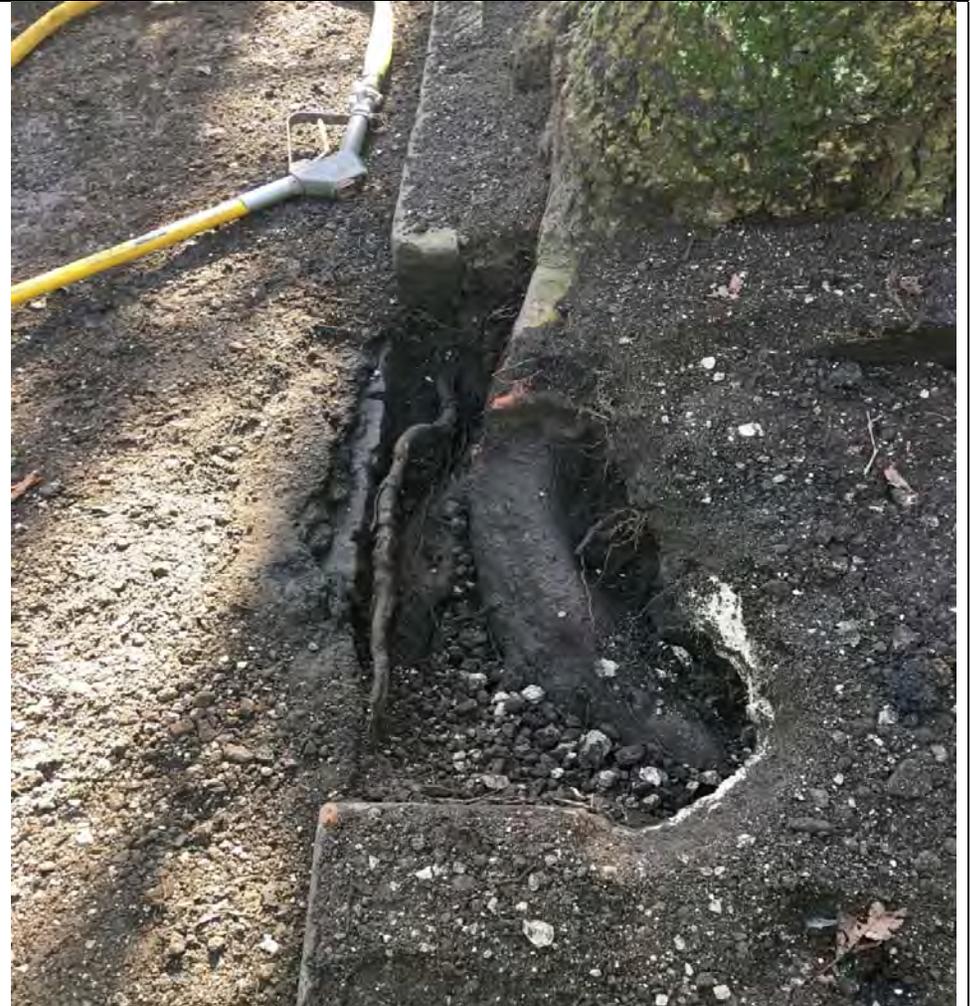
## **Outside 57: SA. Recommend Replacement**

Cannot be kerbed due to root locations kerb displaced by buttress. The location of the roots prevents any form of kerb being provided as suggested by ITP. The footway also cannot be ramped within normal tolerance due to forecourt at rear.

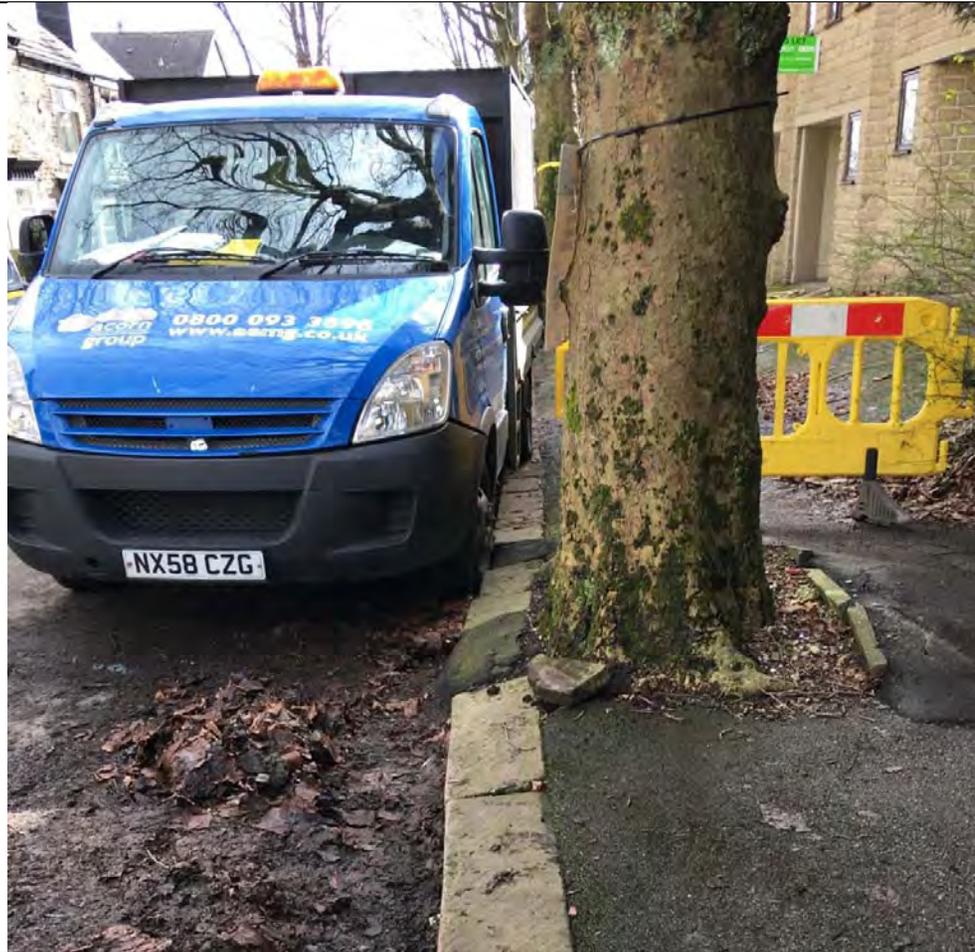
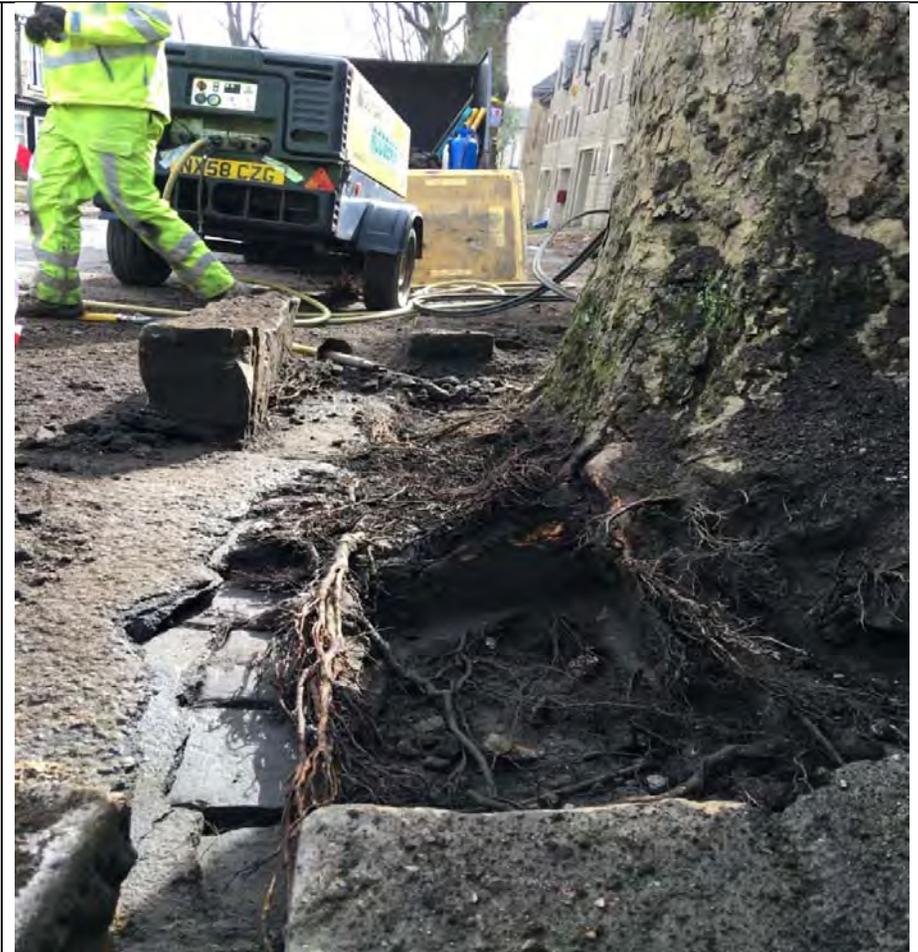
## **Outside No. 63: SA. Recommend Replacement: Airspade in Agreement:**

Replacement only option - Kerb displaced, unable to reset or provide half kerb. Roots continuing to trace under carriageway causing significant structural damage. Footway already ramped and damaged by shallow roots.

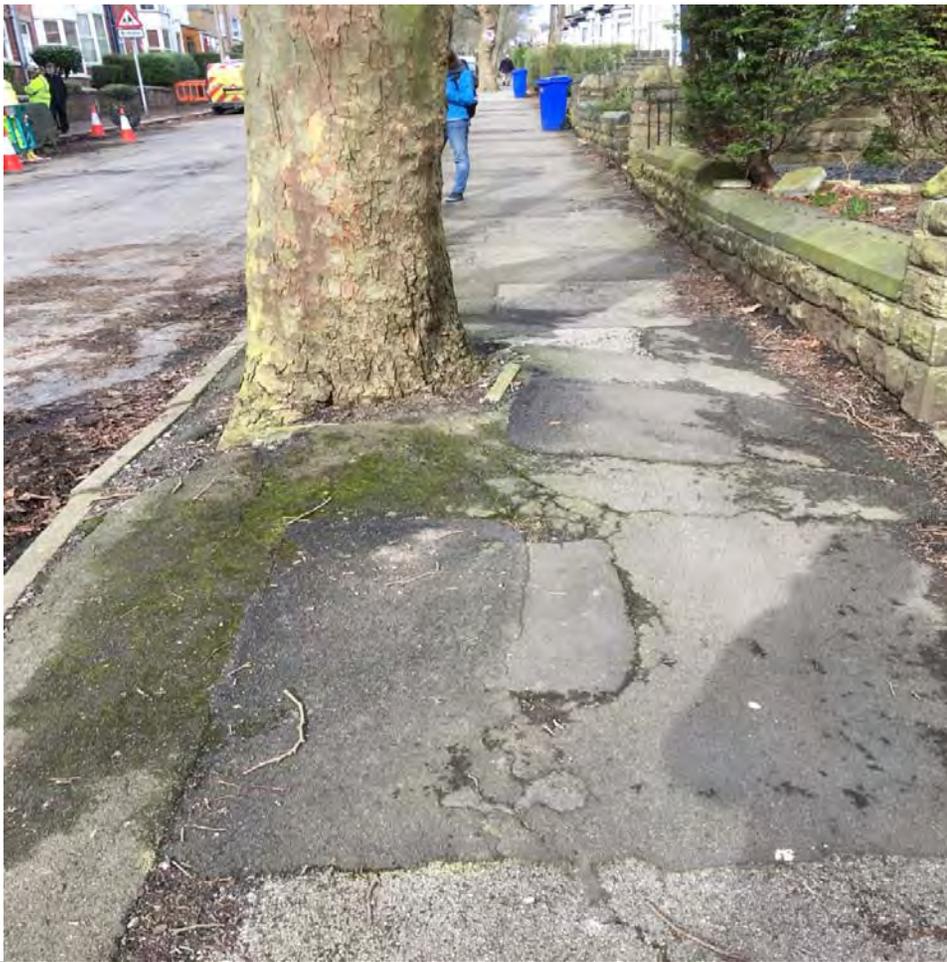
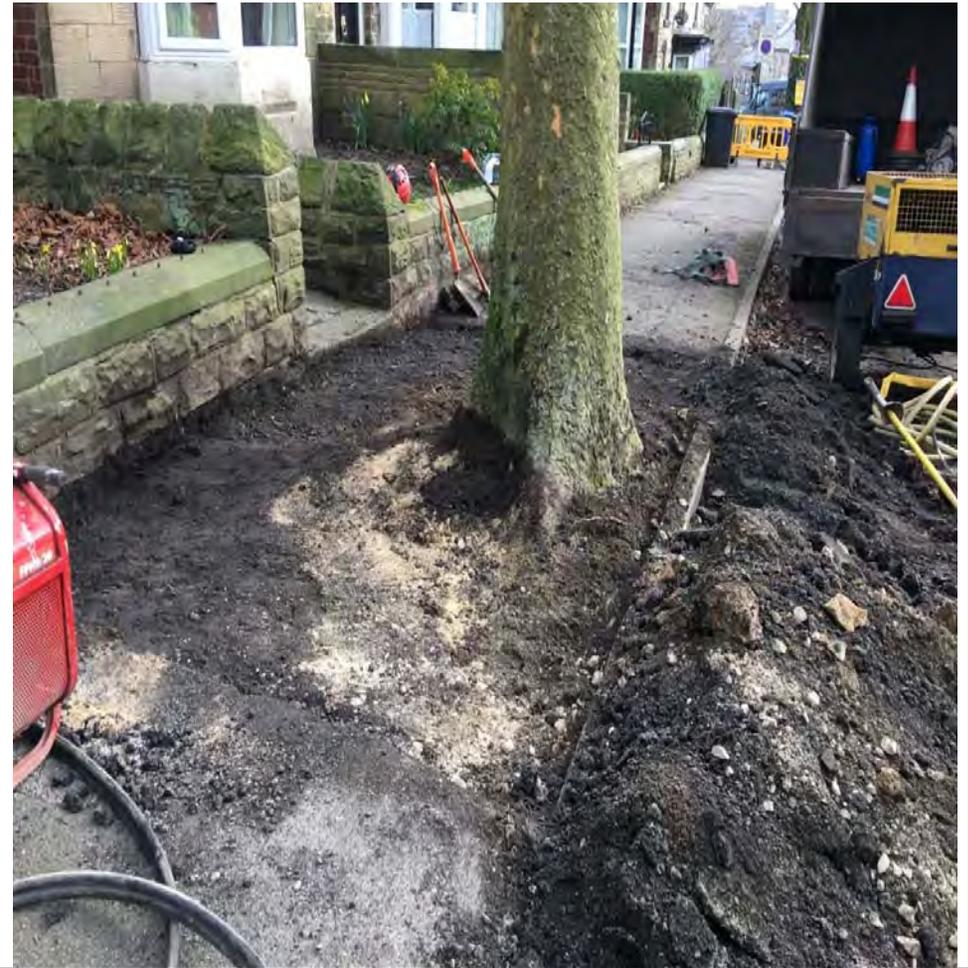
**Outside No. 72: SA. Recommend Replacement: ITP in Agreement:**

The existing kerb have been displaced and footway are severely ramped by over 30cm in height. Footway ramped by shallow roots,

The location of the roots prevents the kerb being correctly aligned and backed up with concrete.

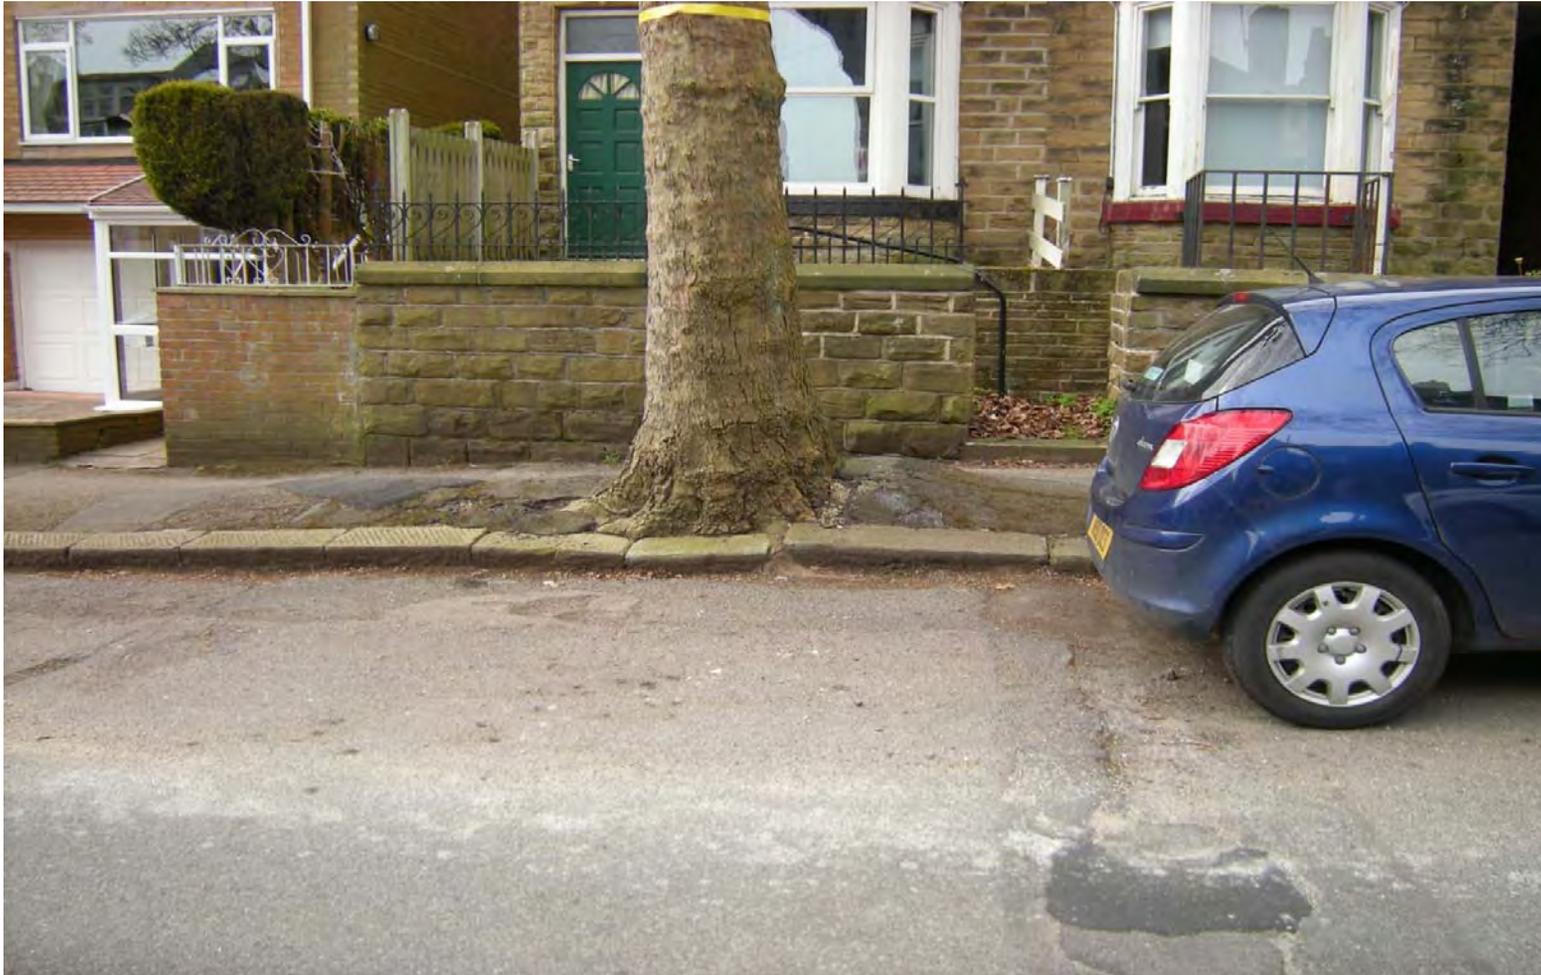
**Outside No 81: SA. Recommend Replacement: ITP in Agreement:**

Footway already significantly ramped by roots tracing to boundary wall: Kerb pushed out into channel line: Photo also showing recently repaired wall to the property

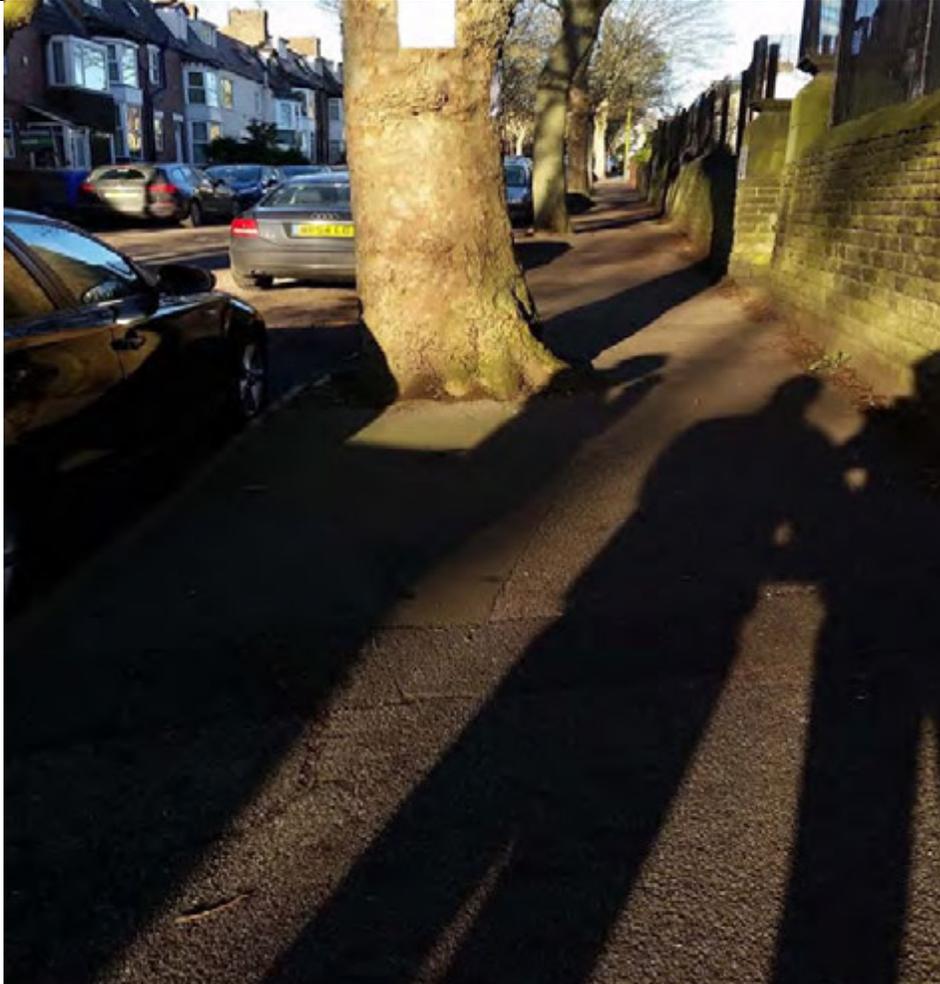
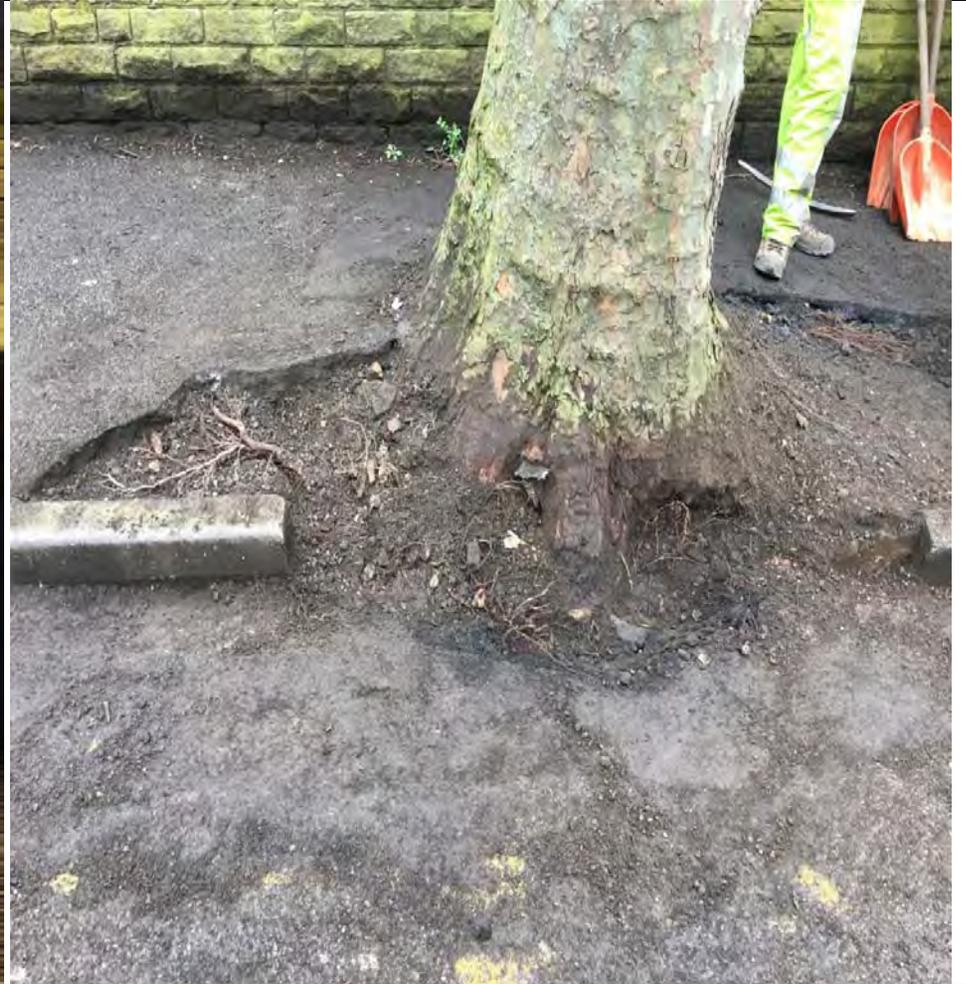
**Opposite 87: SA. Recommend Replacement**

**Mat of roots emanating from a historical wound where a piece of pedestrian guard rail has grown into the tree. Cannot be kerbed or half kerb as suggested by ITP due to root buttress protruding into carriageway**

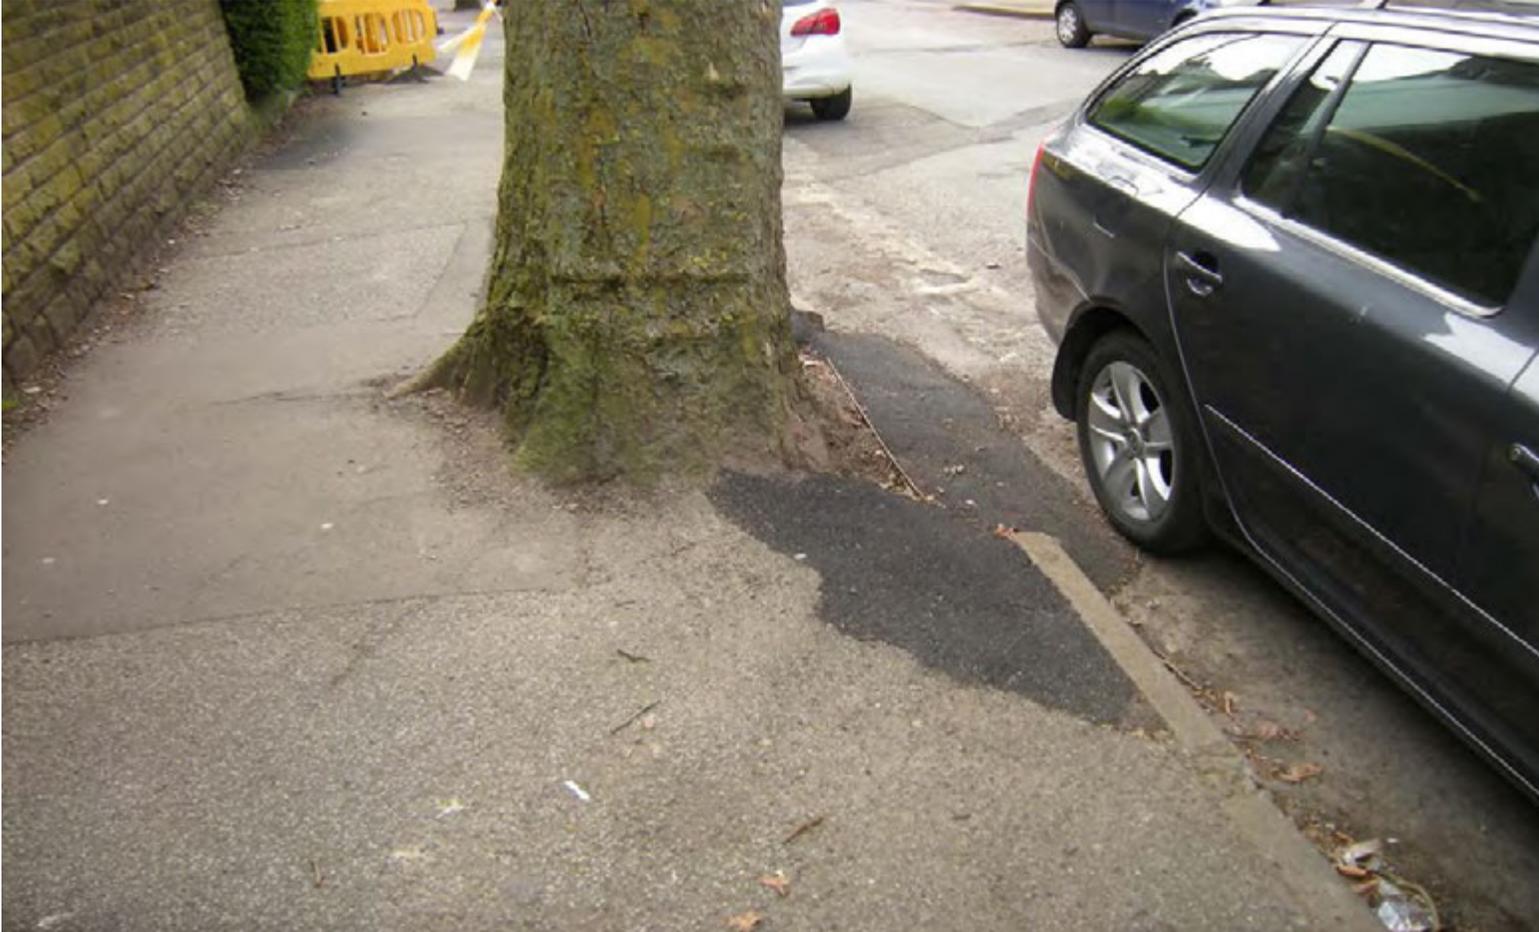
**OPP No. 87 Additional**

**Temporary repair in Bitmac to cover roots into carriageway. Evidence of roots tracing towards property. Previous thin kerb already failed and removed due to roots, unable therefore to replace half kerb .**

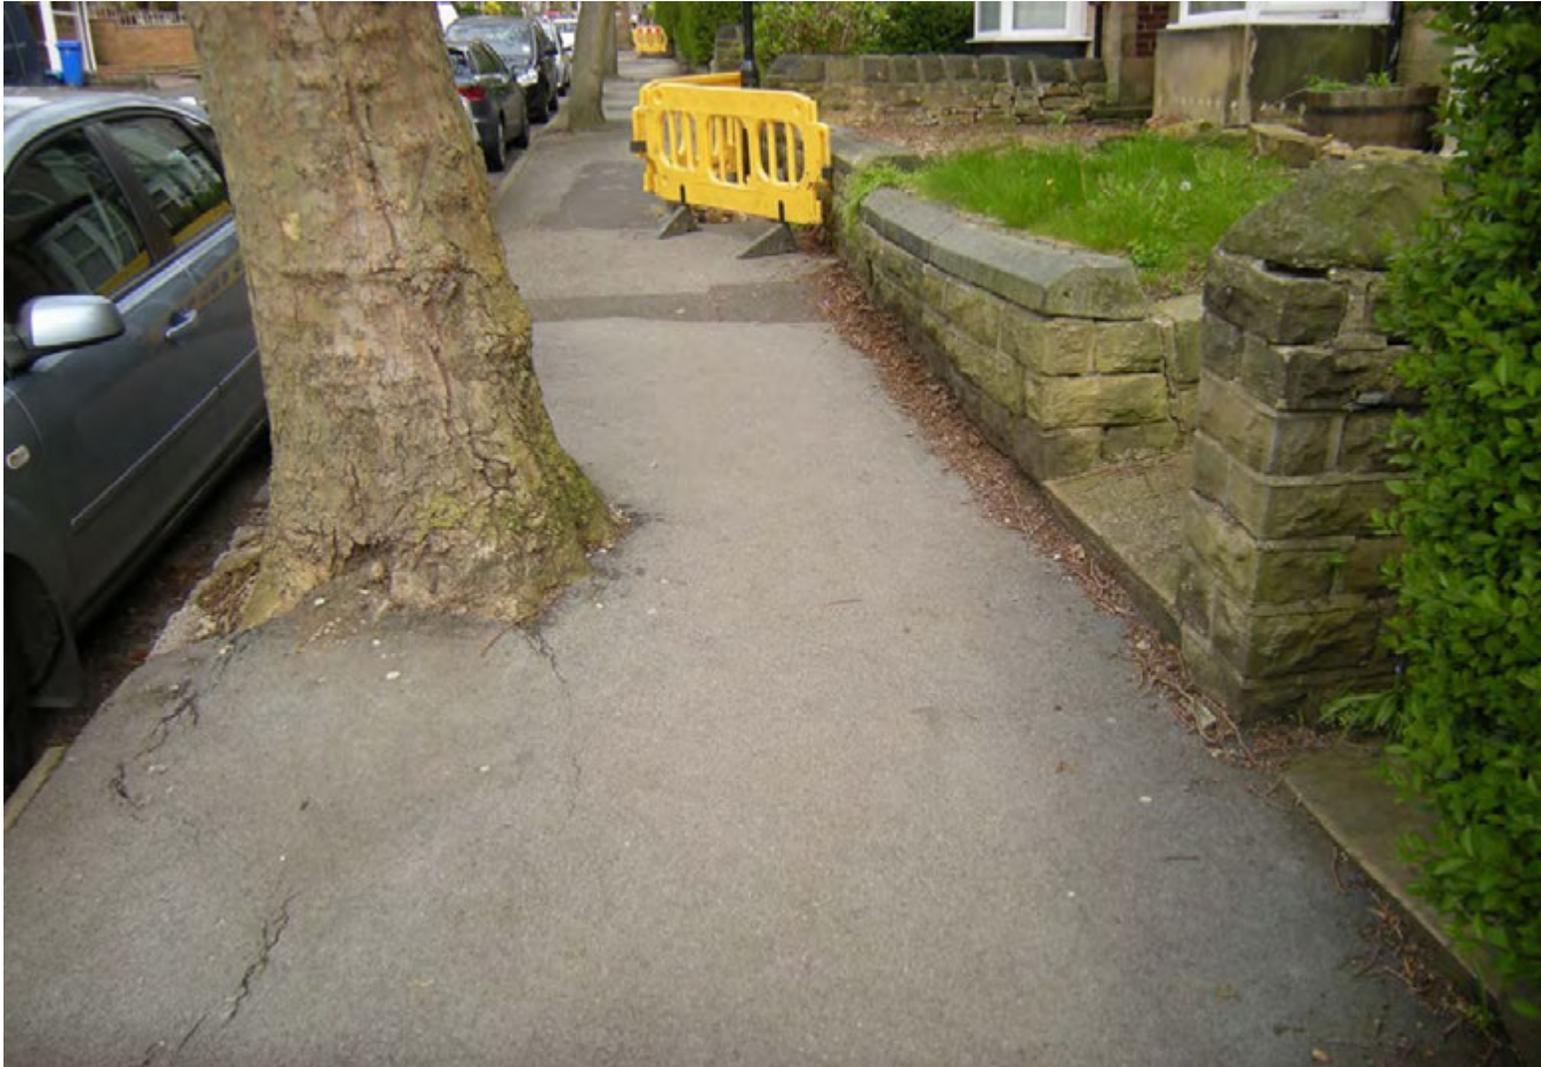
## **Outside No. 92: SA. Recommend Replacement**

**Evidence of slight bowing to wall: Cannot install full kerb at this location as it would encroach channel line. Kerb already missing due to be pushed out by roots. Roots would therefore prevent half kerb suggested by ITP**

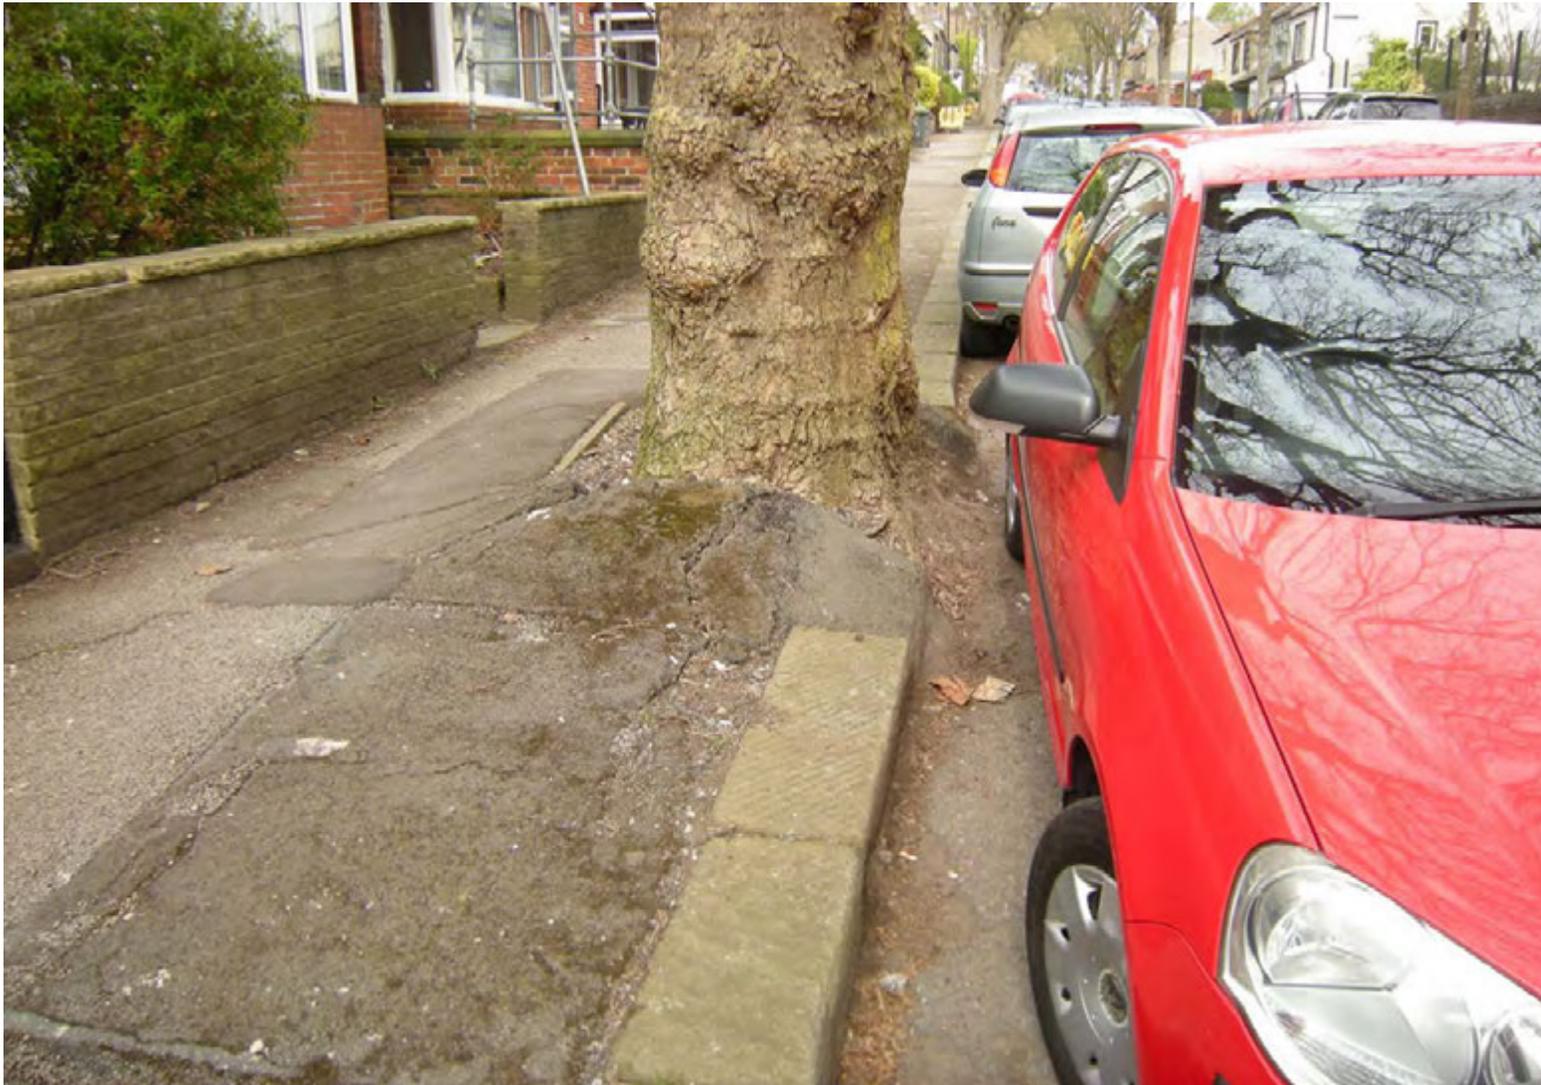
**Outside No. 93: SA. Recommend Replacement: ITP in Agreement:**

Root/buttness in carriageway causing damage and preventing any further kerb placement. Roots also in channel line of traffic and tracing towards third party boundary wall near gate.
