# **REPORT ON WESTERN ROAD**

## Report on Western Road:

## REPORT ON WESTERN ROAD – TREE PROPOSALS

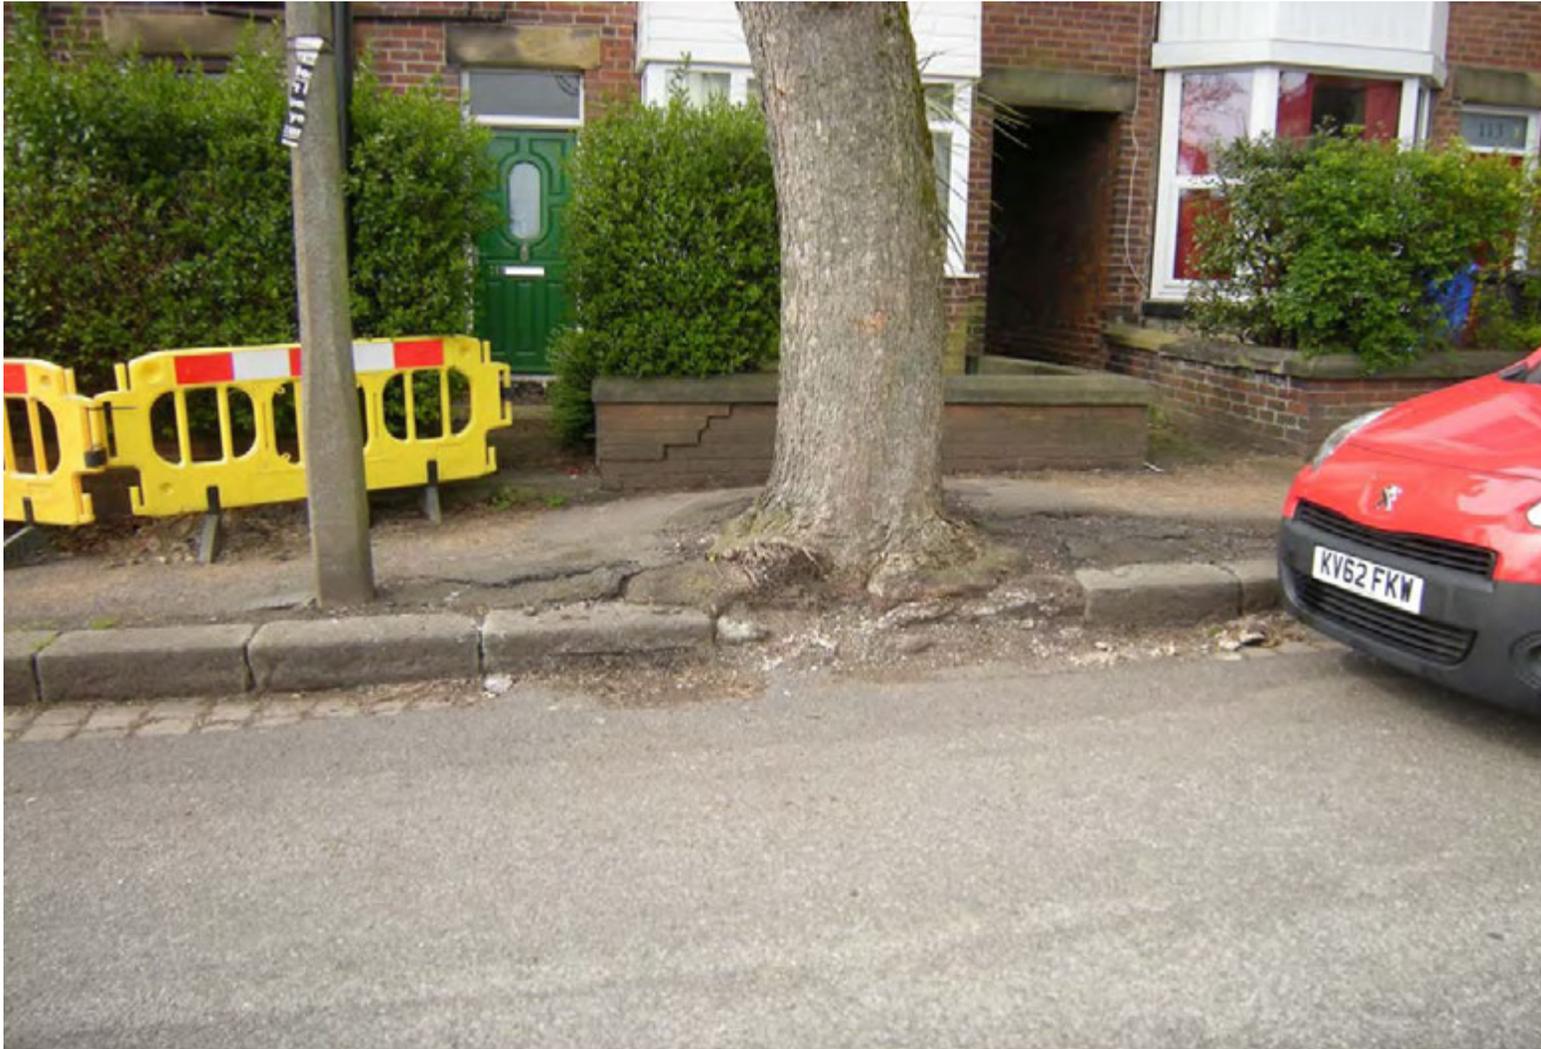
**Outside No. 111: SA. Recommend Replacement: ITP in Agreement:**

Cannot install full profile kerb as roots growing under carriageway. Footway already ramped by shallow roots. Damage to private wall by roots tracing to property is very evident

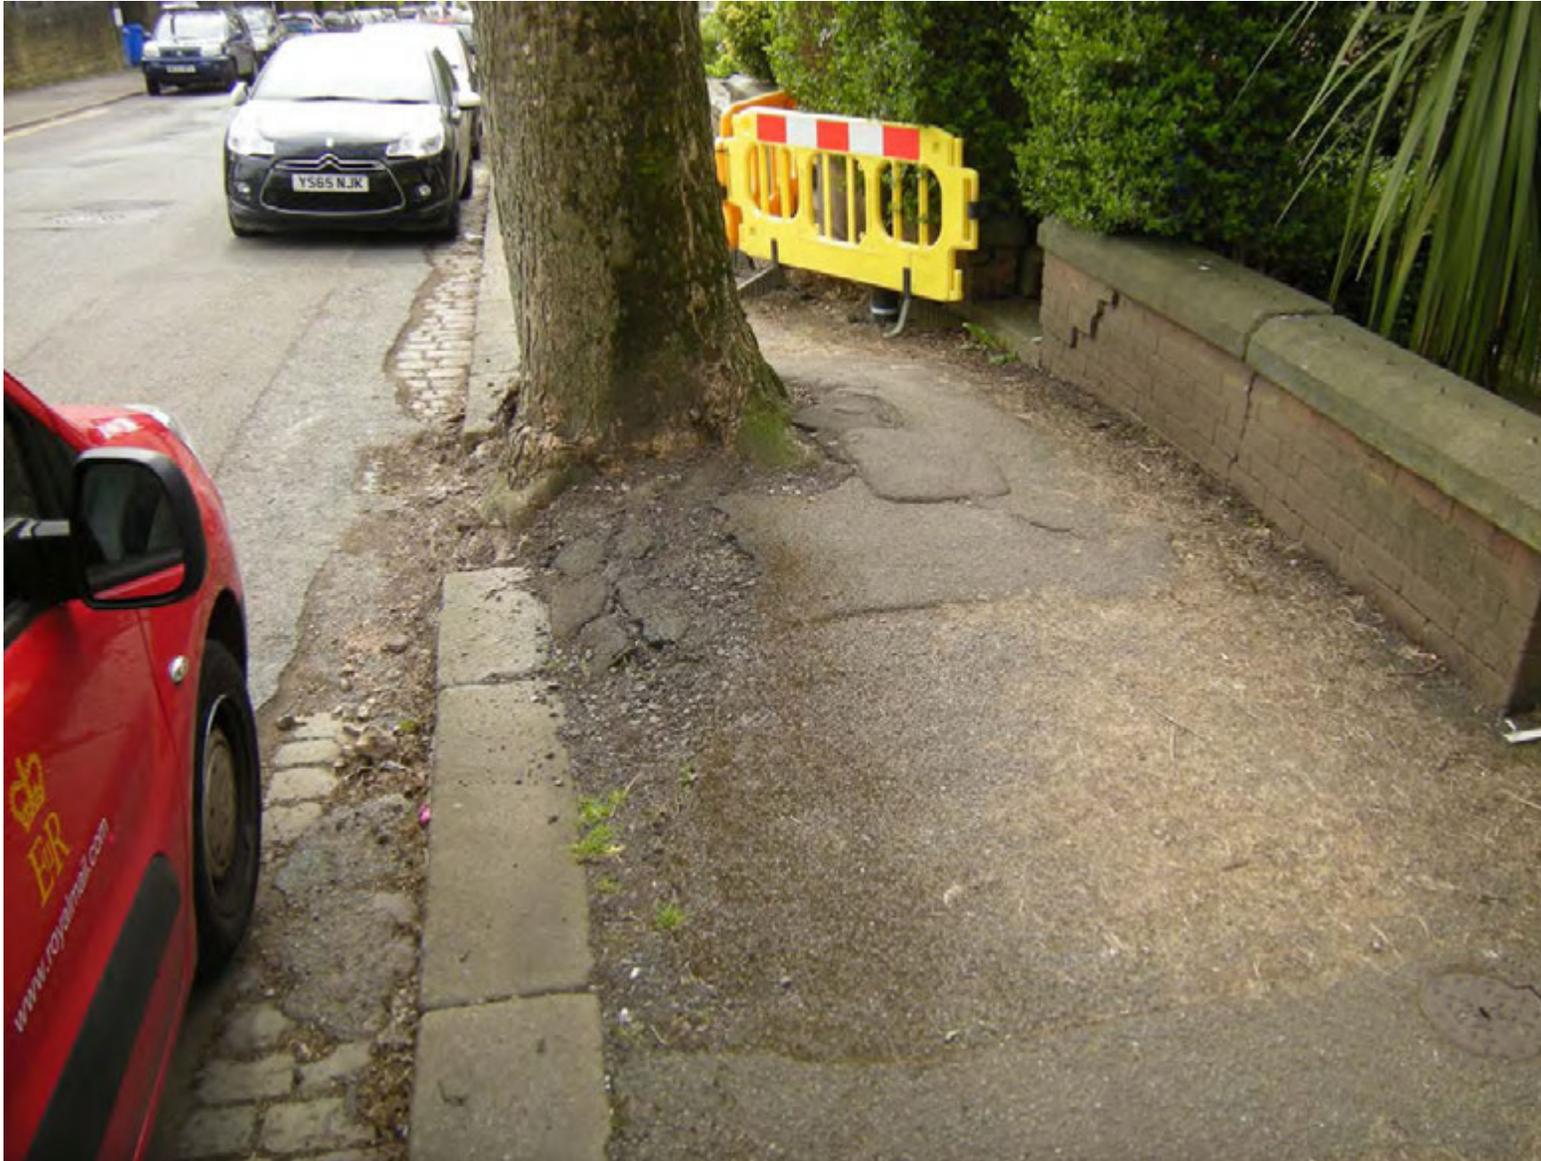
O/S 111: Additional evidence showing severe damage to boundary wall

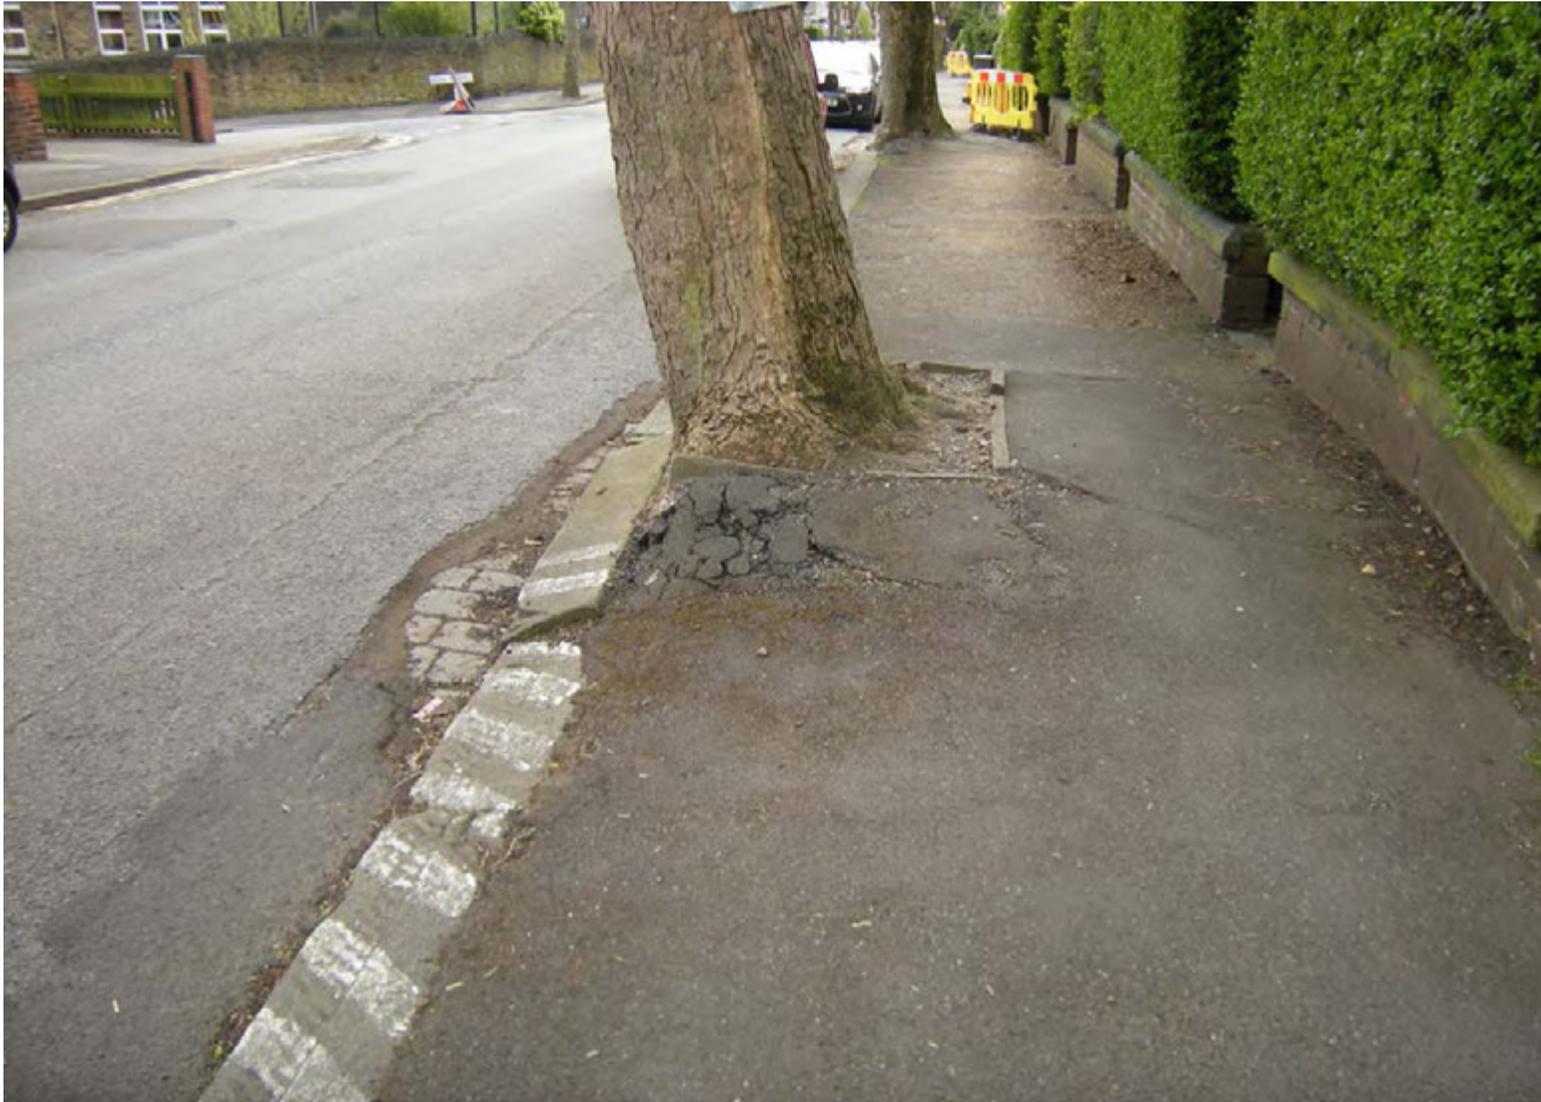
**Outside No 115: SA. Recommend Replacement:**

**Kerb displaced by buttress. Unable to reset or provide half kerb as suggested by ITP due to roots already in kerblines. Also damage by roots tracing to boundary wall, this is evident by bowing**

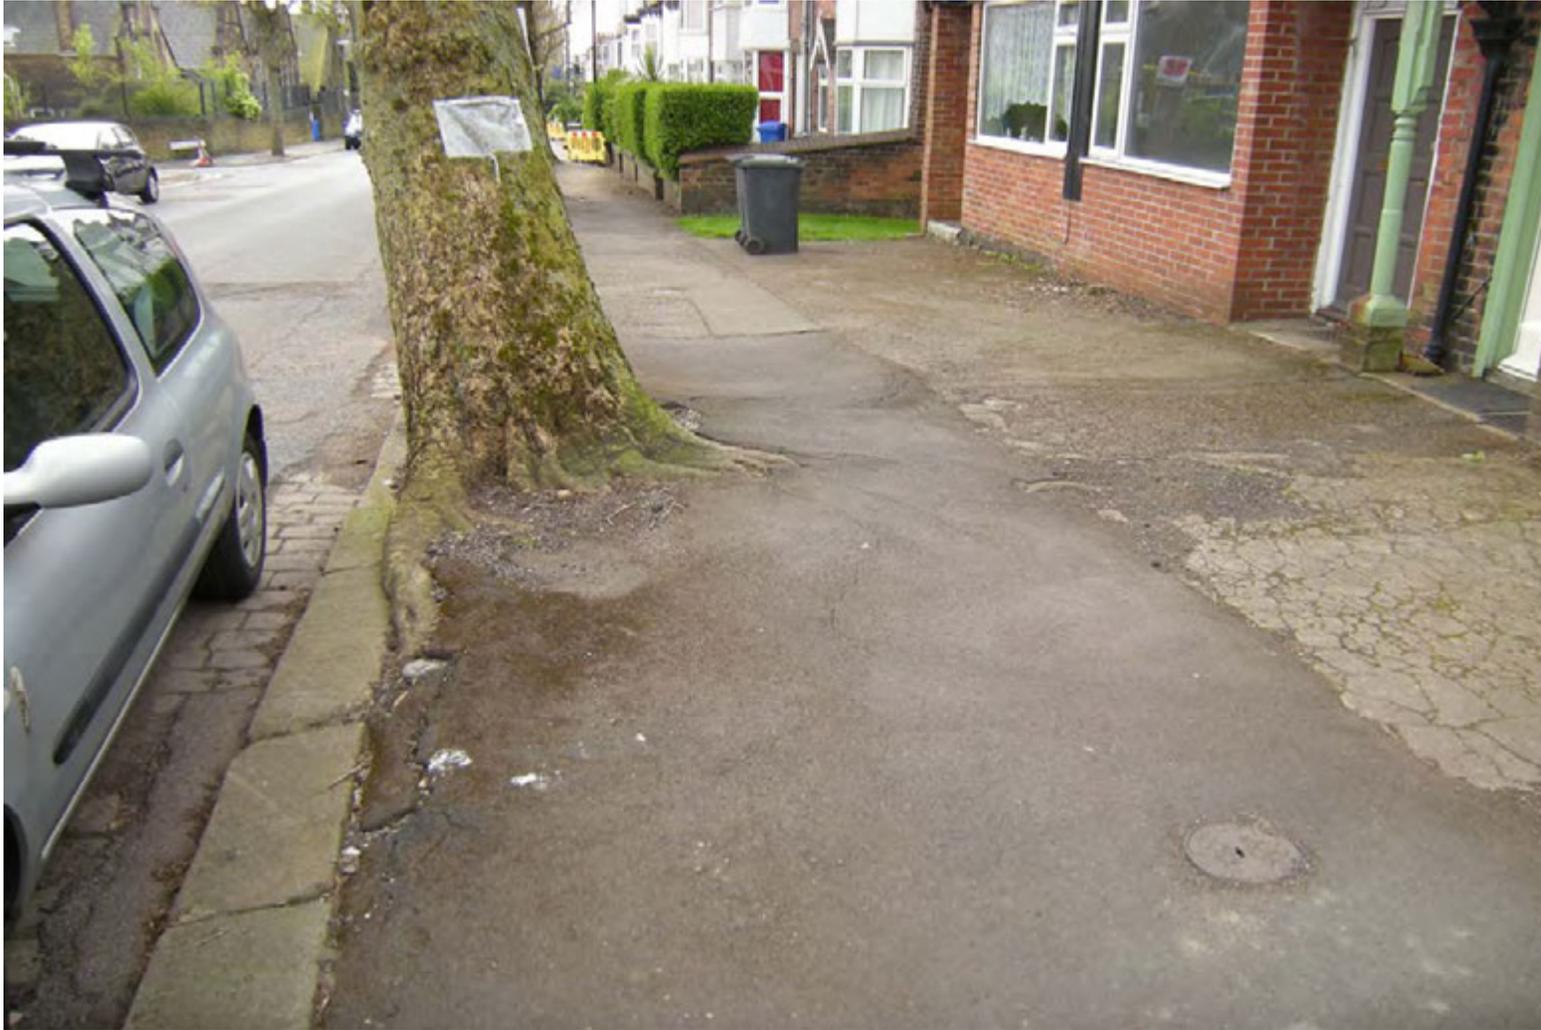
**Outside No. 123: Recommend Replacement:**

Shallow roots damage to footway including evidence of roots showing at surface level in private forecourt causing crazing to bituminous material.

Further Ramping of this footway would also incur a severe backfall into private forecourt area

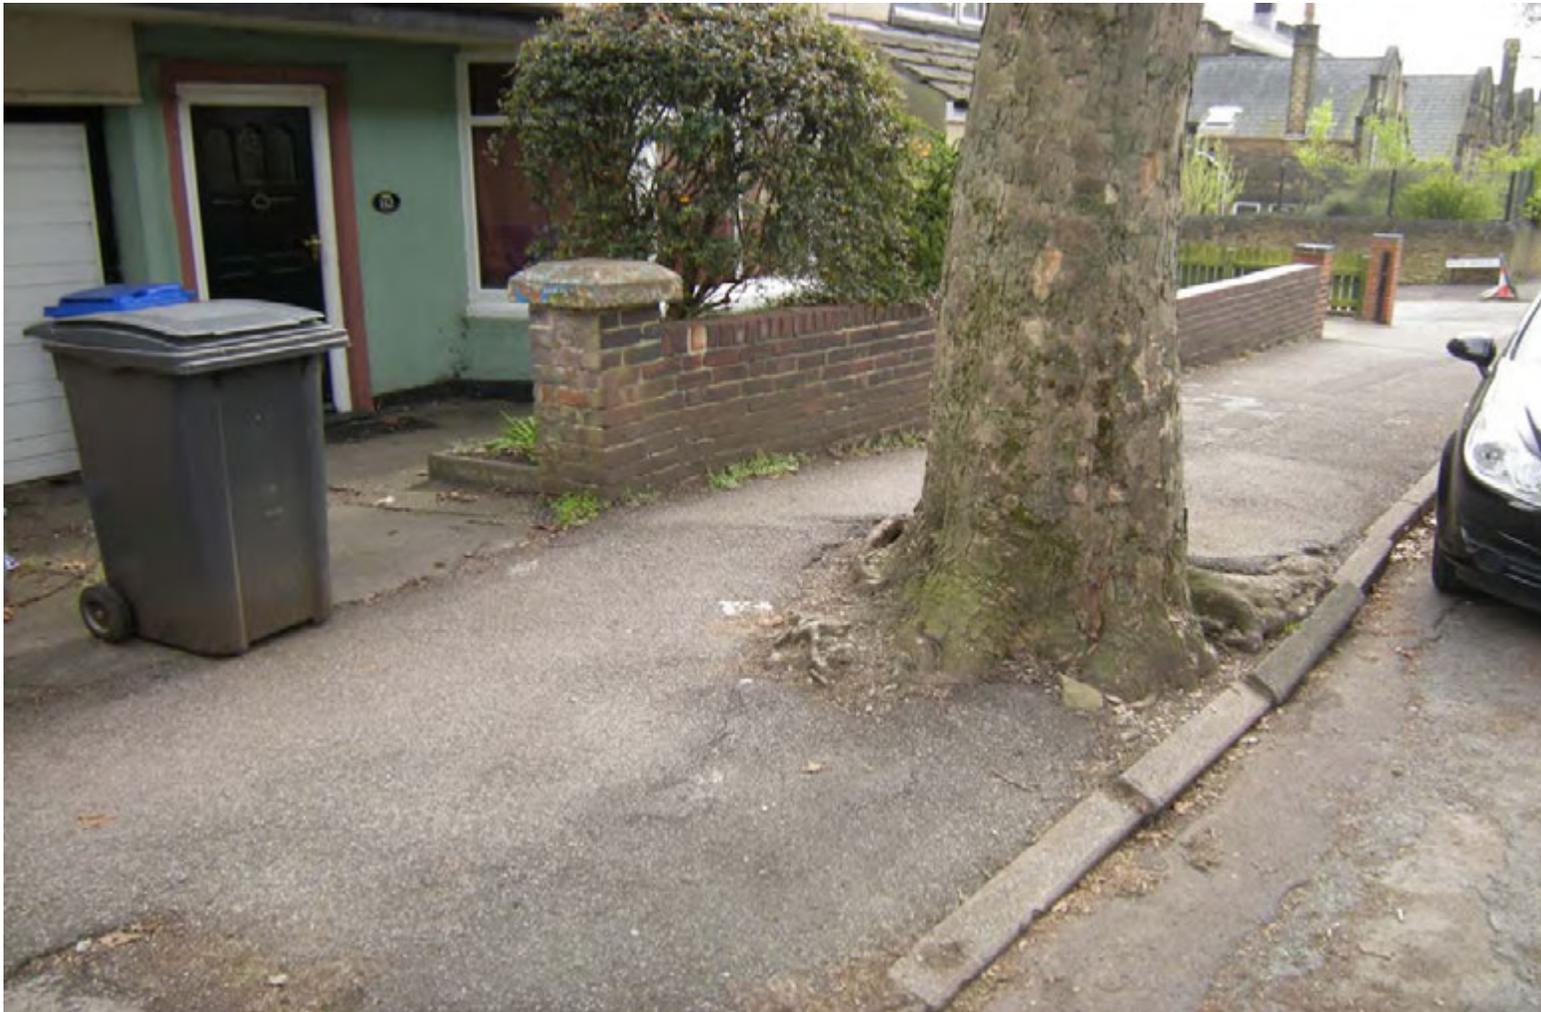
## **Outside No. 142: Recommend Replacement:**

**Kerb displaced. Unable to reset half kerb as roots in carriageway line of channel as suggested by ITP . Also evidence of roots tracing to third party wall with slight distortion occurring to wall near access point which is partially being obstructed. Further ramping would cause severe backfall into property on the narrowed section of footway.**

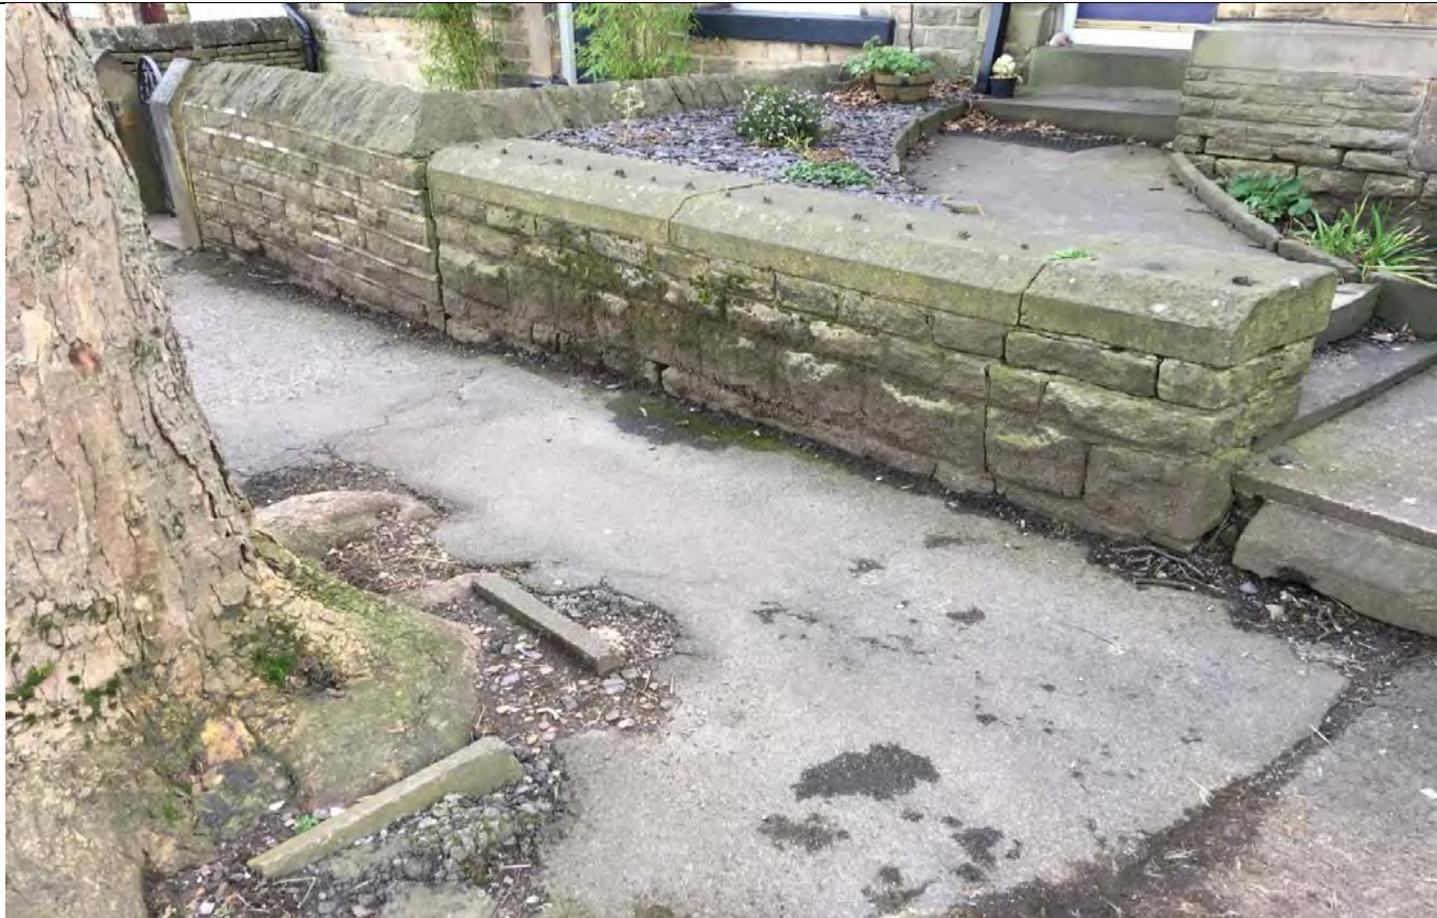
**Outside No. 143: SA. Recommend Replacement: ITP & Airspade in Agreement:**

Roots overgrowing kerb and causing trip hazard. Footway damage severe. Potential 3<sup>rd</sup> party wall damage Felling and replacement, due to decay. Basel Ganoderma. Sp. fungal fruiting body.

The tree is now showing signs of major health issues. It was agreed on site that due to its condition further investigation was not required, Continue with replacement

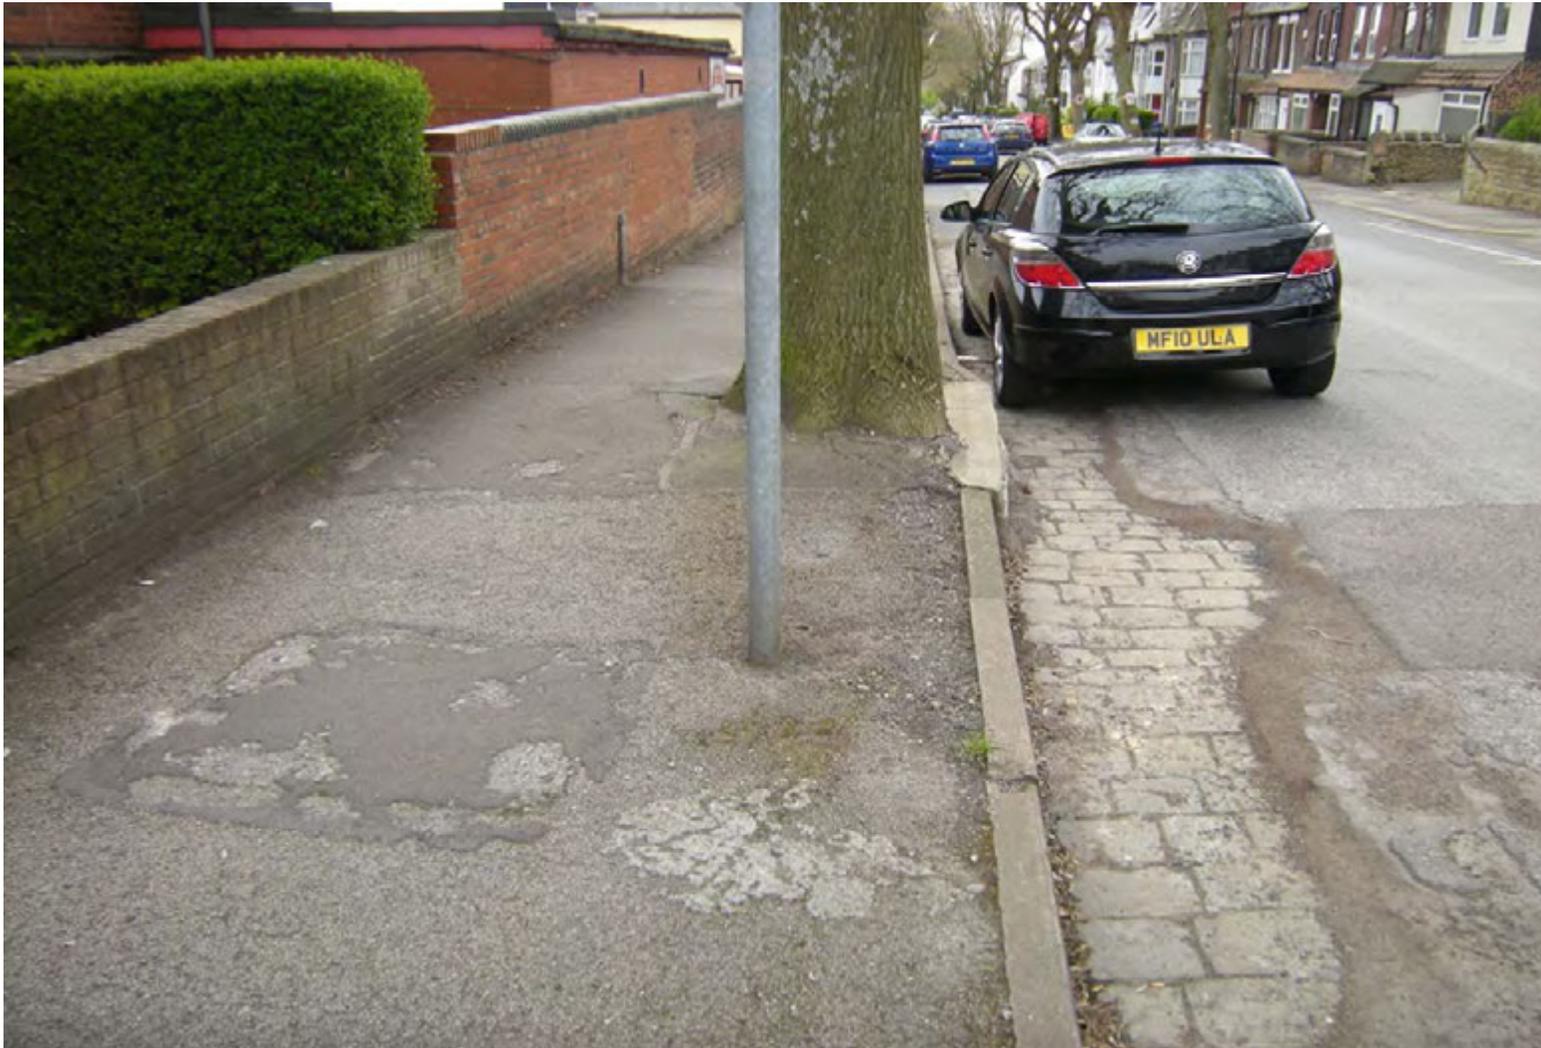
## **Outside No. 156: SA. Recommend Replacement**

**Decay at topping points and poor structural condition: Concrete frontage in place of kerb is only temporary as roots will displace into carriageway causing further distortion to the alignment.**

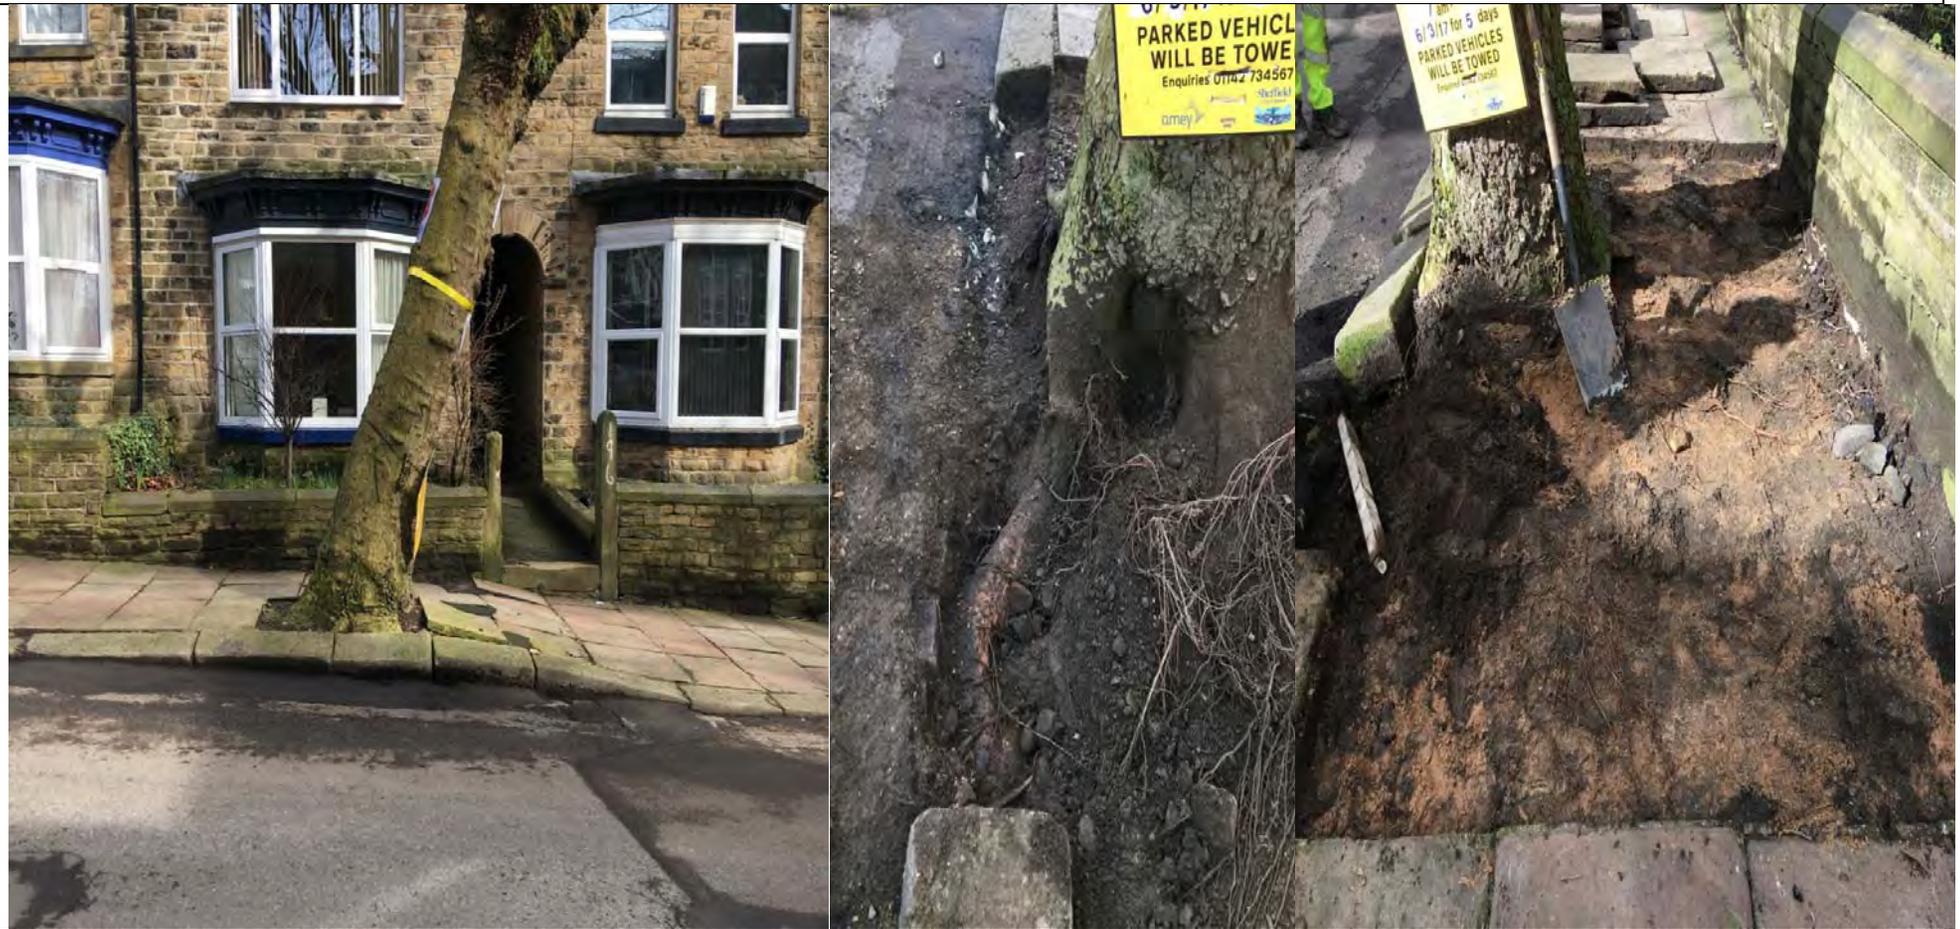
## Outside No. 198: SA. Recommend Replacement

Main buttress root is preventing the replacing of the kerb or half kerb as suggested by ITP.

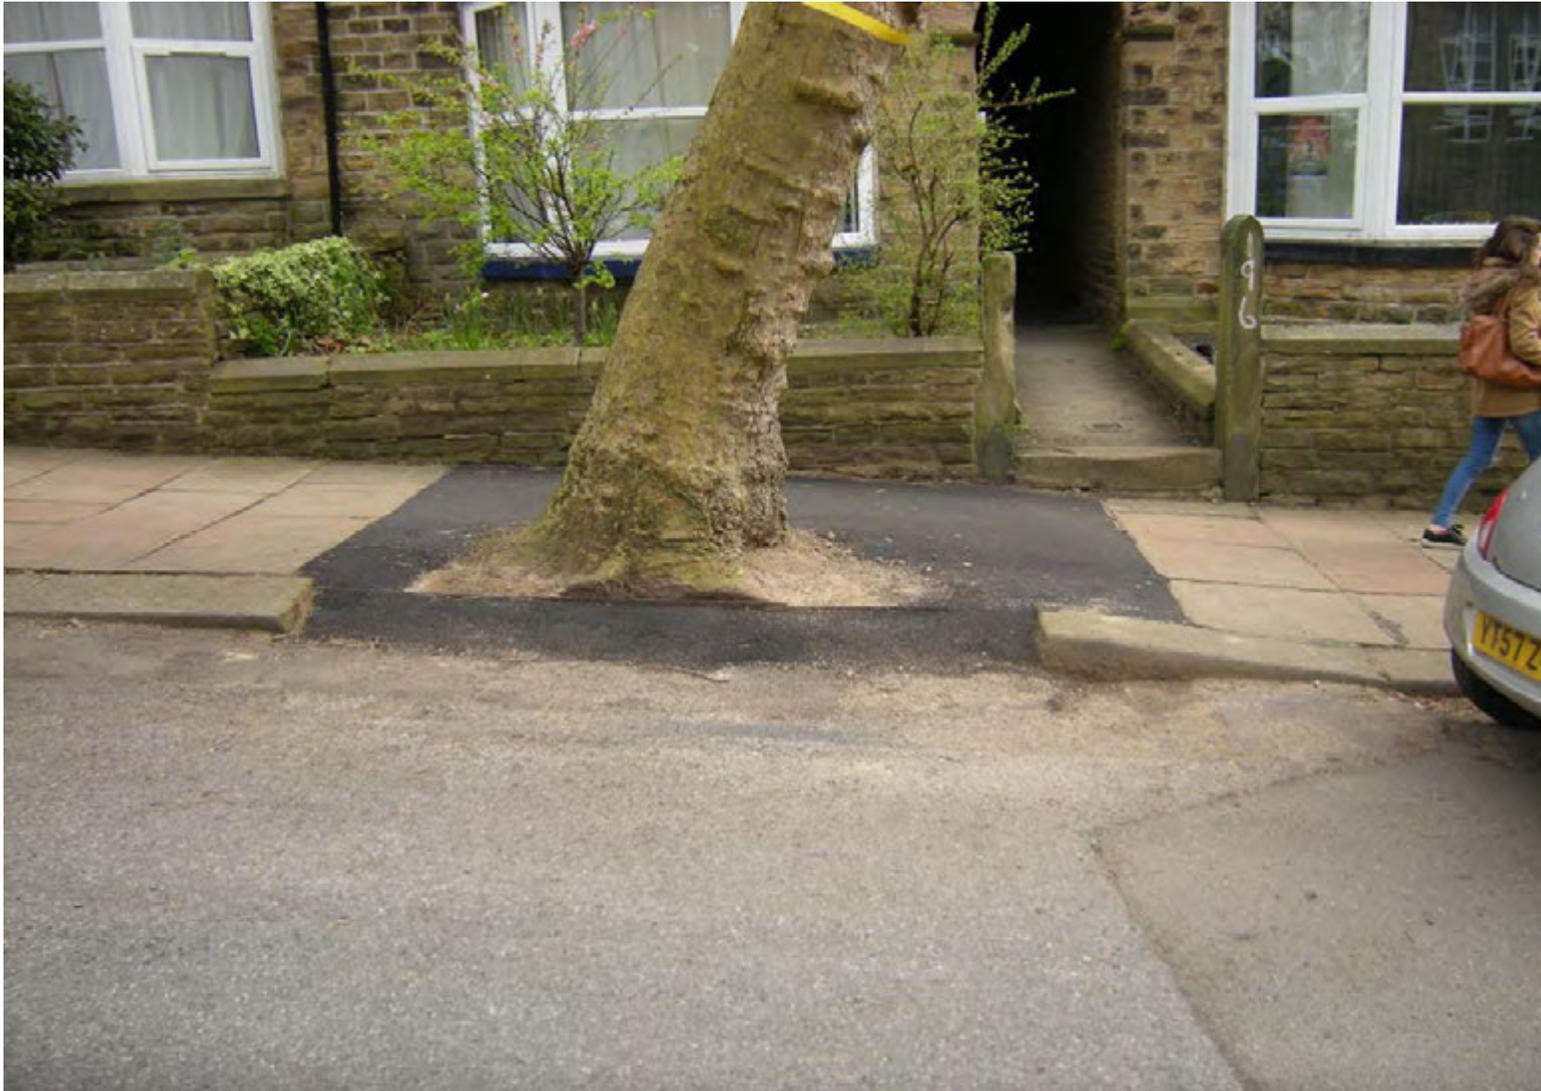
O/S 198 Additional photo: showing temporary ramping and tree leaning severely

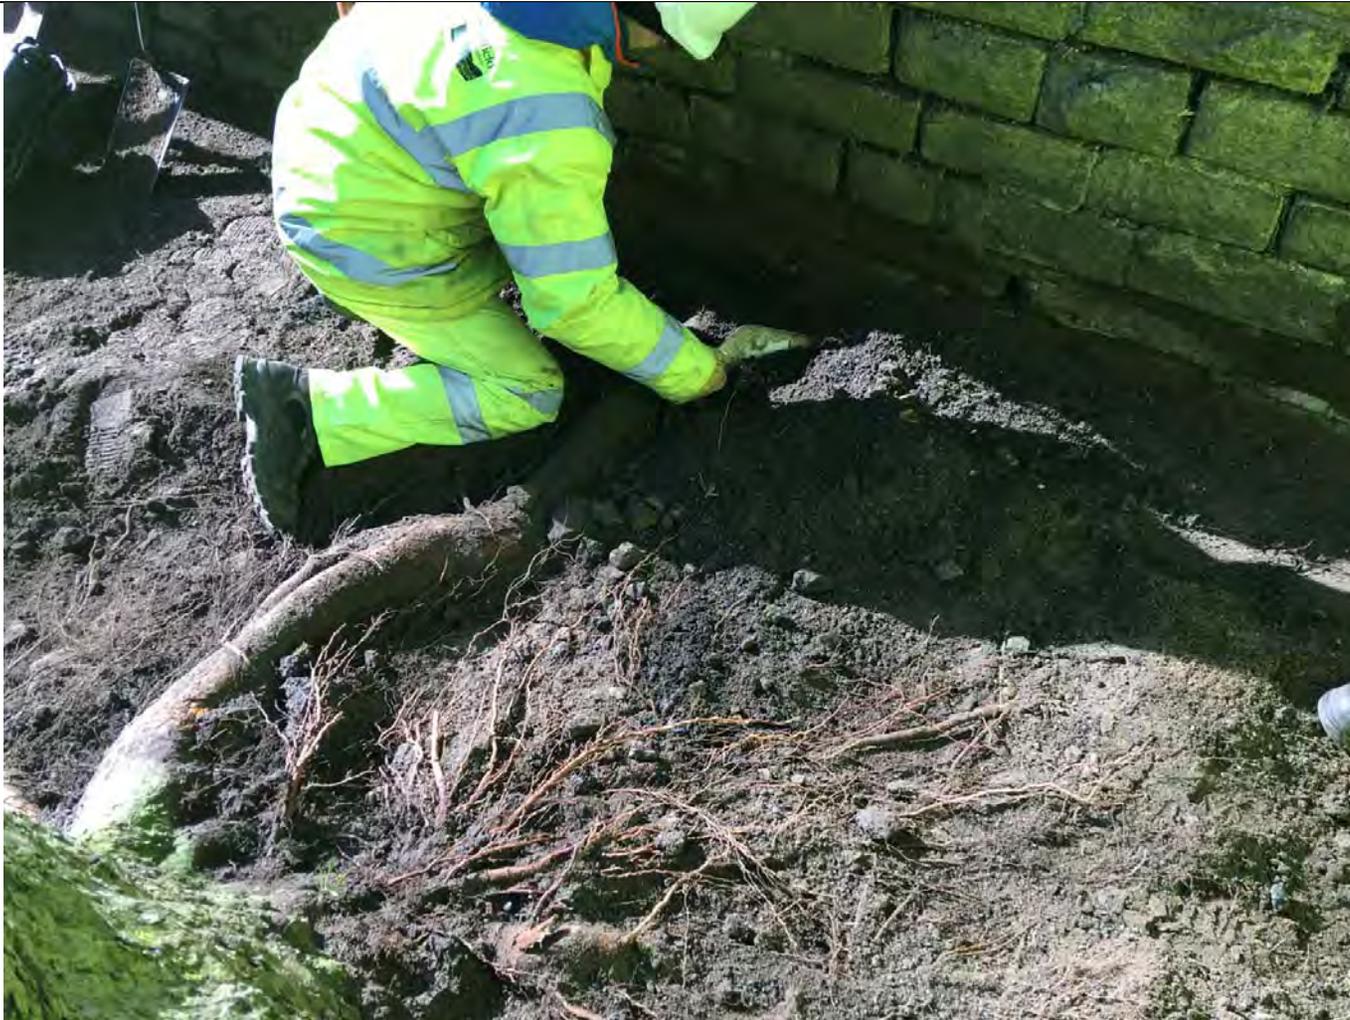
**Outside No. 209: Recommend Replacement: ITP & Airspade in Agreement:**

**Roots displaced kerbs beyond existing channel line. Severe root damage to footway and potential 3<sup>rd</sup> party wall damage. Tree felling and replacement - kerbs displaced by buttress. Footway ramped by shallow roots - Verified third party damage**

**Roots growing into 3<sup>rd</sup> party property causing damage. Continue with replacement.**

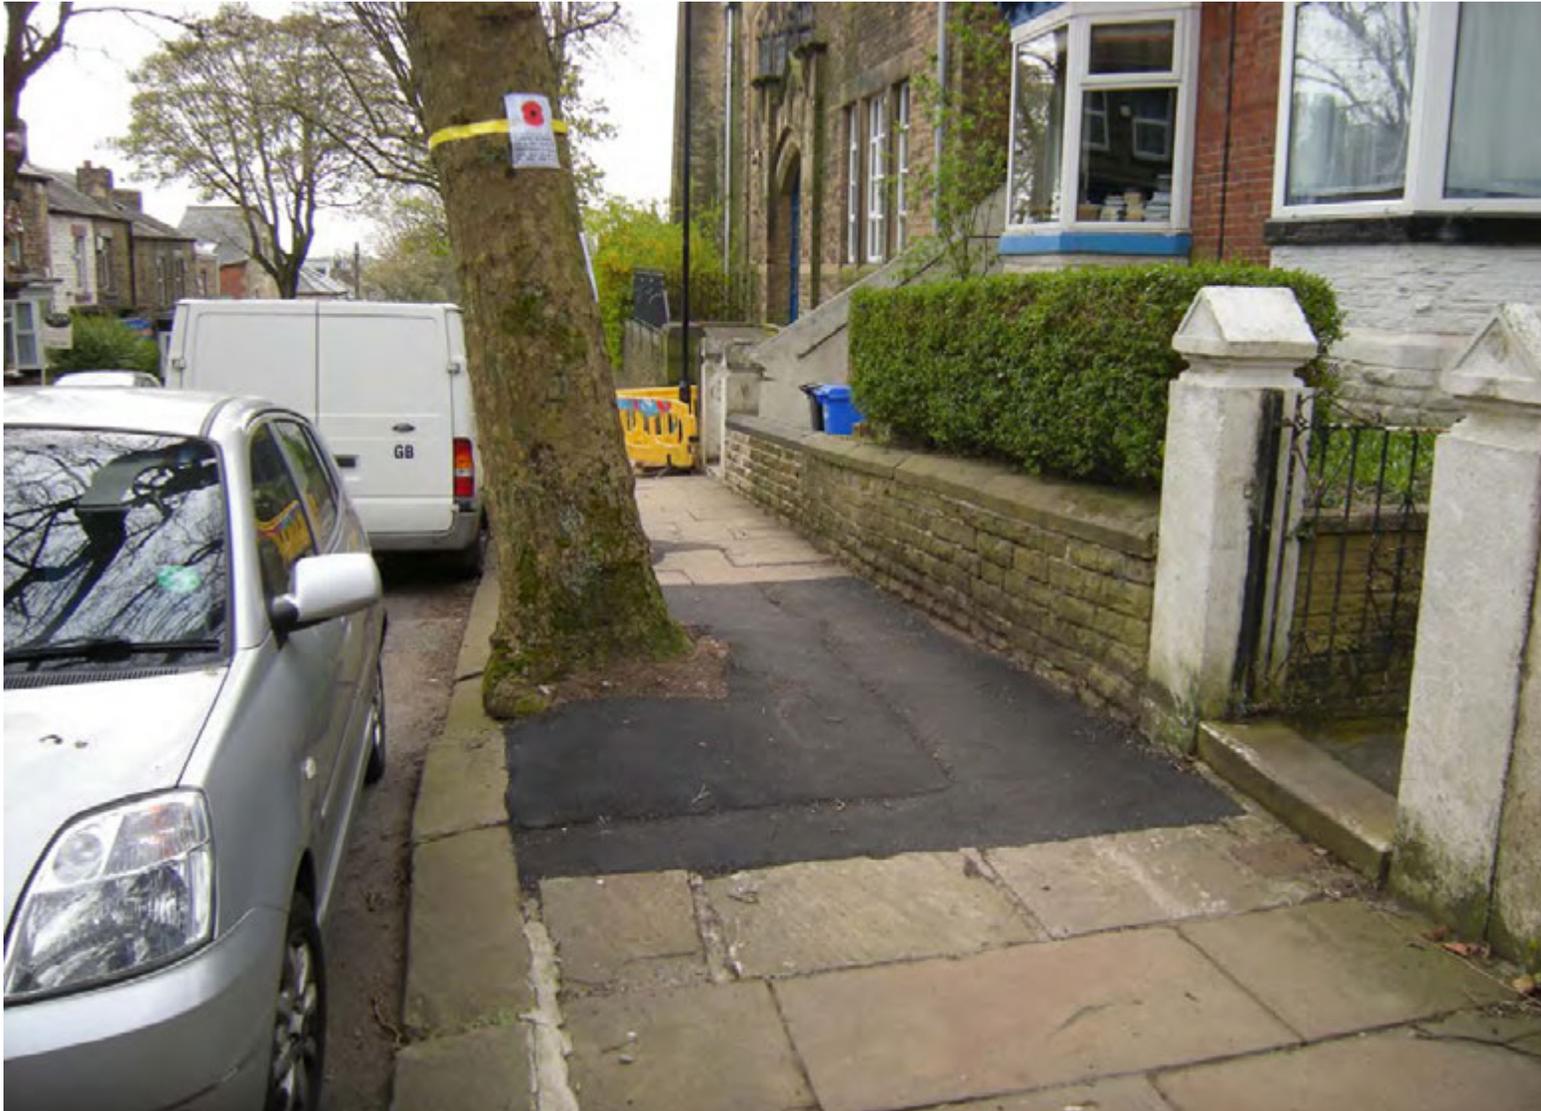
O/S 209 Additional photo showing double ramping of temporary surface.

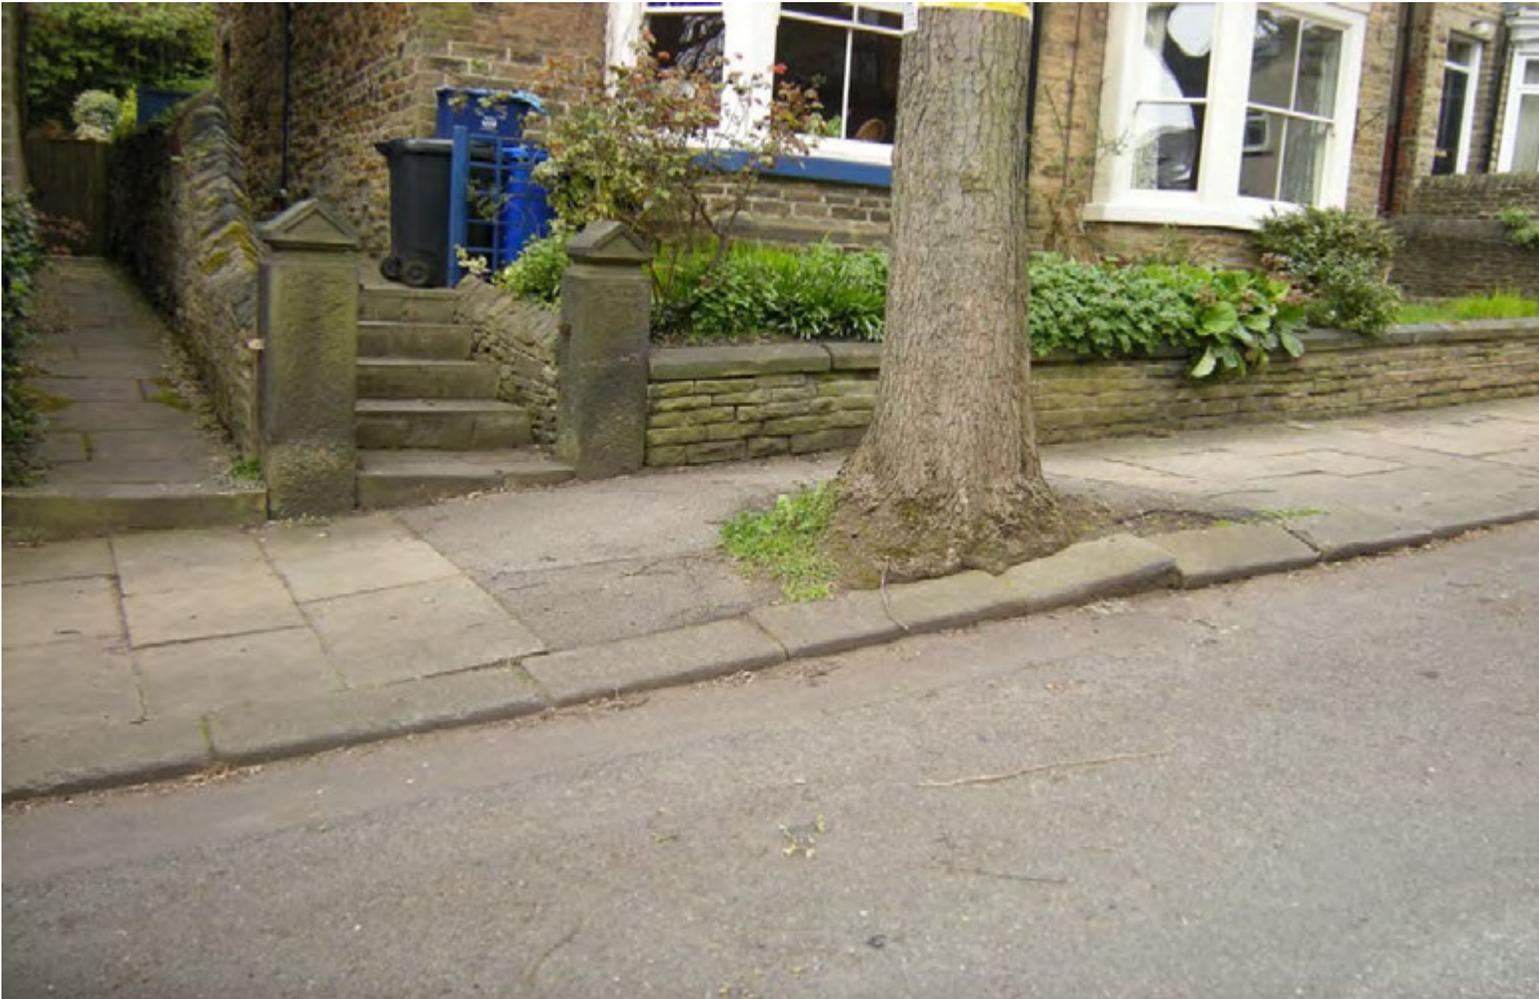
**Outside No. 219: Recommend Replacement: ITP in Agreement:**

**Due to declining physiological condition and basal decay. Slight damage to wall by roots tracing**

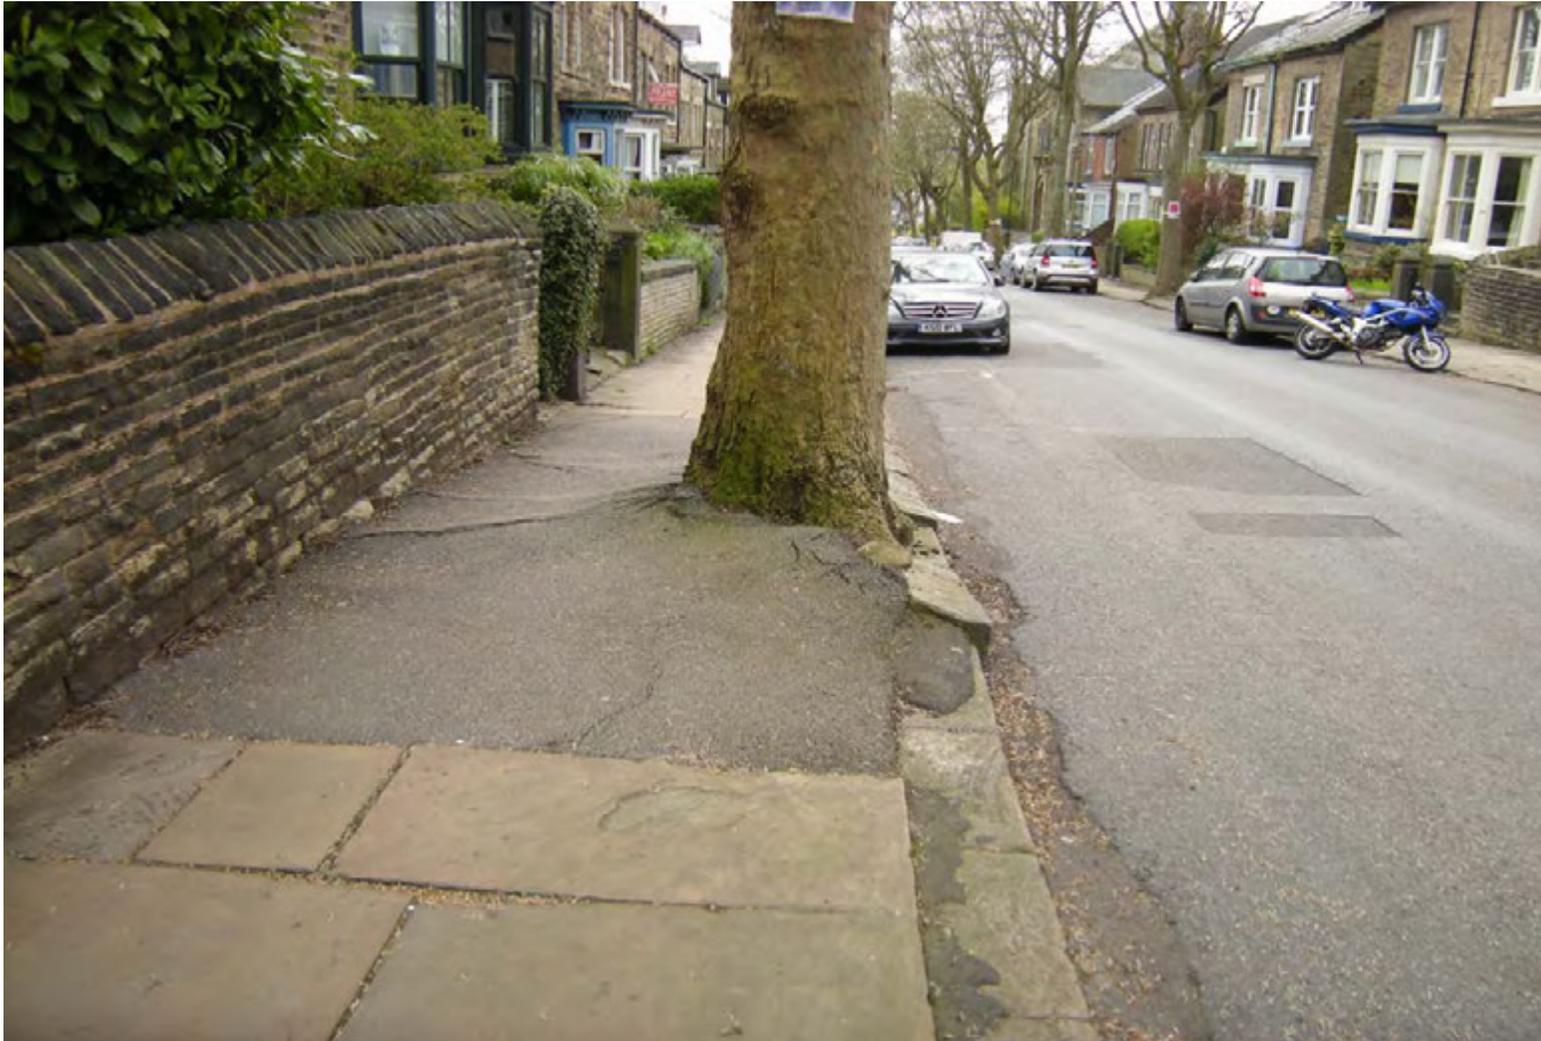
## **Opposite No. 231: SA Recommend Replacement**

**Kerb displaced by buttress. Unable to reset or provide half kerb suggested by ITP. due to roots in kerblines. Roots tracing to and undermining third party wall, future damage is imminent.**
