# **REPORT ON WESTERN ROAD**

## Report on Western Road:

## REPORT ON WESTERN ROAD – TREE PROPOSALS

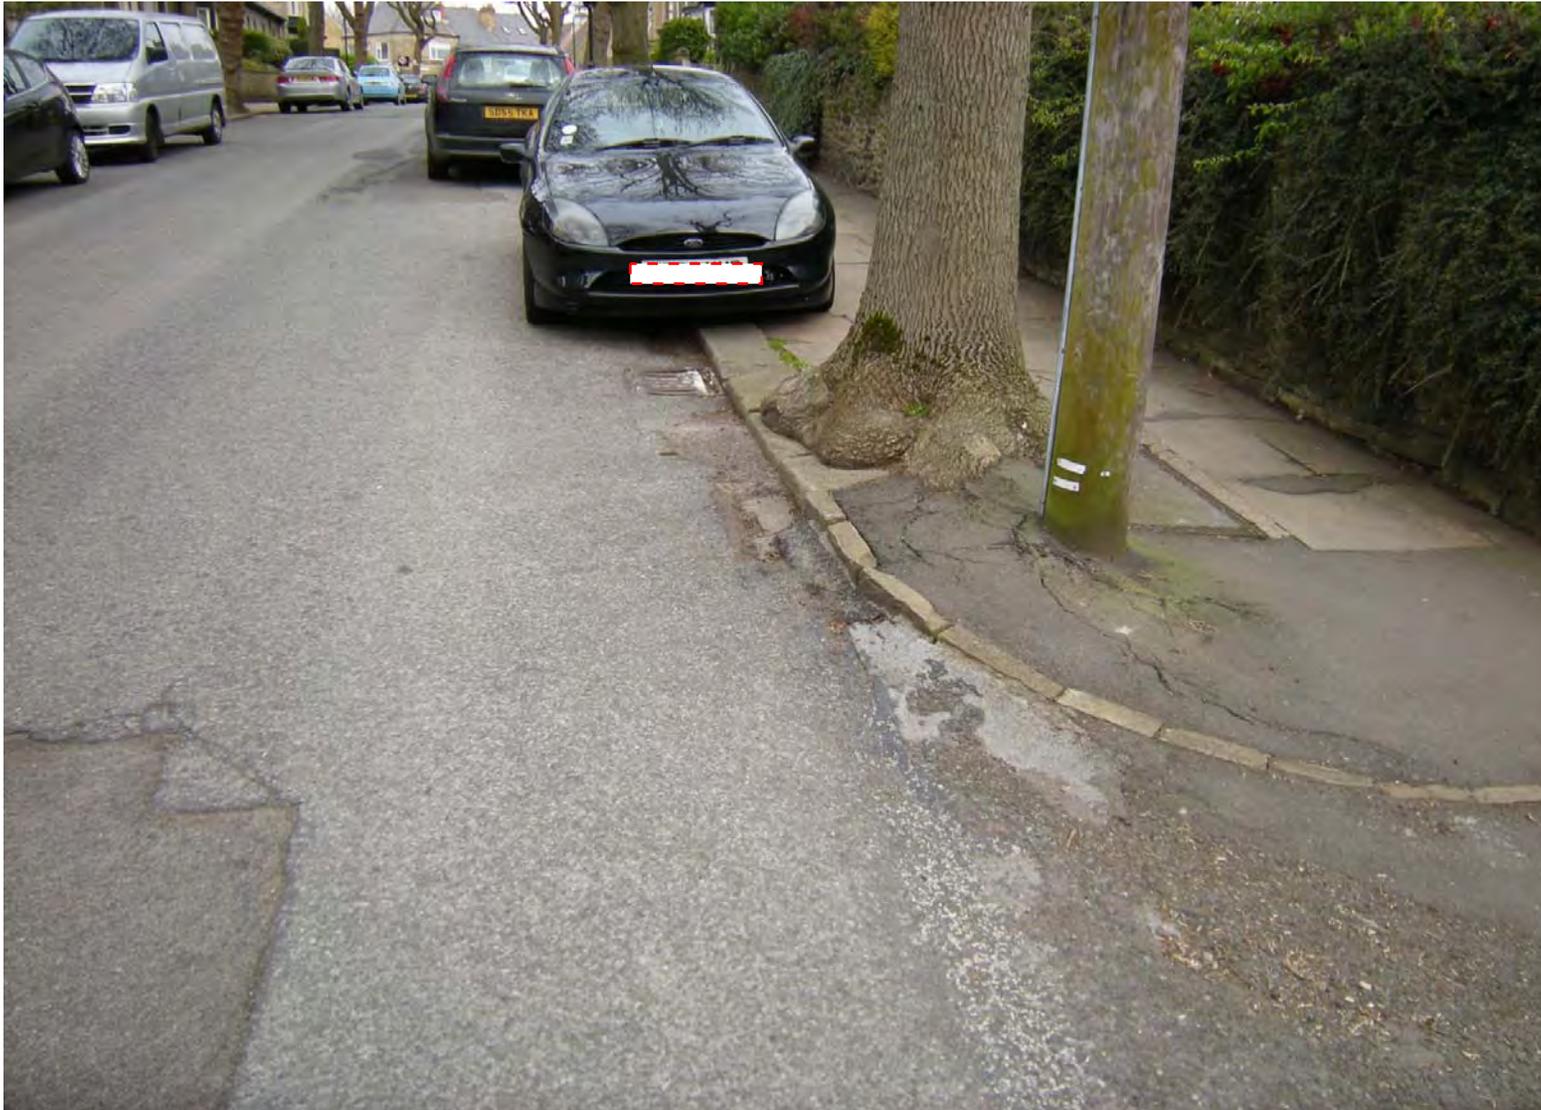
**Opposite No. 239: SA. Recommend Replacement: ITP in Agreement:**

Buttress enveloping kerbs and preventing access to service cover. Unable to provide half kerb.

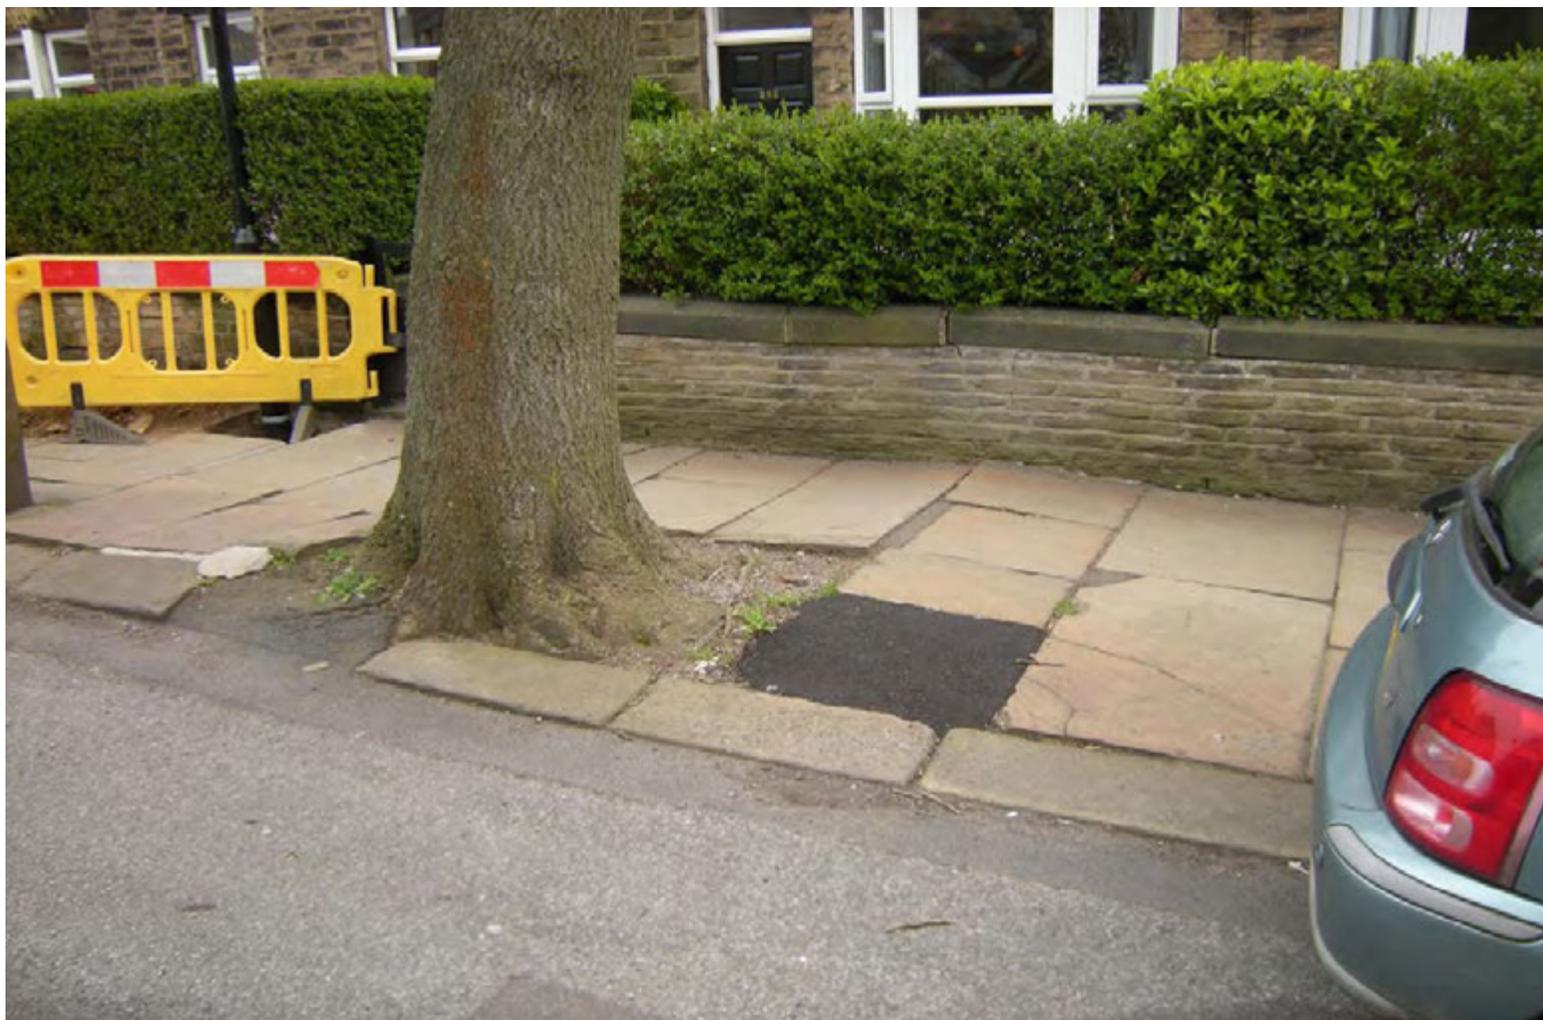
**Outside No. 262: SA Recommend replacement:**

**Kerb missing: Unable to reinstall half kerb as suggested by ITP due to buttress roots tracing into carriageway . Damage to third party wall by roots tracing below flags is evident.**

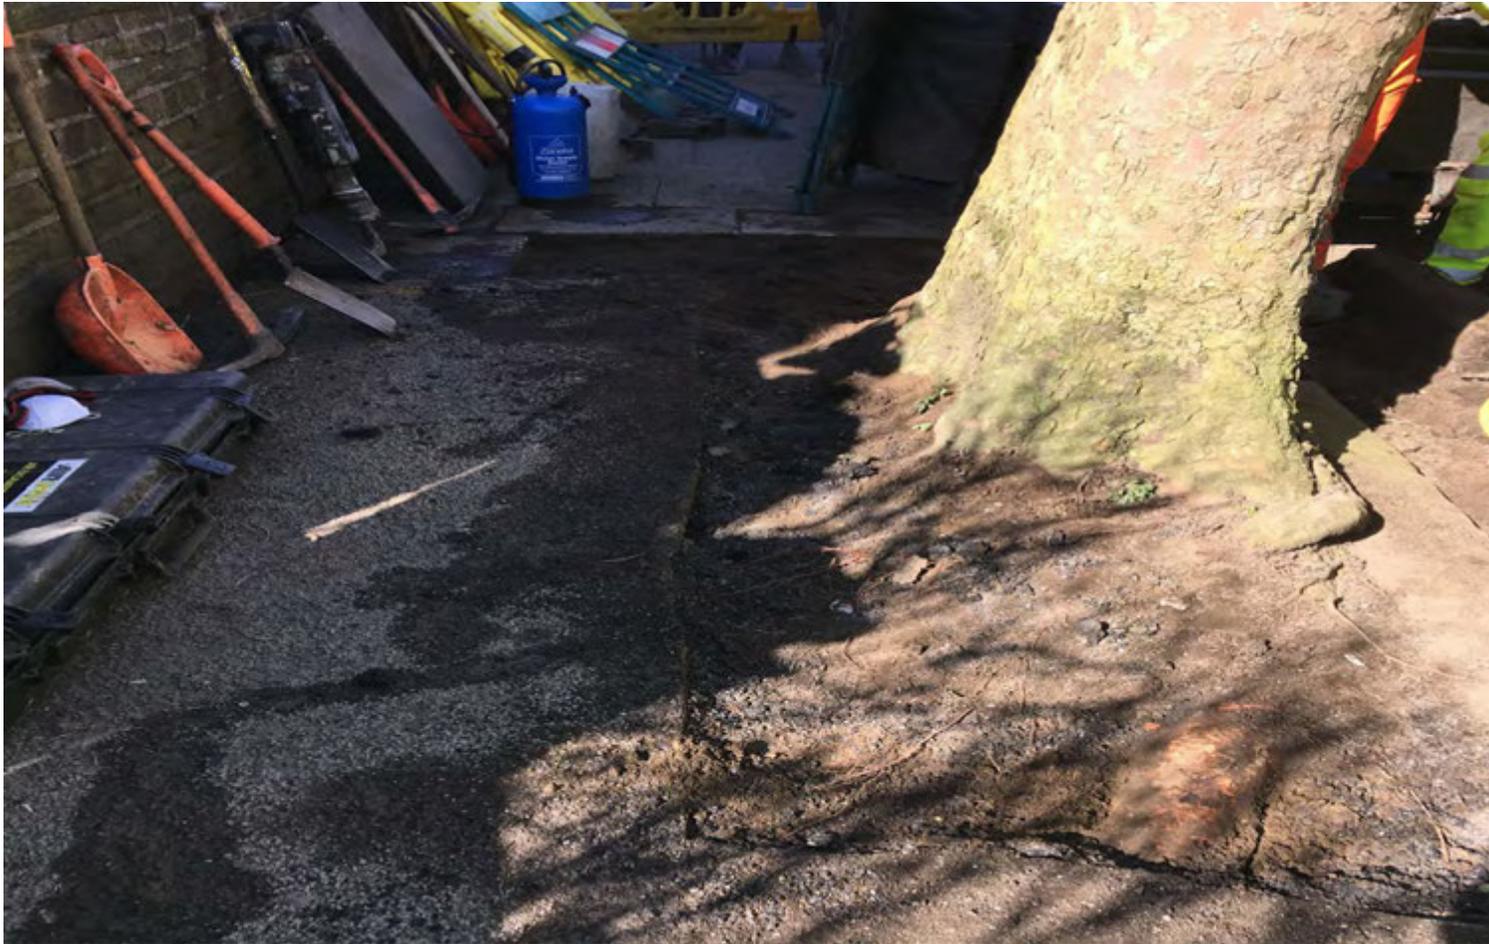
**Outside No. 271: Recommend replacement: Airspade in Agreement: -**

**Kerb displaced by roots, unable to reset due to roots in kerblines. Branches shearing out and in decline. Roots high in footway near gate from house, therefore further increase in build over would cause problems. Branches from this tree have fallen**

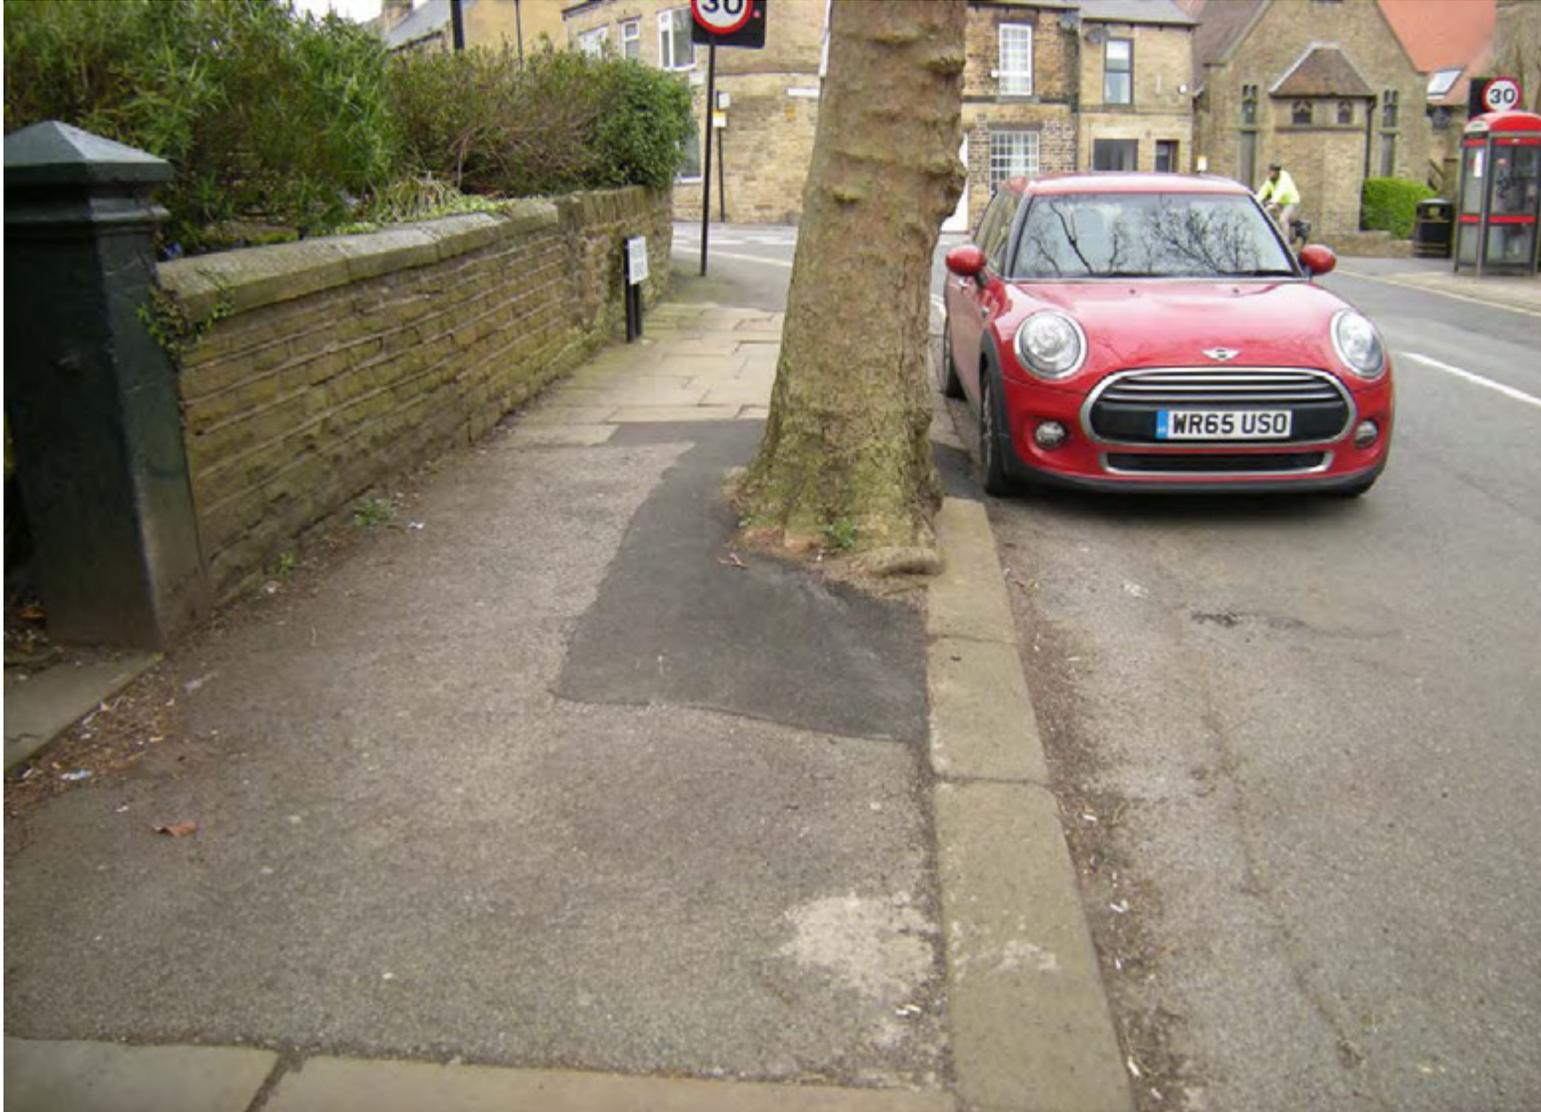
O/S 271 Additional: Photo showing the temporary tarmac solutions just above roots on site .
