## Graves Park - Rose Garden Café

### Stage 1 Report (RE/06513)

05 October 2023

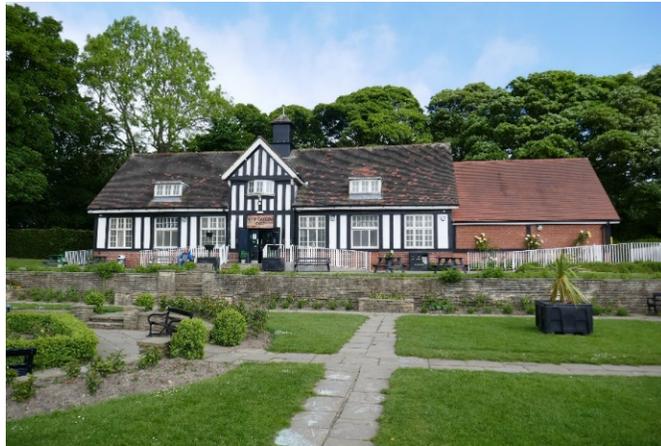
Photo of front elevation facing Rose Gardens

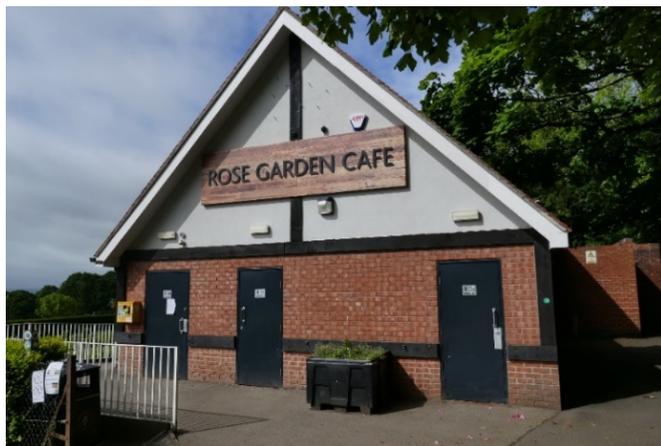
Photo of east facing side elevation of the new WC block to the Rose Garden Café.

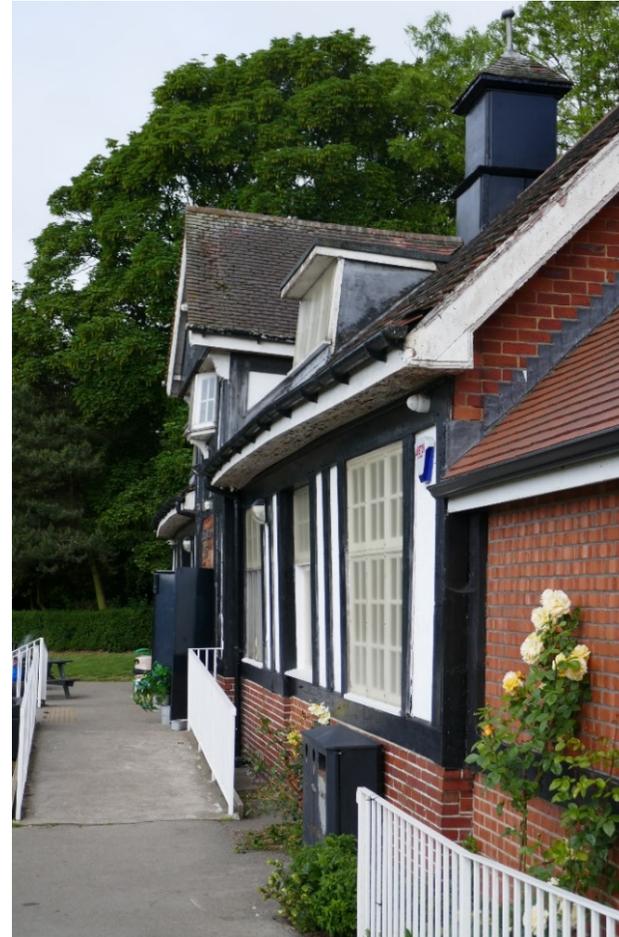
Photo looking west along the south facing front elevation showing the bowing out and leaning in the front wall and roof line to the front façade. Also note the dormers leaning back into the snagging roof line.

An initial site visit was undertaken by a multi-disciplinary design team which raised concerns over the severe bowing seen in the front wall of the café. The observed bowing indicated that the structural integrity of the building may be compromised, posing a potential health and safety risk. Further investigation was required to determine the condition of the building, which could not be undertaken safely whilst the café was in full operation. Therefore, in order to safely investigate the building, the Rose Garden Café Building was temporarily closed on 27<sup>th</sup> July 2022.

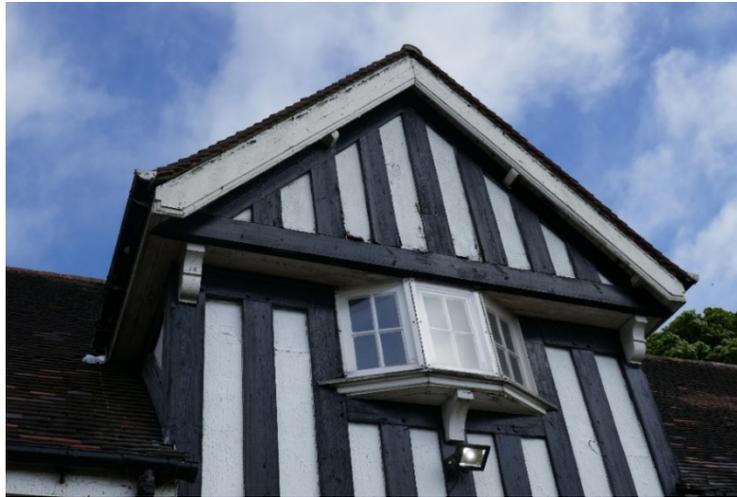
Photo of front elevation gable showing holes in the timber and render panelling, and the deterioration of the roof fascia, soffit and underside of window over main entrance.

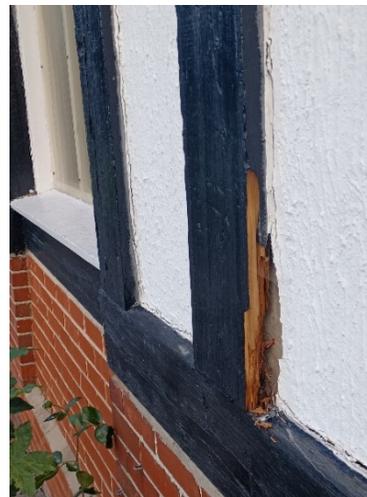
Photo of front elevation showing deterioration and cracking in timber and render façade.

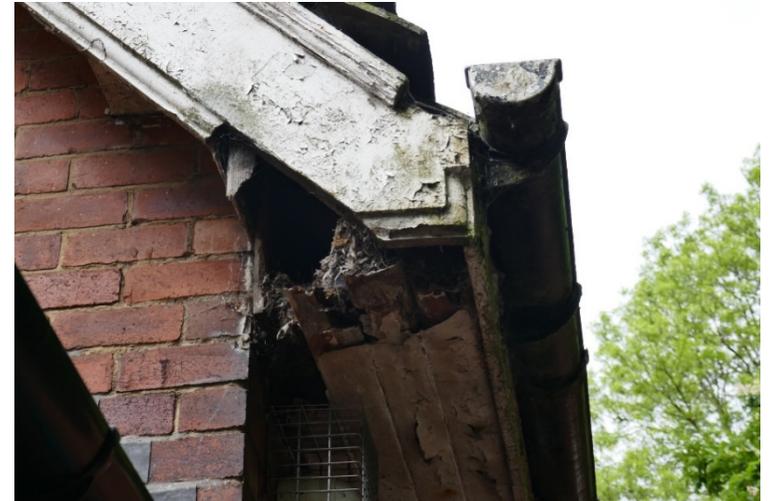
Photo of rear rainwater gutter and roof fascia / soffit detail showing major deterioration in timber panelling, due to missing and cracked roof tiles. Also showing evidence of bird nesting.

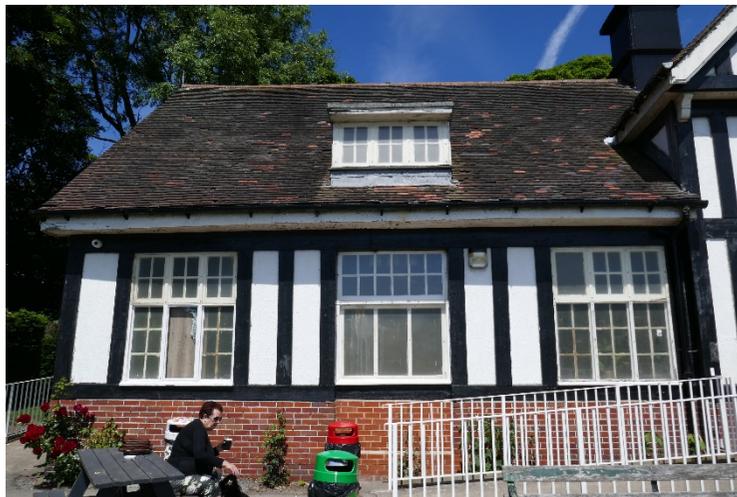
Photo of front elevation tiled roof finish showing missing and cracked roof tiles. Also note broken and boarded-up windows and blocked up clock tower.

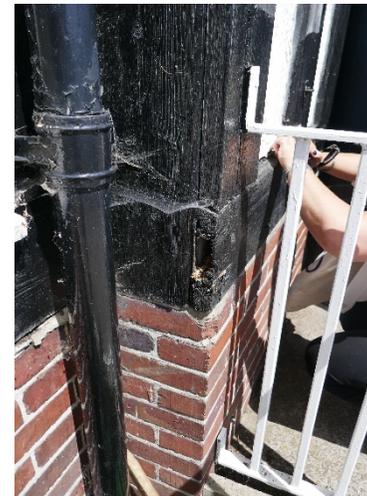
Photo of front elevation showing deterioration in timber panelling façade.

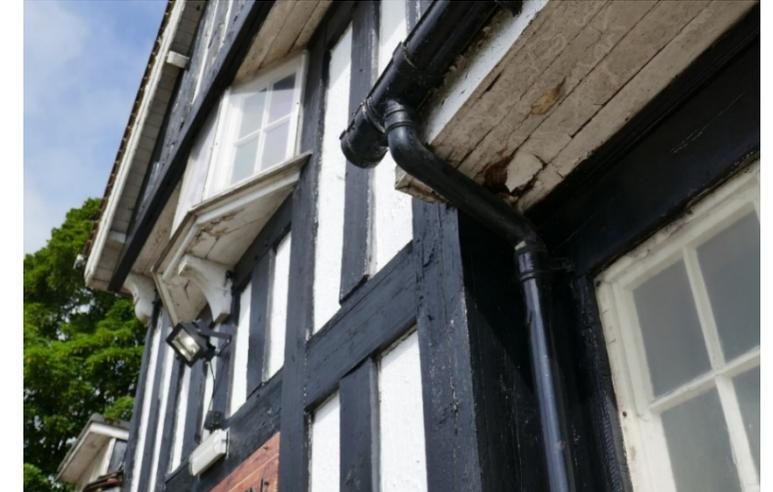
Photo of front elevation gable and roof fascia / soffit showing deterioration in timber roof soffit and bowing in timber panelling.

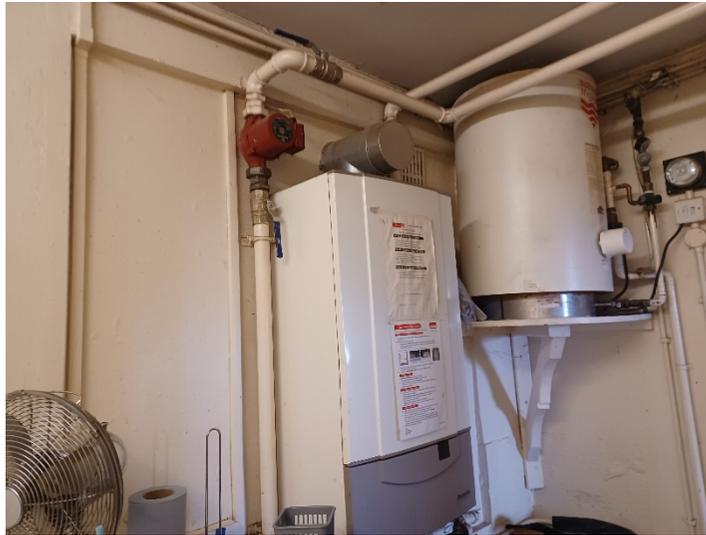
Photo showing existing boiler and hot water storage system.

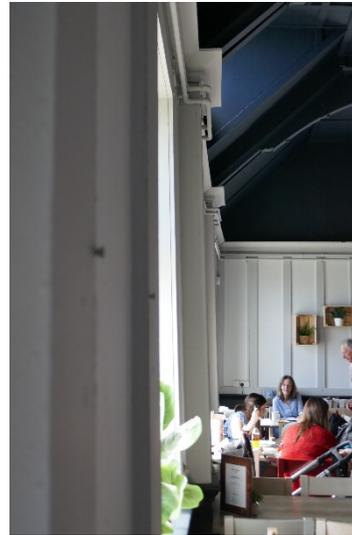
Photo showing front elevation leaning out internally, against vertical in background

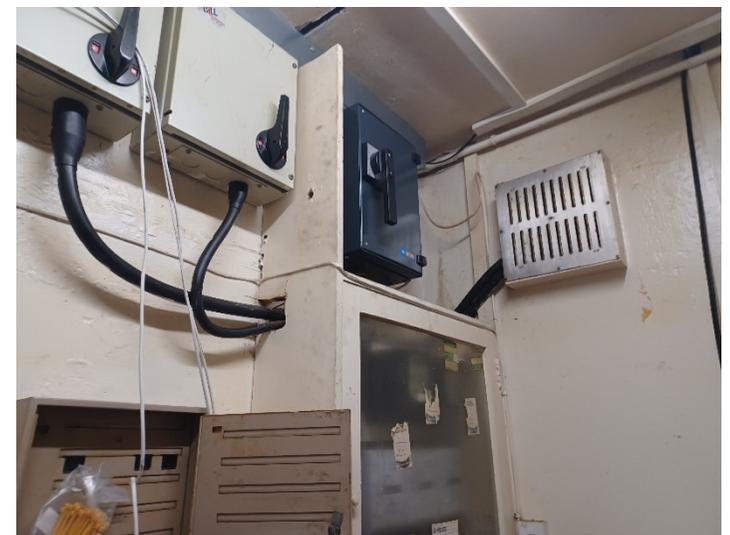
Photo showing existing electrical installation mains units and incoming supply

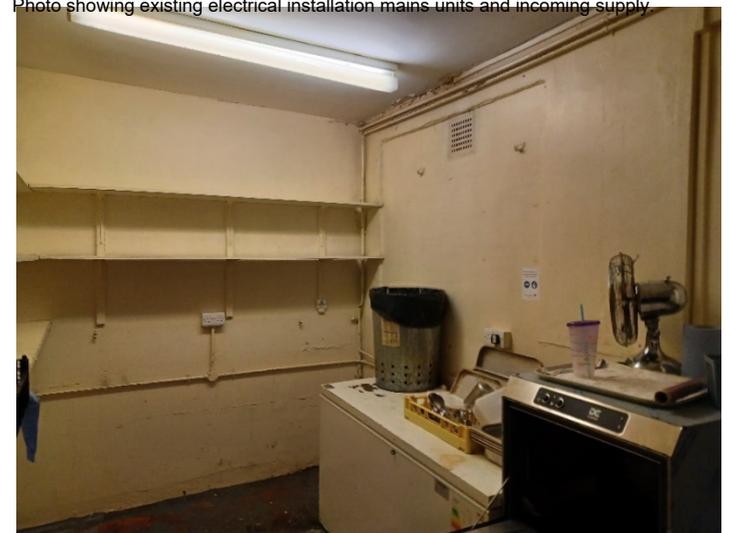
Photo showing existing food storage area with deterioration of internal finishes at junction between side wall and roof finish.

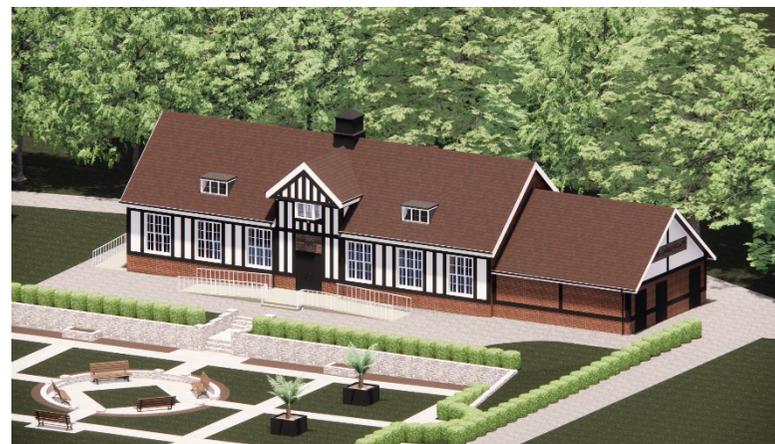
## EXISTING ROSE GARDEN CAFÉ LAYOUT

- Kitchen, lobby, office, store, staff welfare facility and servery, including walls and circulation area – 62m<sup>2</sup>
- Café area – 163m<sup>2</sup>
- WC block area – 60m<sup>2</sup>

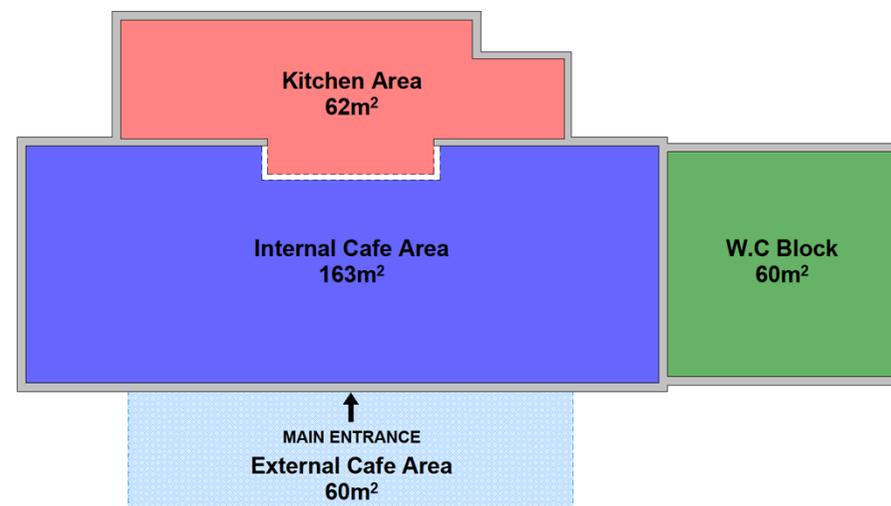
### OPTION 2A – Structural stabilisation of the existing building with full refurbishment

- Maintains the existing building footprint and internal zones generally.
- Retained existing WC block: 60m<sup>2</sup> existing.

- New external seating area for approx. 40 people: 60m<sup>2</sup> (based on 40 spaces @ 1.5m<sup>2</sup> per person / counter service recommended area allocation)

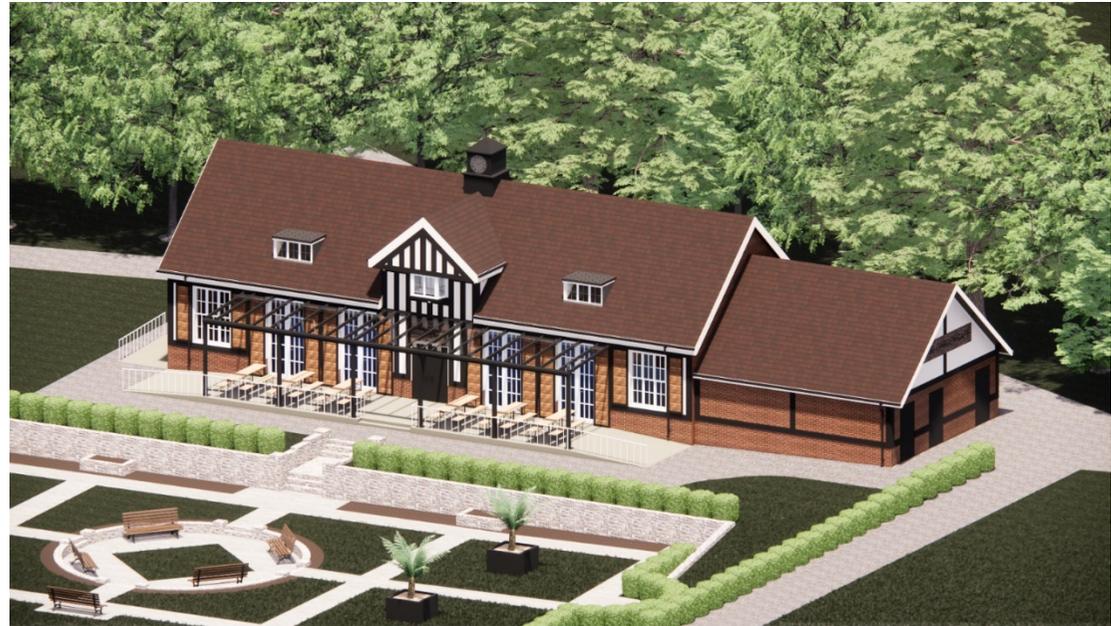
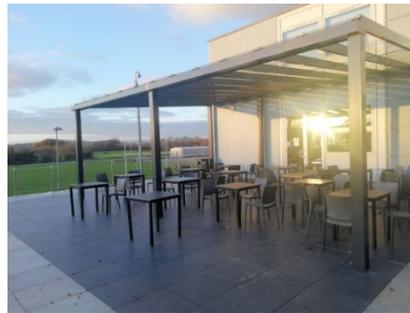
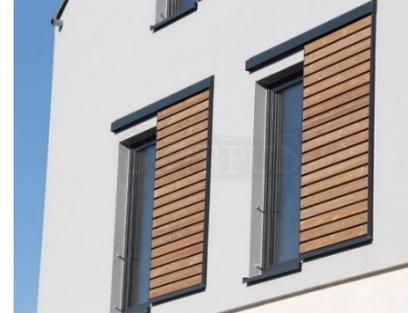
- As original design:
  - Brickwork at low level
  - Timber boarding with rendered infill panels
  - Rosemary roof tiles
- New clock tower
- External covered canopy
- Aluminium full height opening glazed doors
- External sliding timber window shutters

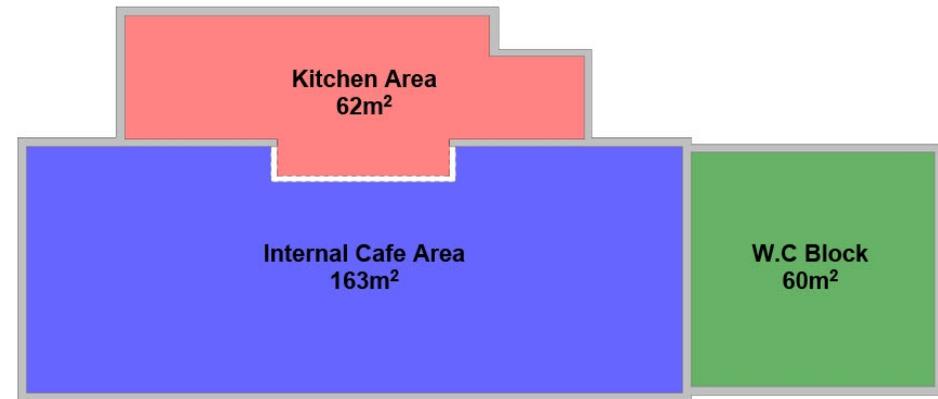
## OPTION 2B – Structural stabilisation of the existing building with light touch refurbishment to café interiors only

- Maintains the existing building footprint and internal layout as existing.
- Retained existing WC block: 60m<sup>2</sup> as existing, no new finishes.
- NO works to the following:
  - No repair works to external walls, except the front wall.
  - No upgrading of U-Values by the installation of insulation to existing floor and external walls.
  - No internal remodelling works to café, kitchen, store, servery, office, and welfare area.
  - No works to upgrade kitchen catering installation or finishes.
  - No new FF&E.

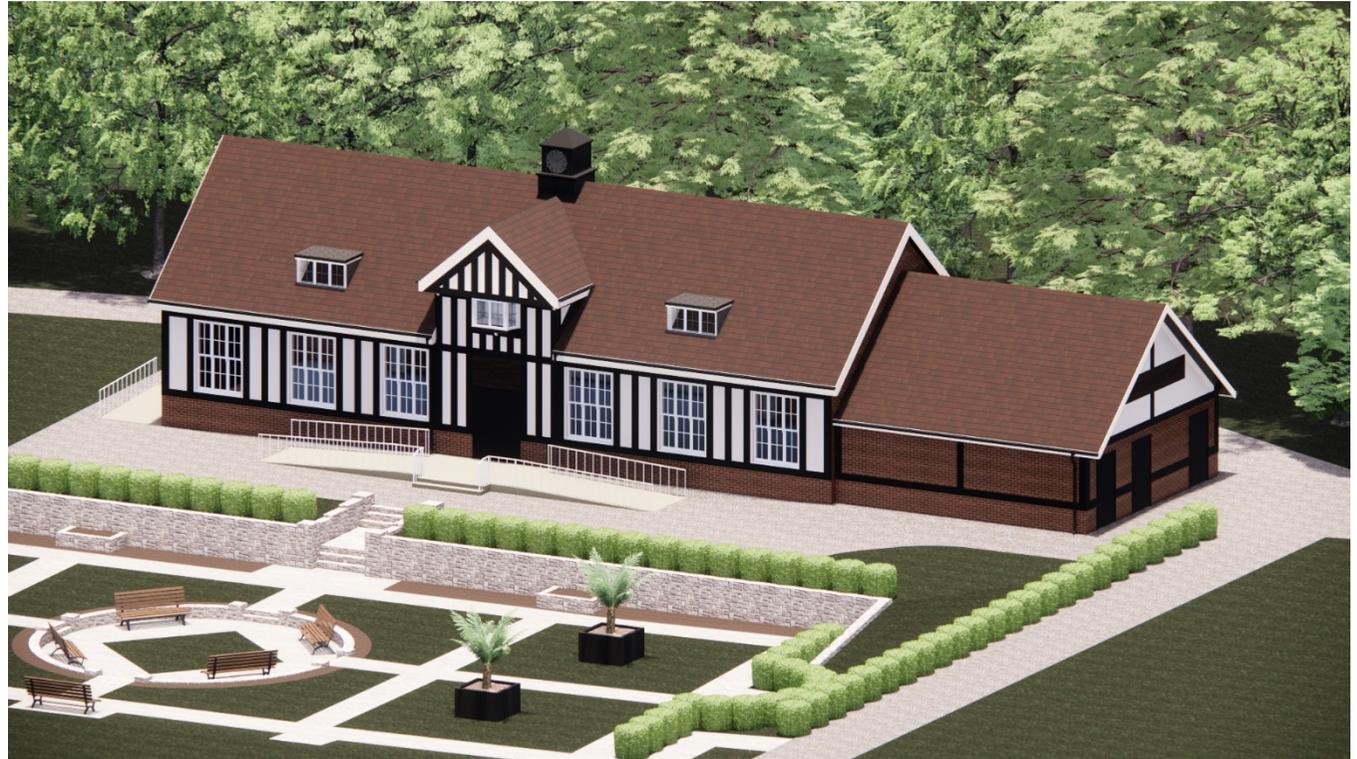
- As Original Design:
  - Brickwork at low level.
  - Timber boarding with rendered Infill Panels.
  - Rosemary Roof Tiles.
  - Timber windows.
  - Clock Tower restored.

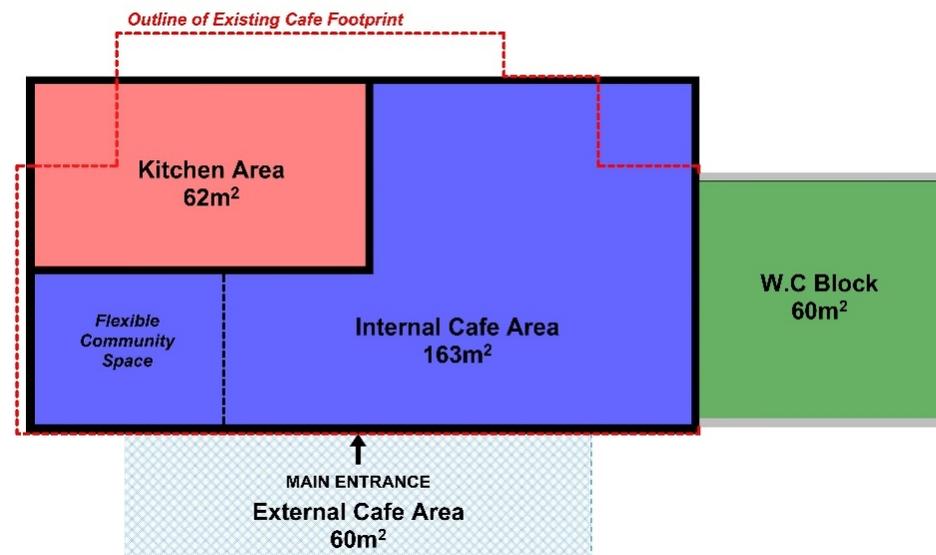
### OPTION 3 – Demolition of existing building and provision of new MMC (Modern Methods of Construction) facility

- Retained existing WC block: 60m<sup>2</sup> existing.
- External seating Patio with seating for approx. 40 external: 60m<sup>2</sup> (based on 40 spaces @ 1.5m<sup>2</sup> per person / counter service recommended area allocation)
- Kitchen / Store / Servery / Office and Staff Welfare area (generally based on average café kitchen being approx. 25% to 30% of total café area served)

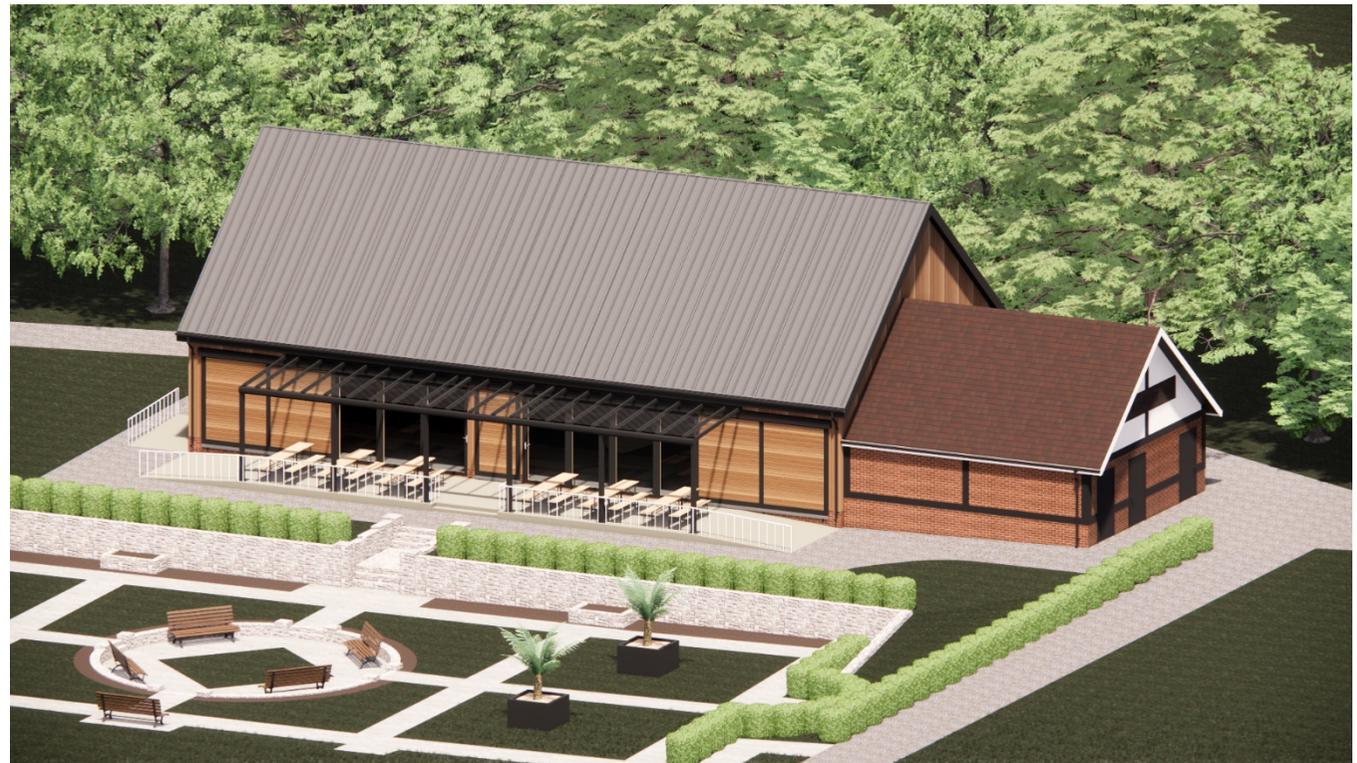
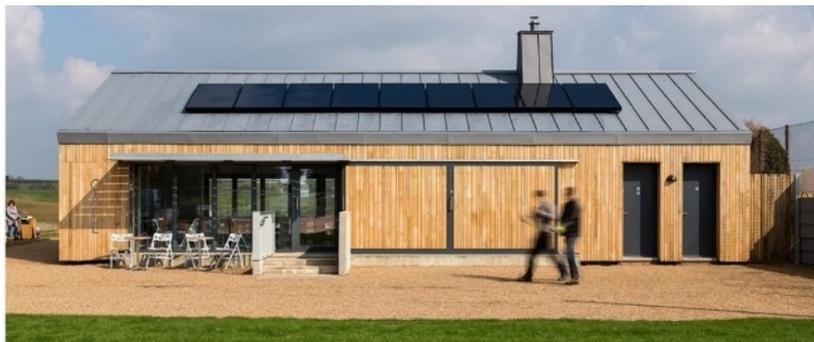
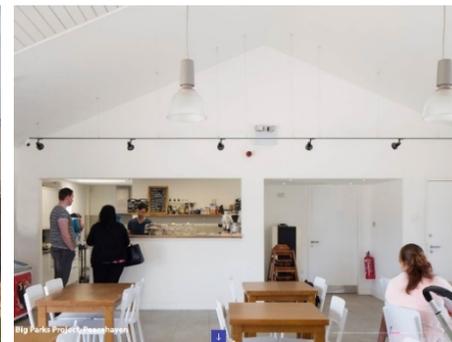
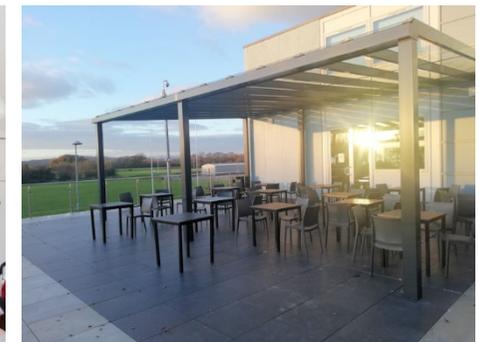
- Brickwork at low level
- Timber cladding
- Zinc roofing
- External covered canopy
- Aluminium bi-fold opening Doors/screens
- External sliding timber Window shutters
- 
- North facing roof lights
- Naturally ventilated
- Potential to add P.V.'s

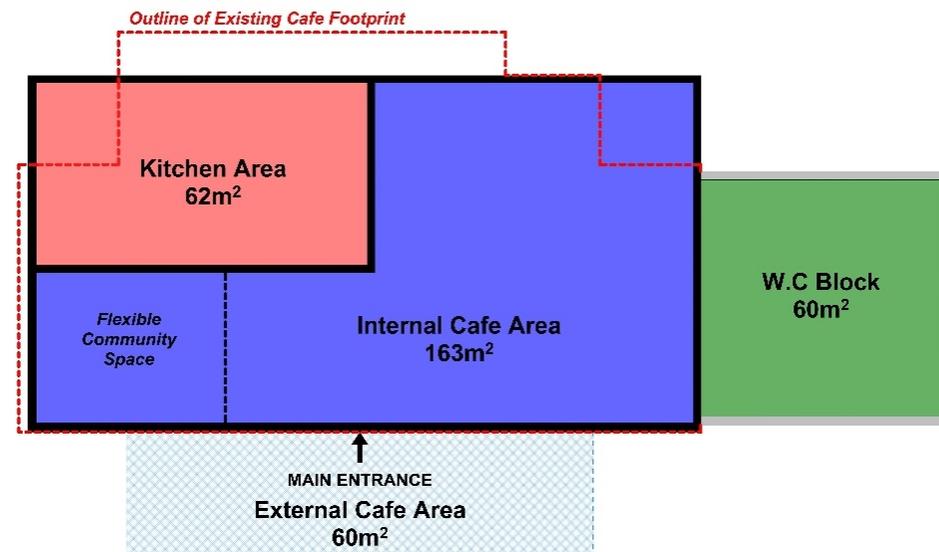
## OPTION 4 – Demolition of existing building and provision of new traditional build facility

- Retained existing WC block: 60m<sup>2</sup> existing.
- External seating Patio with seating for approx. 40 external: 60m<sup>2</sup> (based on 40 spaces @ 1.5m<sup>2</sup> per person / counter service recommended area allocation)
- Kitchen / Store / Servery / Office and Staff Welfare area (generally based on average café kitchen being approx. 25% to 30% of total café area served)

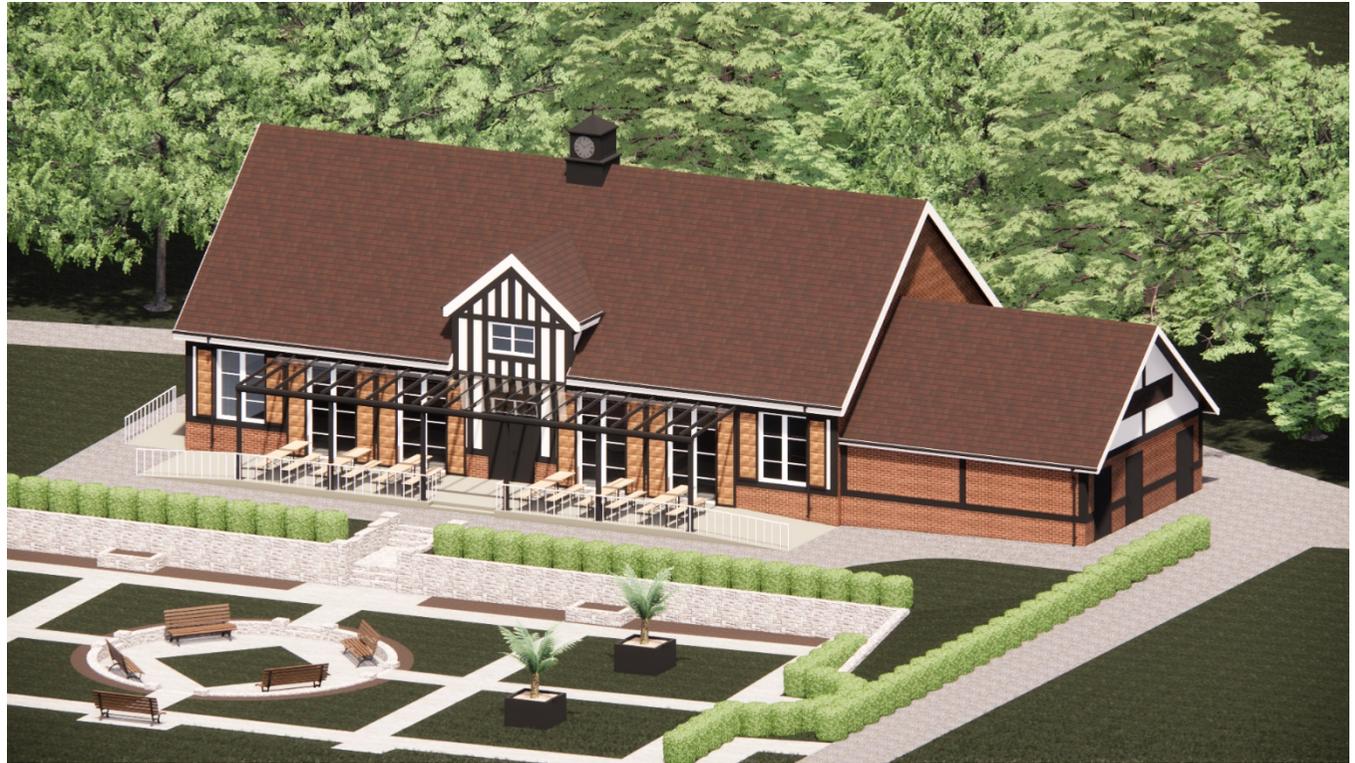
- As original design:
  - Brickwork at low level
  - Timber boarding with rendered infill panels
  - Rosemary roof tiles
- New clock tower
- External covered canopy
- Aluminium full height opening glazed doors
- External sliding timber Window shutters
- North facing roof lights

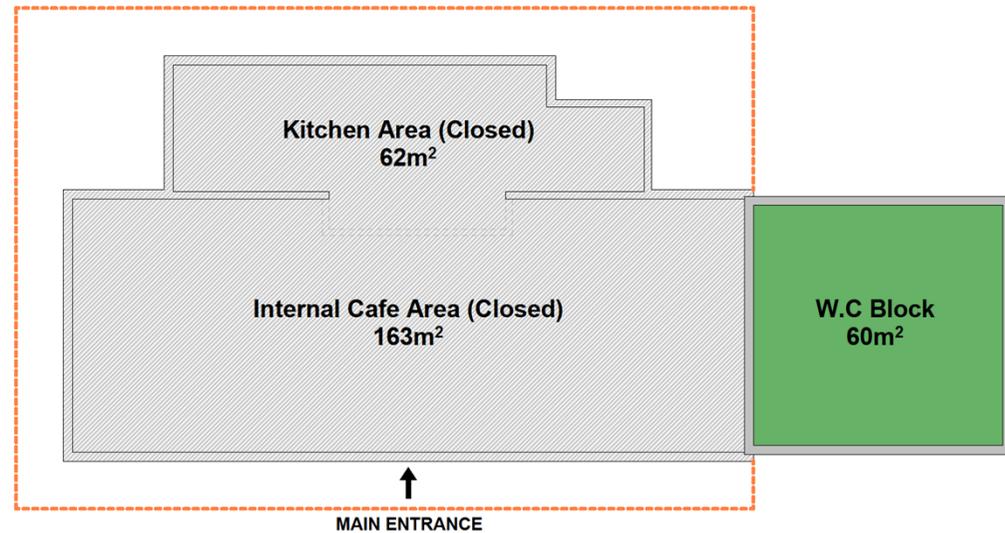
### OPTION 1 – Site safely secured and café building closed

- Maintain scaffolding internally and externally.
- Existing external WCs to remain open.
- Indicative security fencing line as indicated in Orange dotted line.
- CLOSED Rose Garden Café building footprint as identified in Grey lines and hatched area.

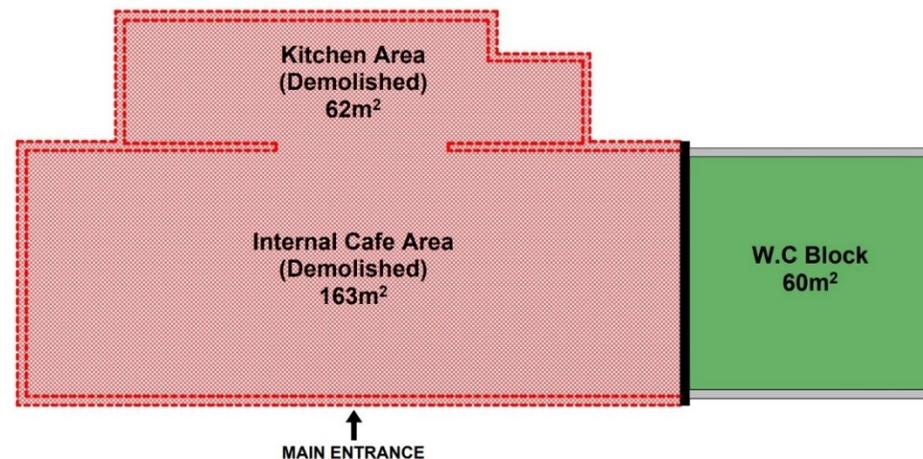
**OPTION 5 – Demolition of existing building and site clearance only**

- Retained existing WC block: 60m<sup>2</sup> existing.
- Works required to make good existing wall between café and WC block.
- Demolished existing Rose Garden Café building footprint as identified in red dotted line and hatched area.
