Re-investigating Sheffield Castle

Shaun Richardson

Ed Dennison Archaeological
Services Ltd

Presentation to South Yorkshire Archaeology Day,
November 2013. Edited by
South Yorkshire Archaeology Service

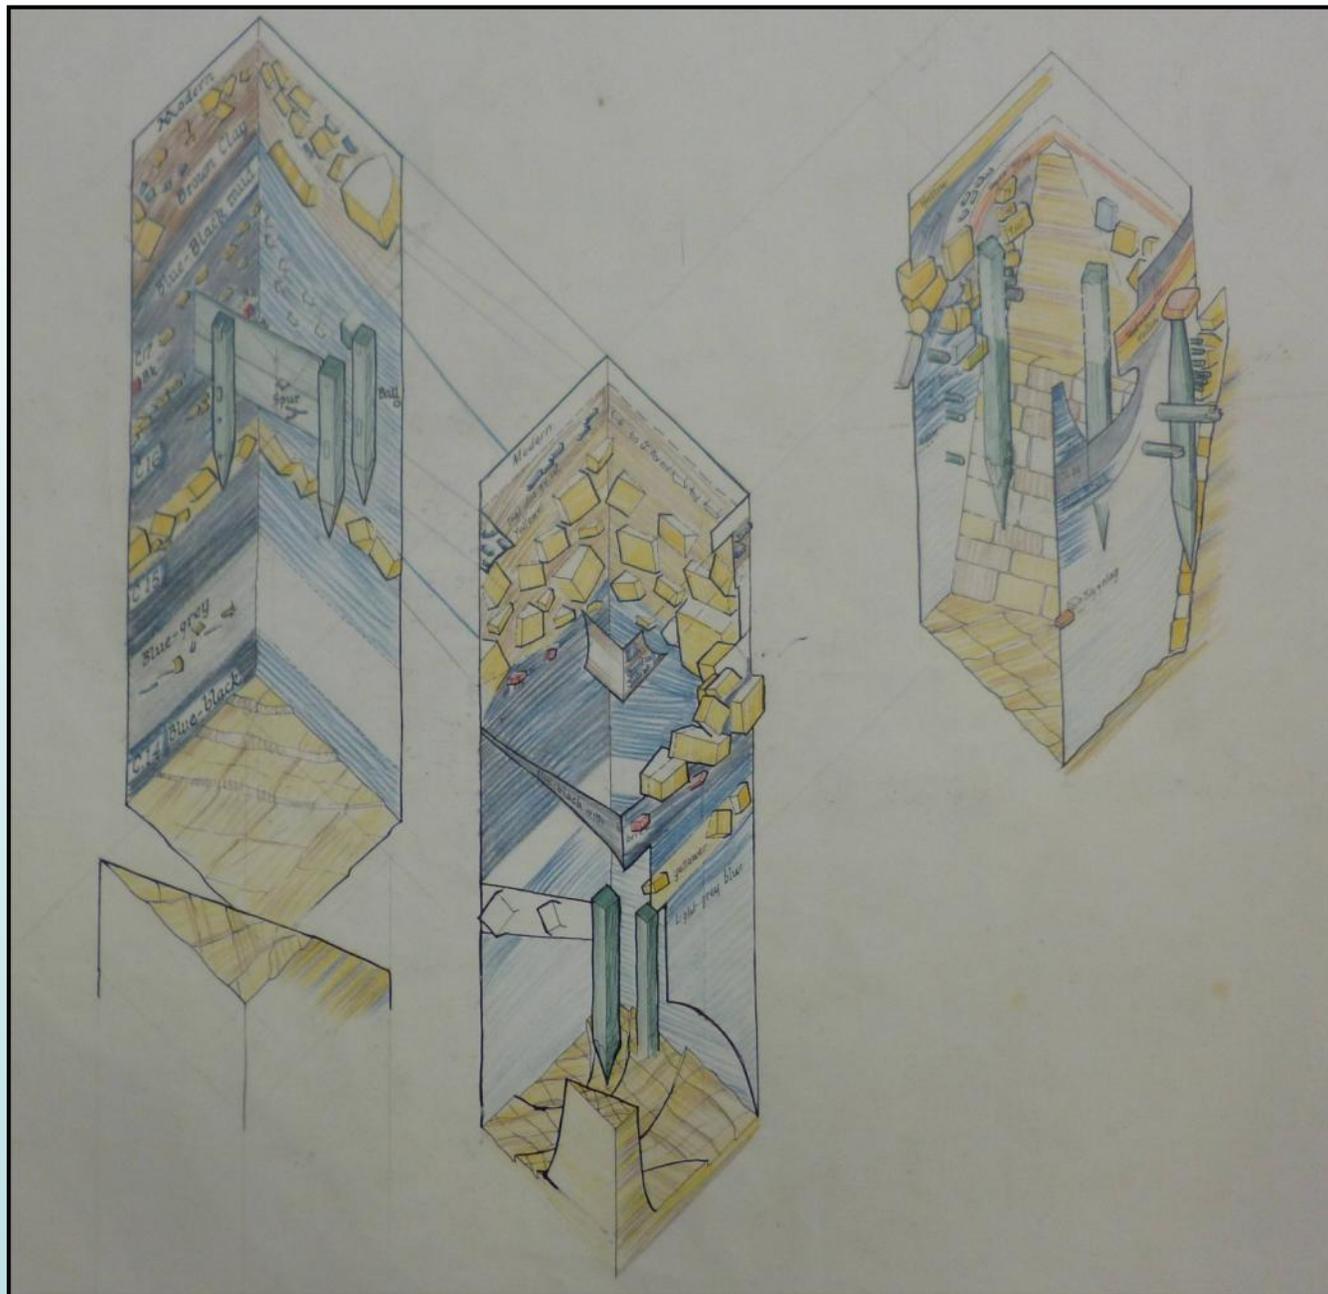
Isometric colour
cut-away
drawings of
moat deposits,
by Leslie
Butcher, c.1961

As EDAS reviewed archive material, it became increasingly clear that **Leslie Butcher spent much of the 1960s grappling with exactly the same issues that the evaluation strategy had been considering**; where had ground levels formerly been, what depth were the foundations for various buildings; how did one overlie the other; and who had found what where? Although the only publication deriving from Butcher's work was a summary note in the journal *Medieval Archaeology*, he left behind an unpublished typescript report as well as notes for a lecture given on 10th January 1961, both of which have proved invaluable. These are accompanied by a large number of unpublished drawings like the one shown in the next slide, testament to his great skill as a draughtsman. Another aspect of Butcher's work which contributed greatly to that undertaken by EDAS was his preservation of earlier plans still in existence during the 1960s, some of which are now the only known surviving representations of earlier construction works.

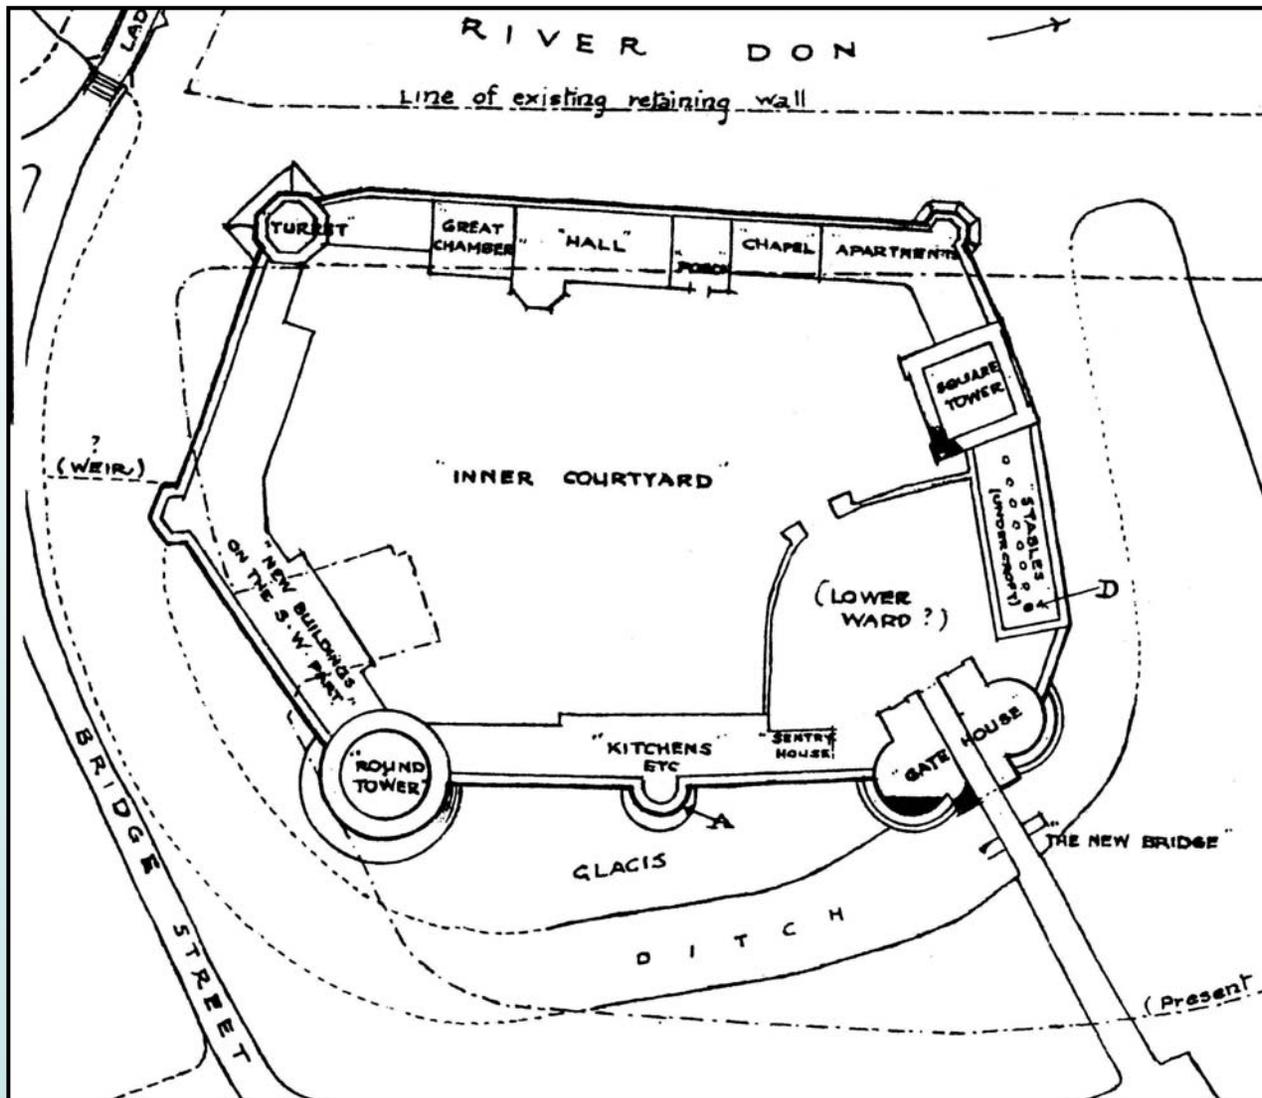
Earliest known attempt to reconstruct the castle layout incorporating archaeological evidence, by F Pearce-Edward, November 1930, in a private letter to A L Armstrong (Museums Sheffield)

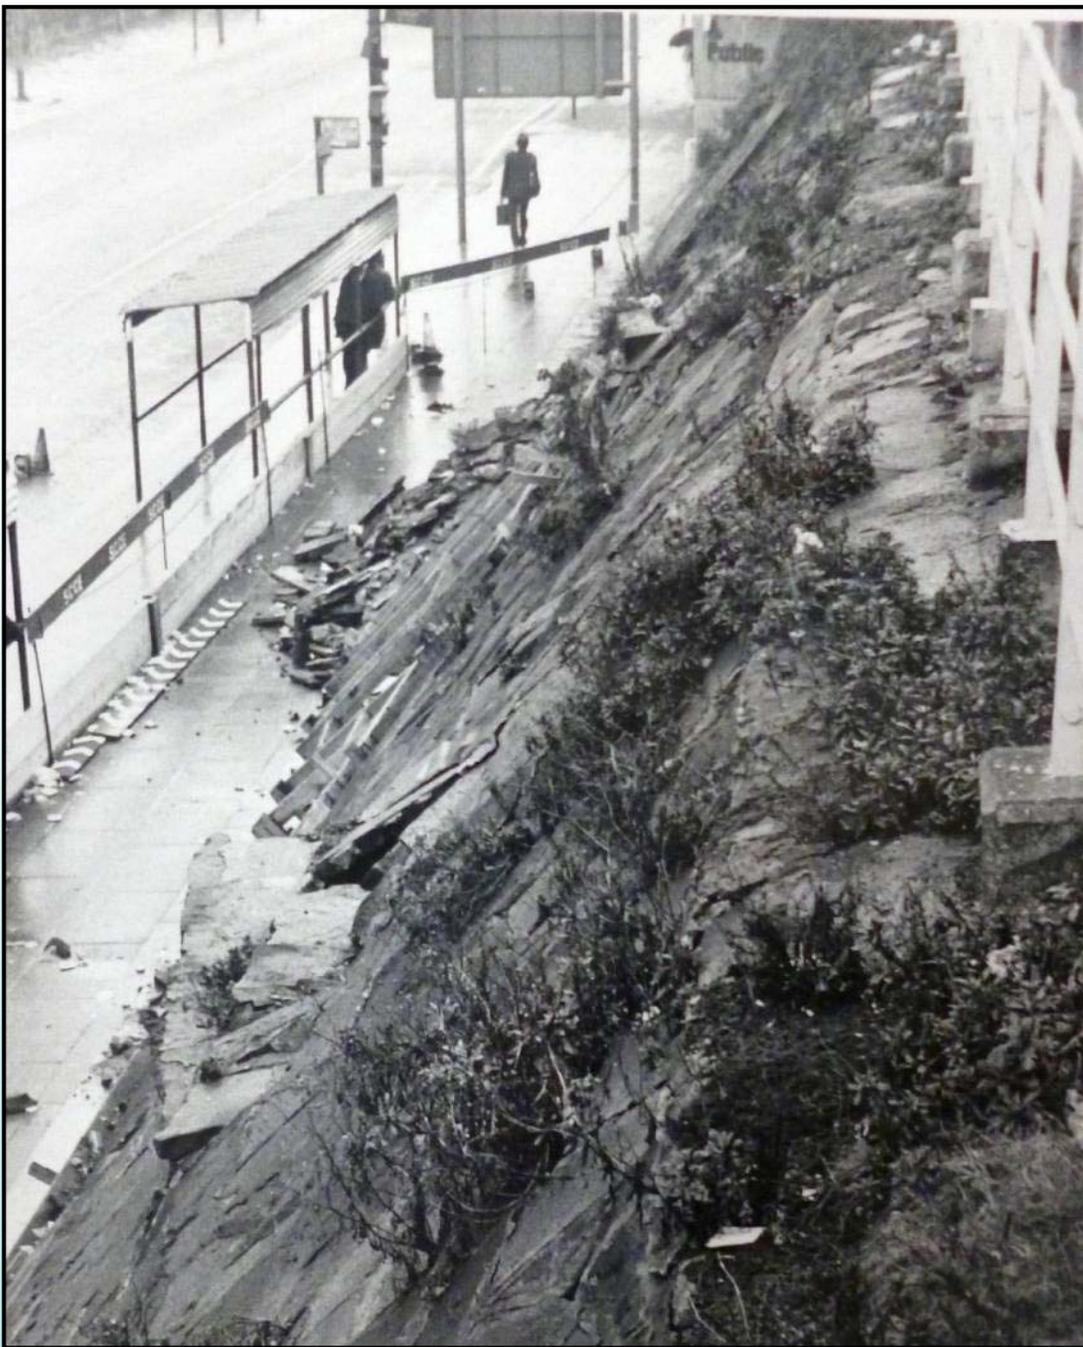
A reasonable starting point is 1972, as this was the last date that a fragment of the castle remained clearly visible above ground to all passers-by, although for entirely understandable reasons, very few probably appreciated its significance. It can be seen in the foreground of this slide, projecting from the collapsing crazy paving lining the slope above the bus shelters on the south side of Castlegate.

Castlegate, looking east
towards Blonk Street
Bridge, 1972
(Museums Sheffield)

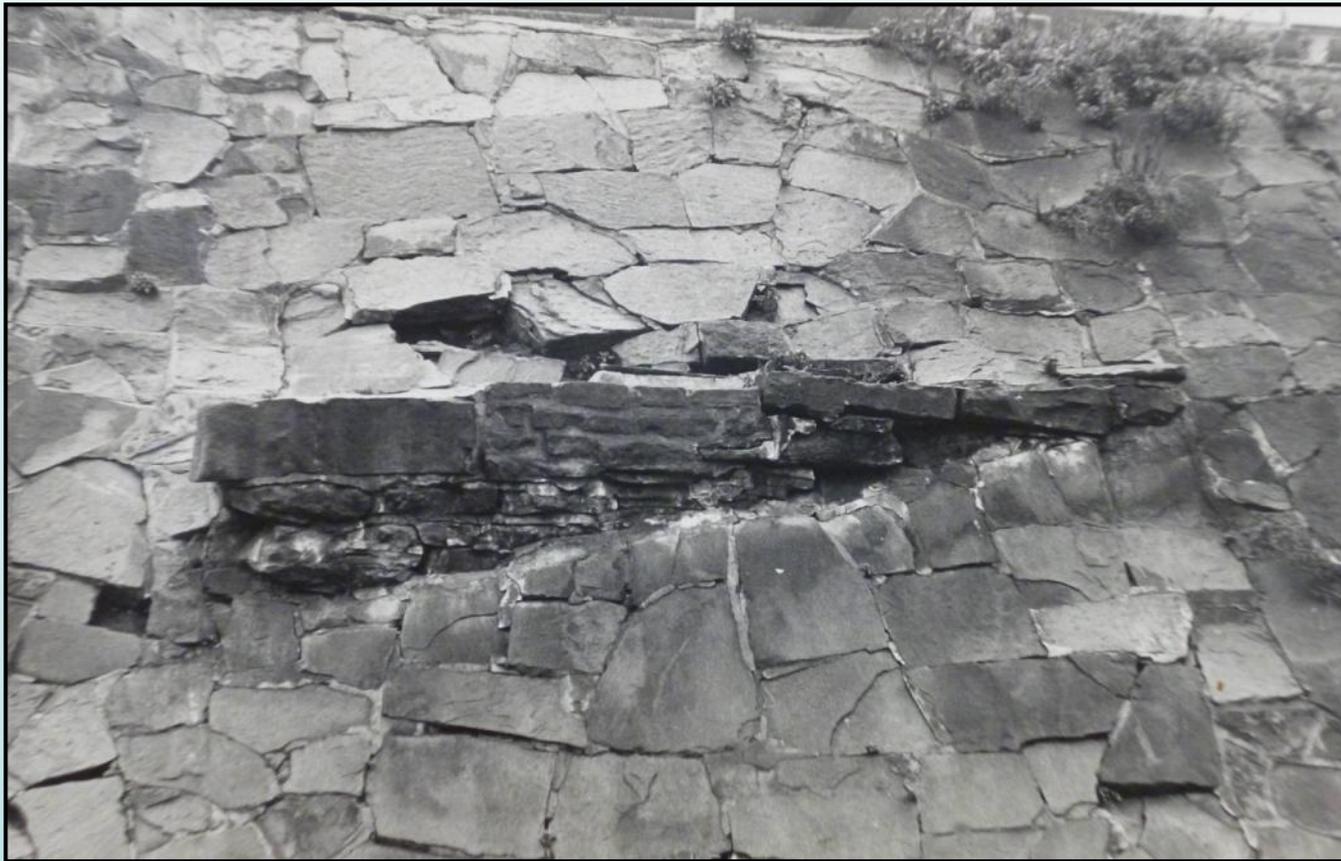
Castlegate, remnant of north range of castle,
looking south, 1972 (Museums Sheffield)

As this closer view shows, by 1972 the remains were in fairly poor condition. The fragment of wall had almost certainly been exposed in this position since 1929-1930, when the paved slope to the south side of Castlegate was constructed, and it had obviously been heavily repointed several times. The fragment barely outlasted the photograph as, unsurprisingly given its poor condition, it collapsed during the construction of the existing Castlegate vertical concrete retaining wall.

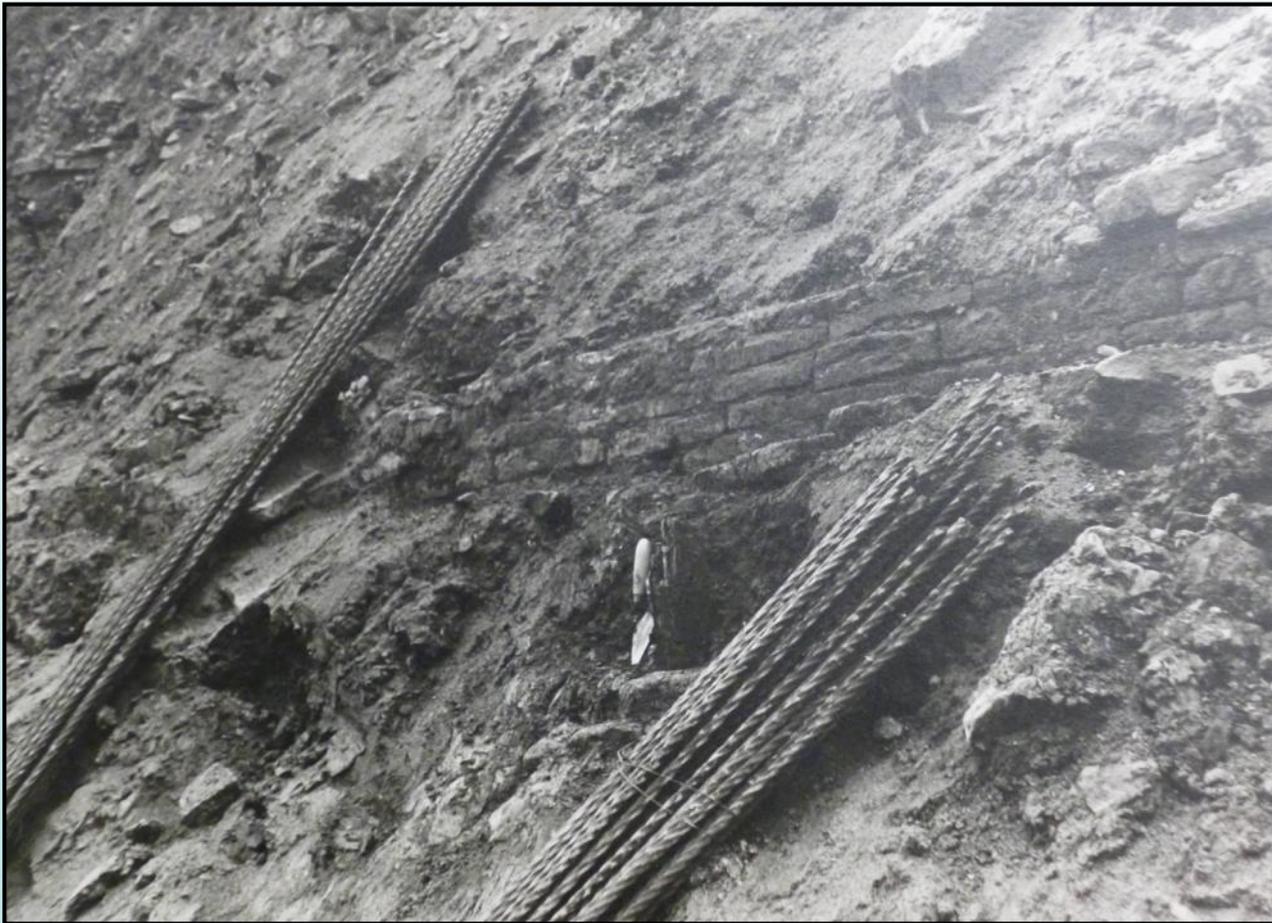
Castlegate, wall recorded by Pauline Beswick during retaining wall construction, 1972 (Museums Sheffield)

As the works on the new concrete retaining wall progressed, further sections of earlier wall alignment were exposed, and these were recorded by Pauline Beswick. These fragments and scraps of walling and structure, none of which can be closely dated, may seem insignificant, but when taken together, they begin to contribute to a better understanding of the site.

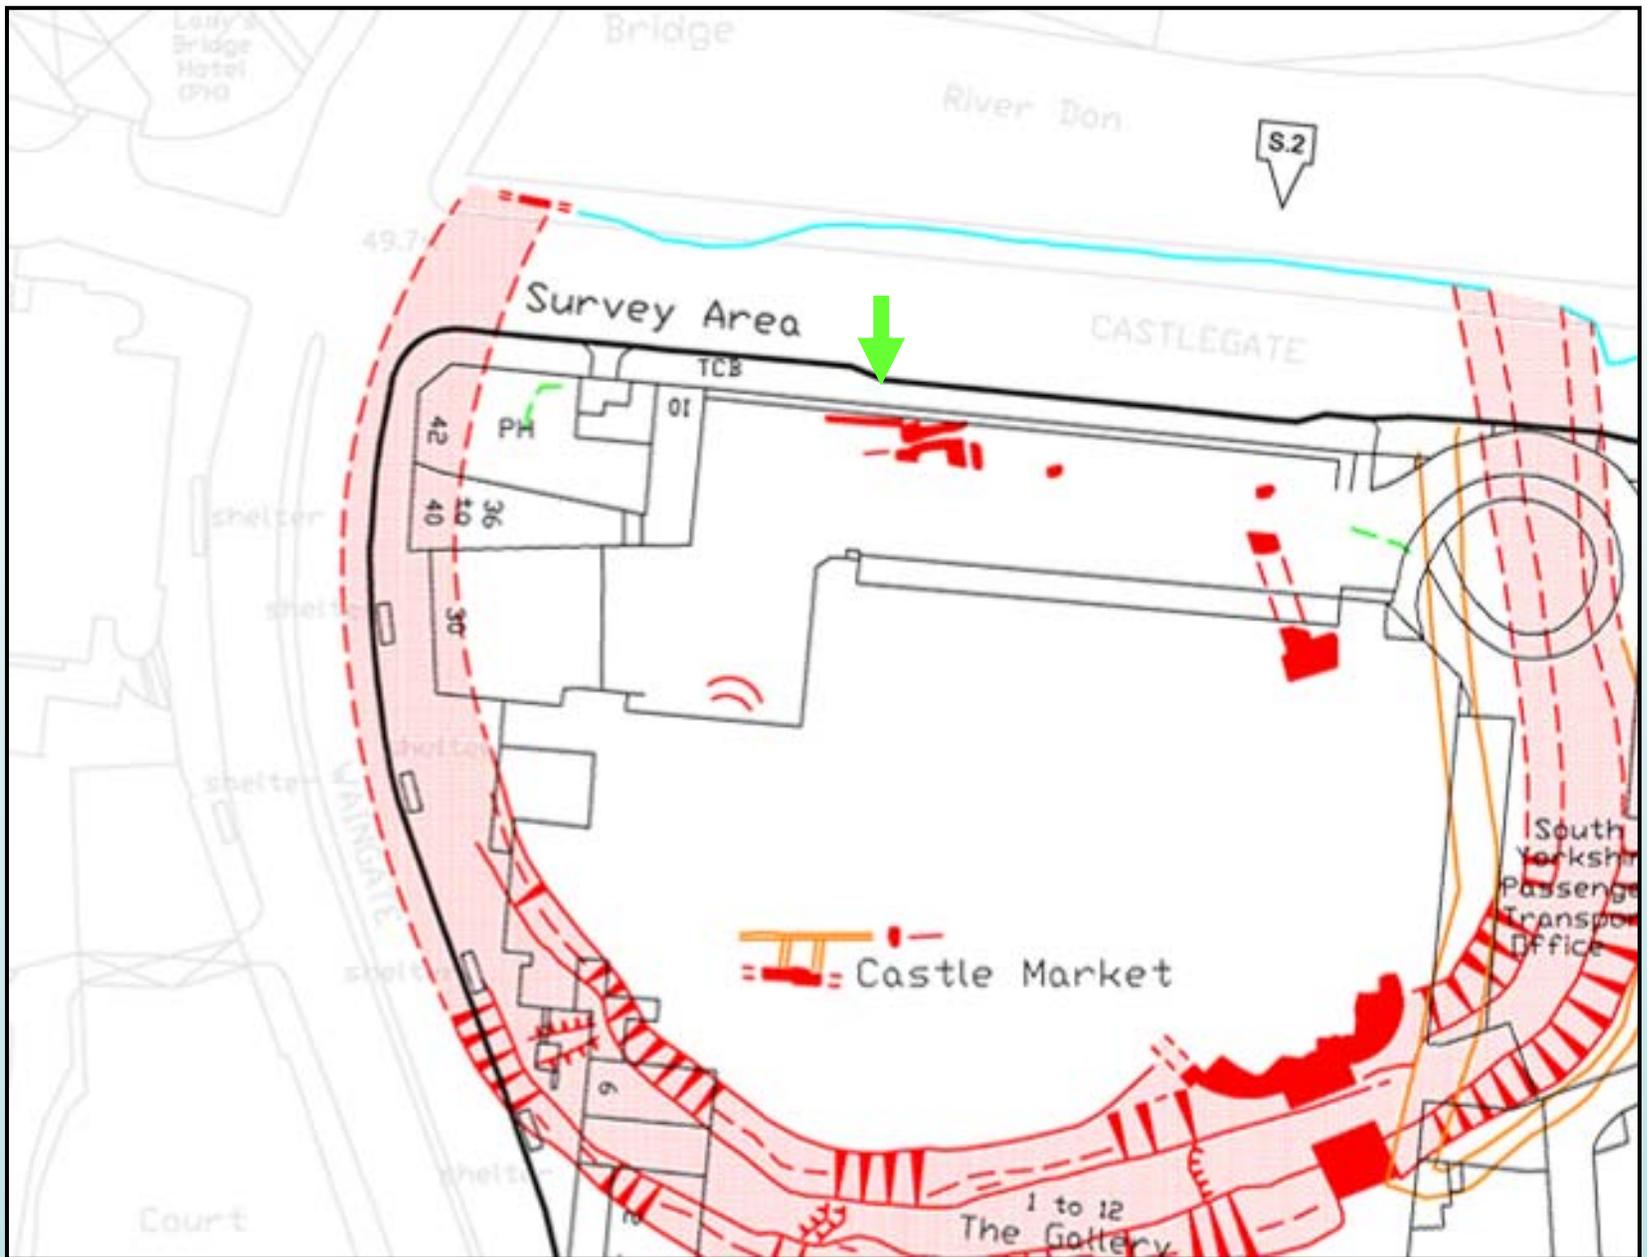
Extract from 1:500 scale draft archaeology plan (EDAS Ltd)

The green arrow points towards the wall fragment photographed in 1972. It can be seen that it actually lay very close to a much more extensive part of the castle's structure that was not excavated until 2000, and it is quite likely that the two were once continuous. Furthermore, shared alignments begin to emerge for at least this part of the castle's former north range, which can then be compared to the layout suggested by the documentary sources.

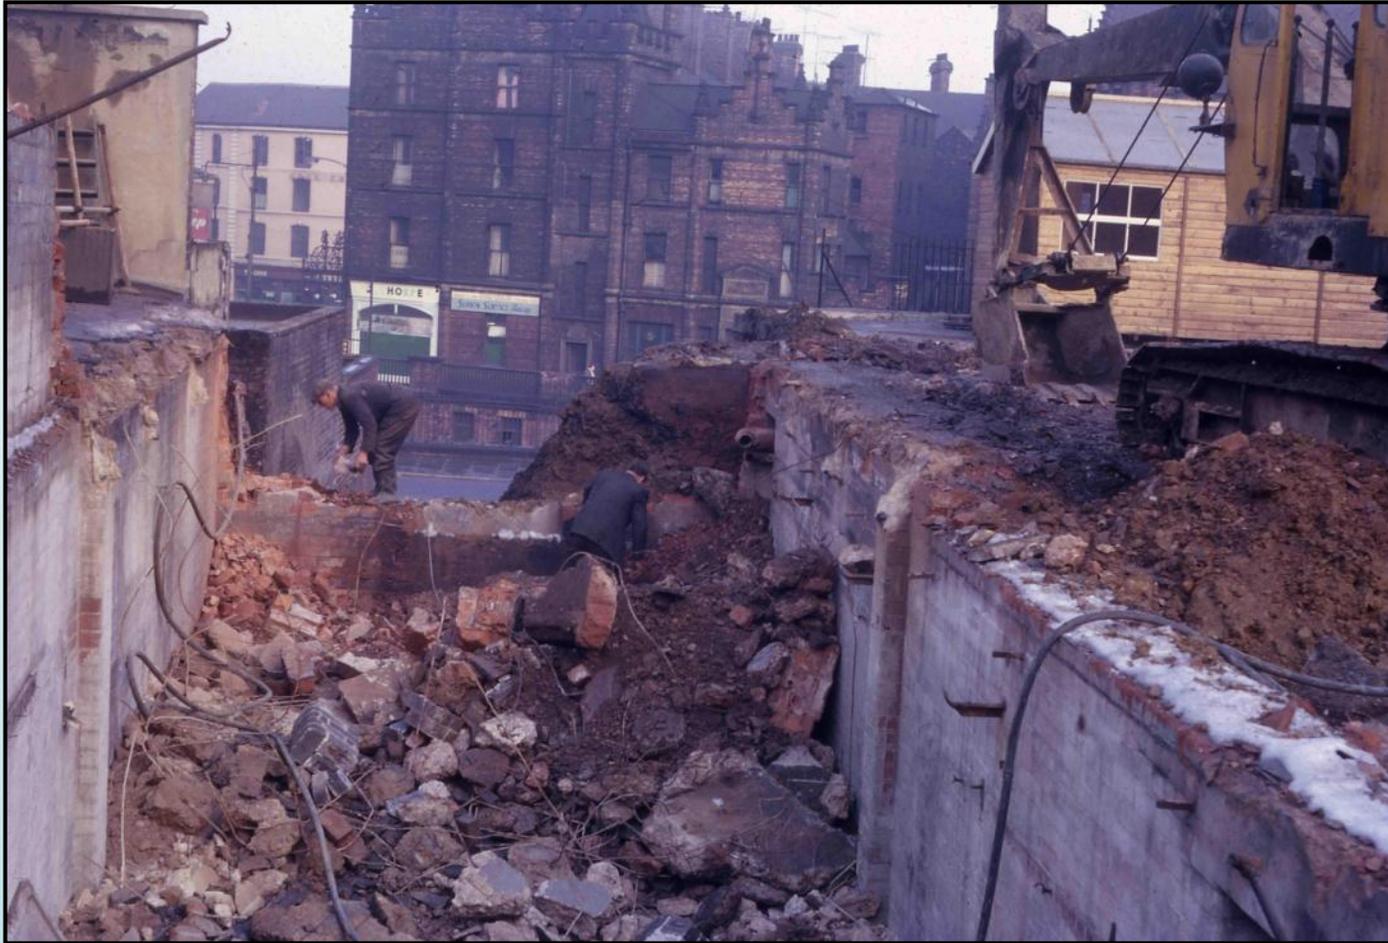
Demolition of 1920s structures, west of Castle Market, taken in 1963 by Leslie Butcher (Museums Sheffield)

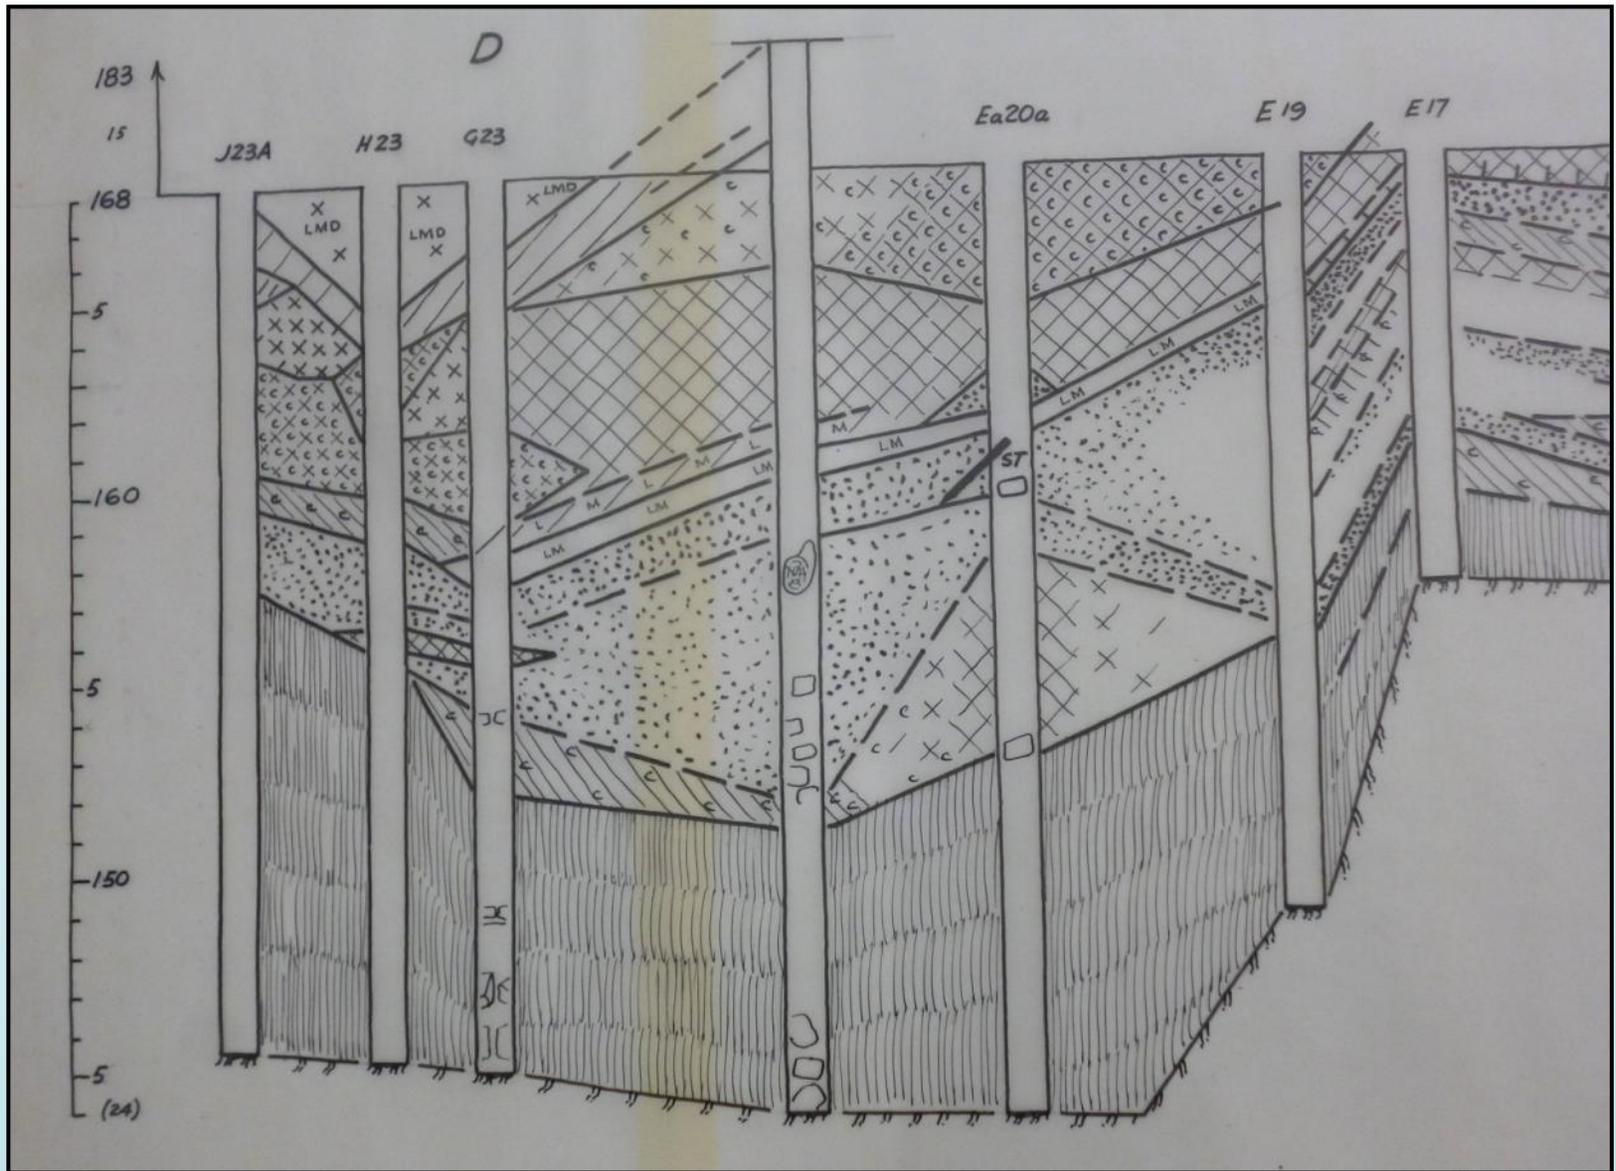
Moat deposits based upon pile / borehole sections,
 Leslie Butcher (Museums Sheffield)

Where possible, he drew all four sides of a foundation excavation, and made notes on the drawings as to what different layers represented. He then started to put these drawings together to produce sections through the moat, as is shown on the next slide; it should be noted that the section on the slide does not run in one direction only, but is a composite one, crossing one end of the south moat, then running along the moat and finally re-crossing the opposite end. **Butcher's re-assessment of earlier interpretations of the shape and varying cross-section of the moat are perhaps his most important contribution to current understanding of the archaeology of the castle.**

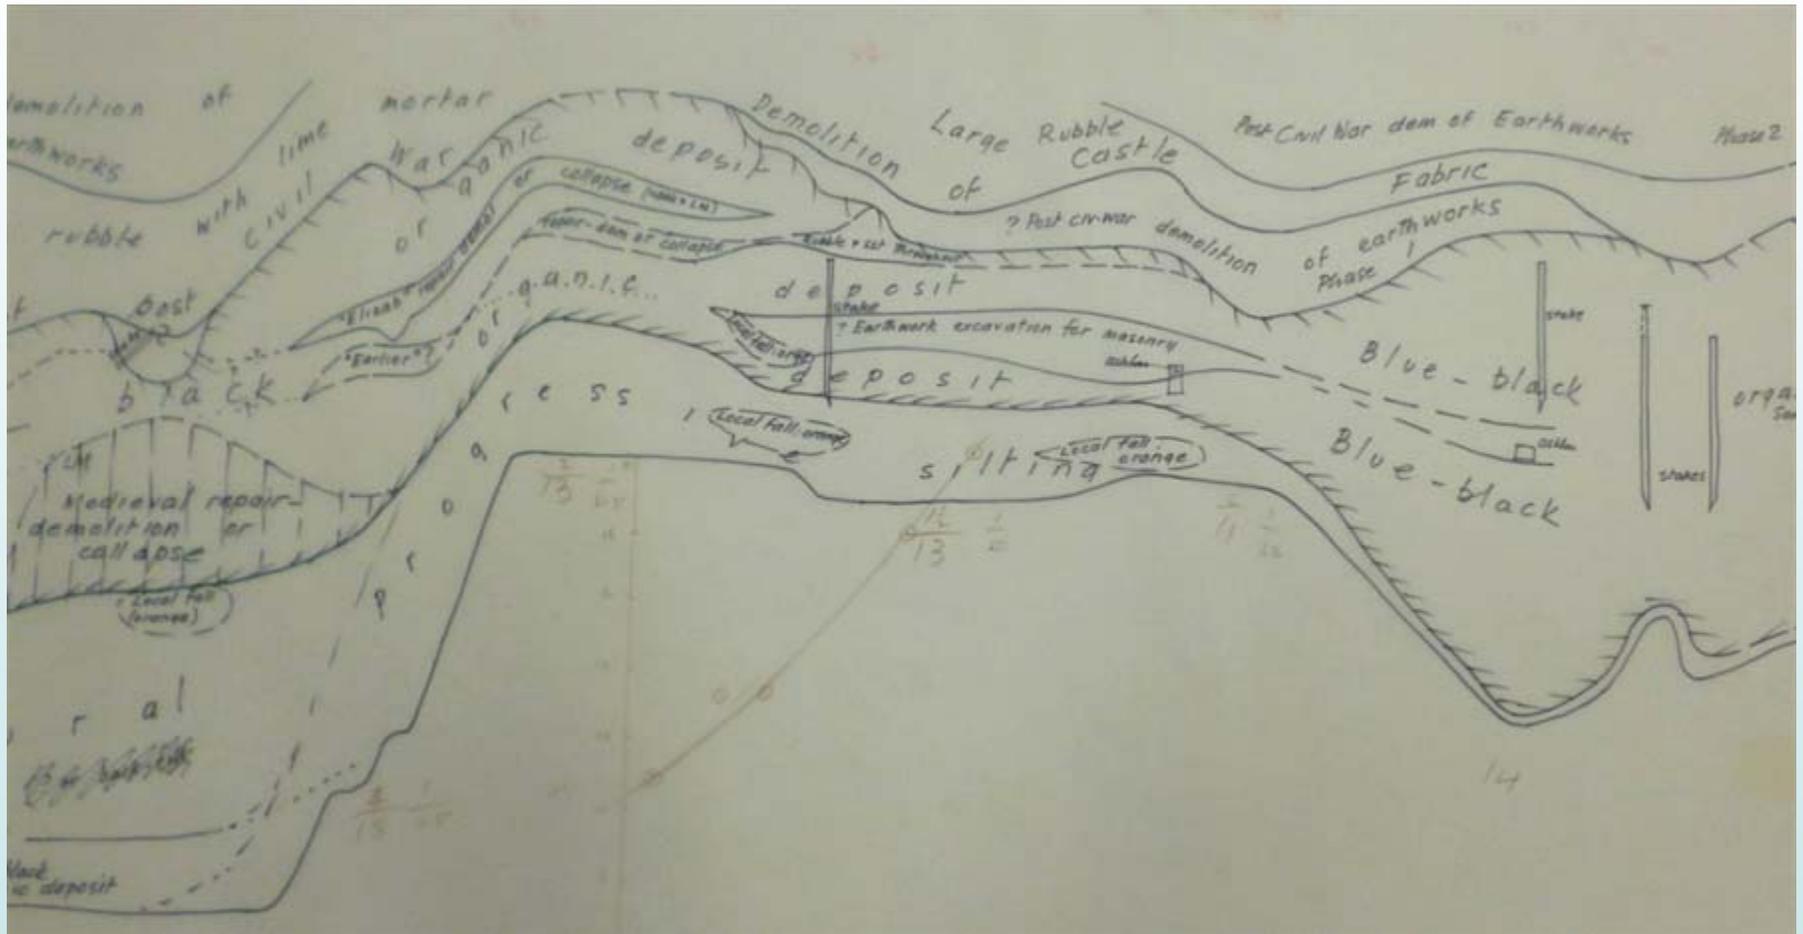
Interpretation of same moat deposits based upon pile / borehole sections, Leslie Butcher (Museums Sheffield)

The next slide shows the part of the same composite section as the previous slide, but with interpretation added by Leslie Butcher. He was of the opinion that the moat fills had been truncated, and that the uppermost surviving levels represented the lower limit of demolition material resulting from the 1649 dismantling works, apparently including a complete section of wall facing which had fallen into the moat. The demolition deposits overlay accumulations of blue-black organic mud, containing many plant remains, including reeds from the moat and an immense amount of small twigs and branches.

There was a great deal of variation in the characteristics of these layers. In the bottom of the moat, earlier observers had noted what they described as 'defensive stakes', sharpened pieces of wood sticking up. Butcher noted that the apparent point of one of the larger stakes had been created by the rotting of the wood resulting in it snapping off, rather than it being deliberately shaped or cut, and furthermore that some stakes had either oak boards or branches set between them. **His interpretation was that they formed a revetment to the sides of the moat, rather than being defensive in purpose.**

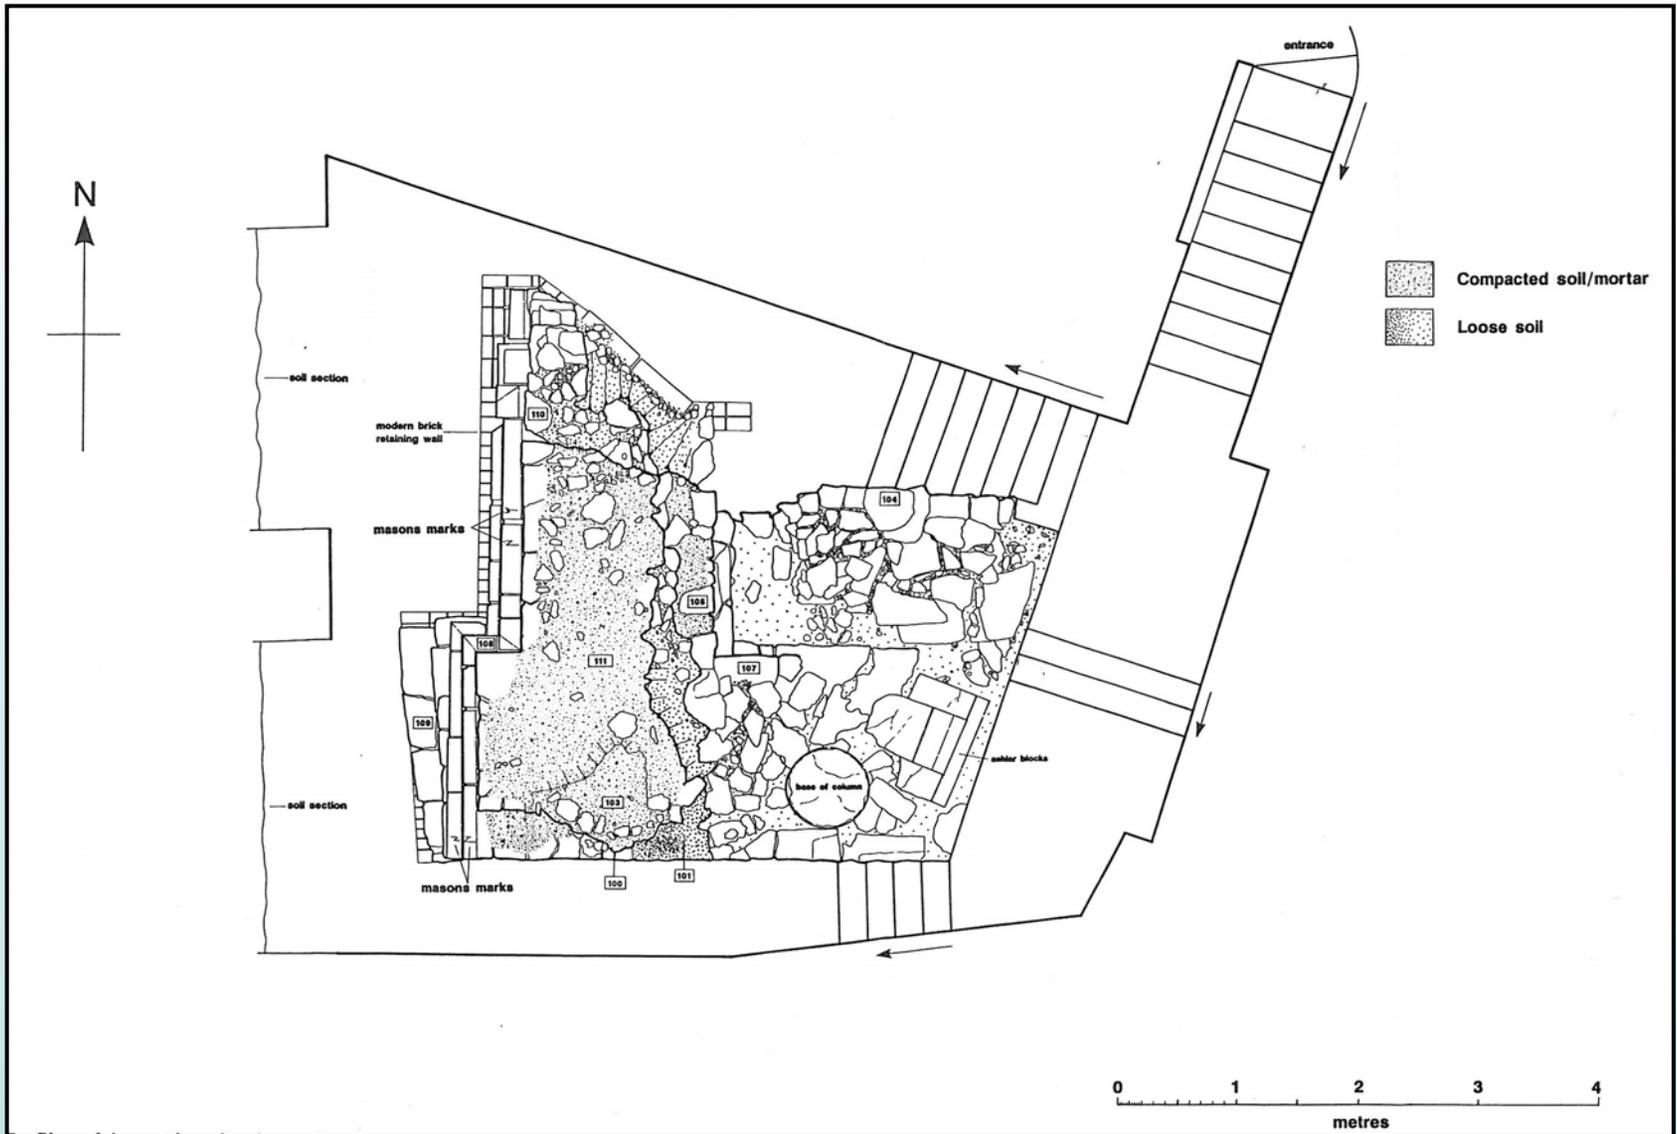
Plan of castle fragment beneath north-east corner of Castle Market complex (taken from Latham & Atkinson 1994)

In the course of the 1958-61 works, **Butcher had the opportunity to re-observe and record in detail two larger parts of the castle that had first been exposed during the late 1920s.** The first of these, shown in the next slide (an illustration taken from a modern archaeological report), lay at the north-east corner of the former inner court of the castle, and is probably the better known and certainly the most easily accessible; it is reached (with permission) through a doorway at the east end of the market's North Loading Dock. The structure is contained within a chamber that originally had soil sections in the west wall through which archaeological stratigraphy could be observed, although these are now blocked.

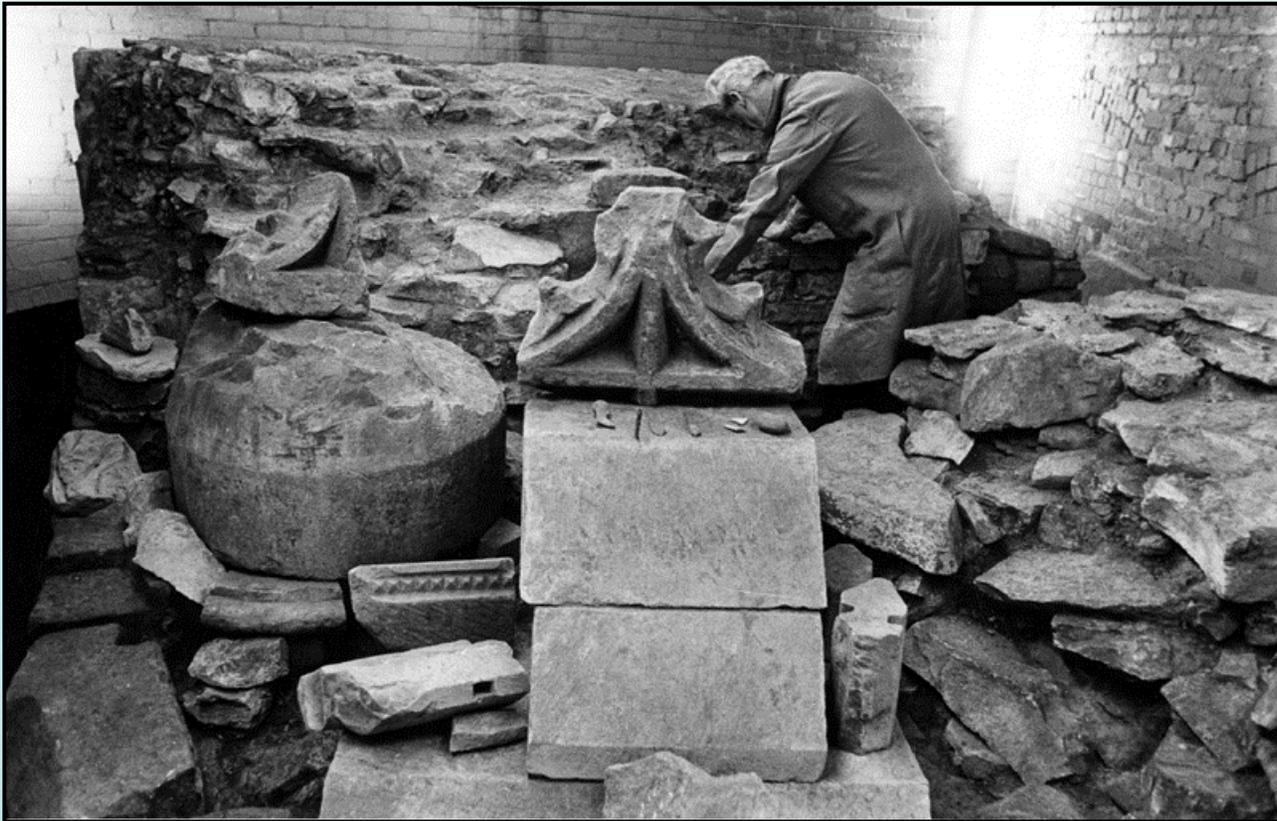
Castle fragment beneath north-east corner of Castle Market complex,
taken in 1975 (www.picturesheffield.com)

It is now difficult to be certain as to exactly what extent the remains were repaired and restored when first exposed in the 1920s, or indeed in more recent times, but there are stones that have clearly been replaced in the wrong location. Much of the former west outer elevation is underlain by a modern brick retaining wall and much of the north end has been rebuilt in a rather haphazard manner. Nevertheless, at least it was preserved, which, as will be explained, was not a certainty at the time when it was first exposed.

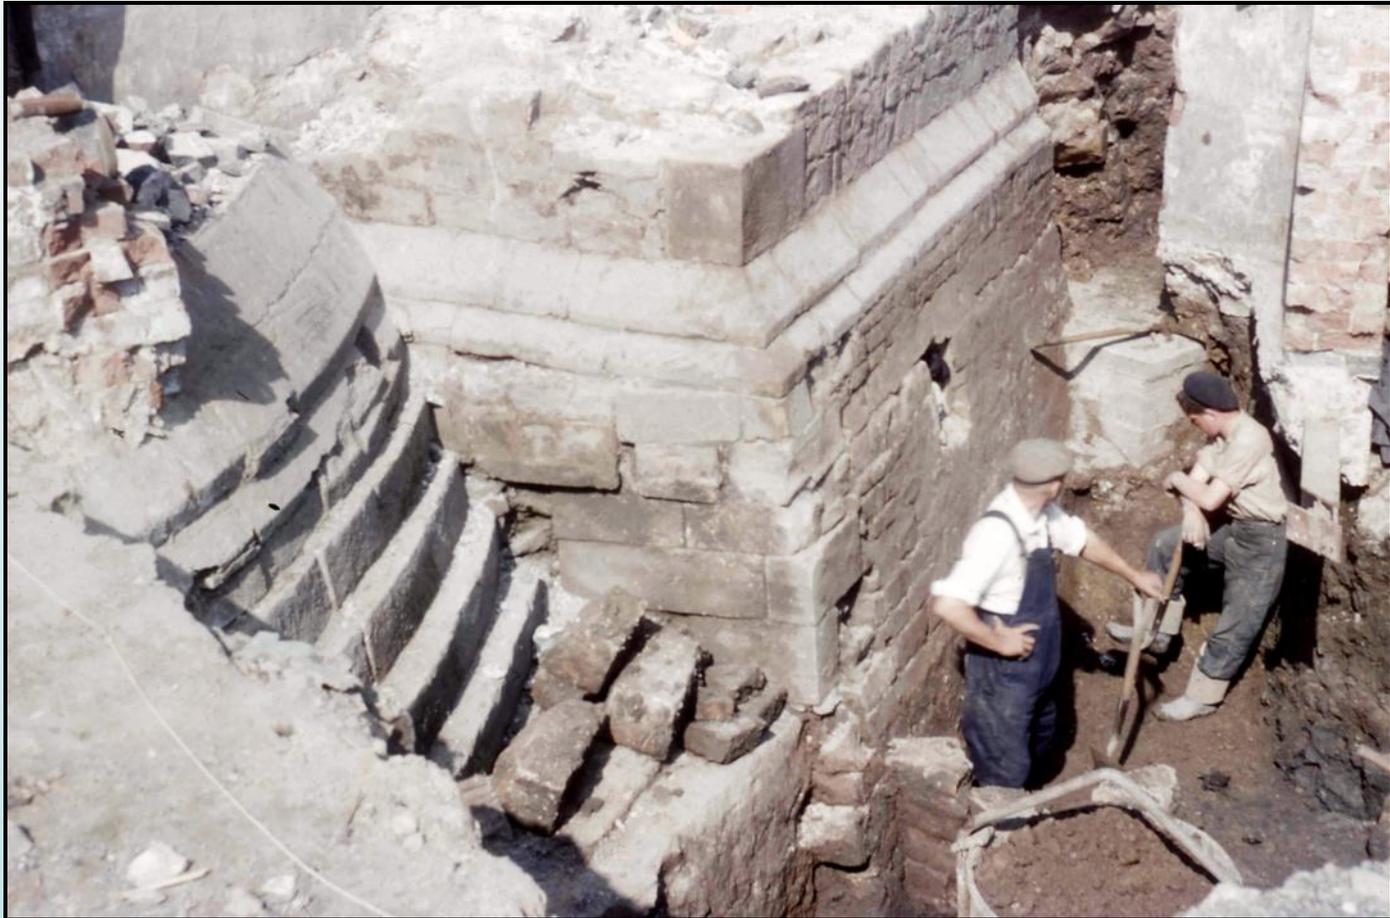
Castle gate structures, looking north-east,
taken by Leslie Butcher, in 1960 (Museums Sheffield)

The other larger fragment of the castle re-exposed during the late 1950s formed part of the gate structures, essentially the gatehouse and flanking semi-circular towers. These had been exposed in the late 1920s, and again they had been preserved within a chamber at that date.

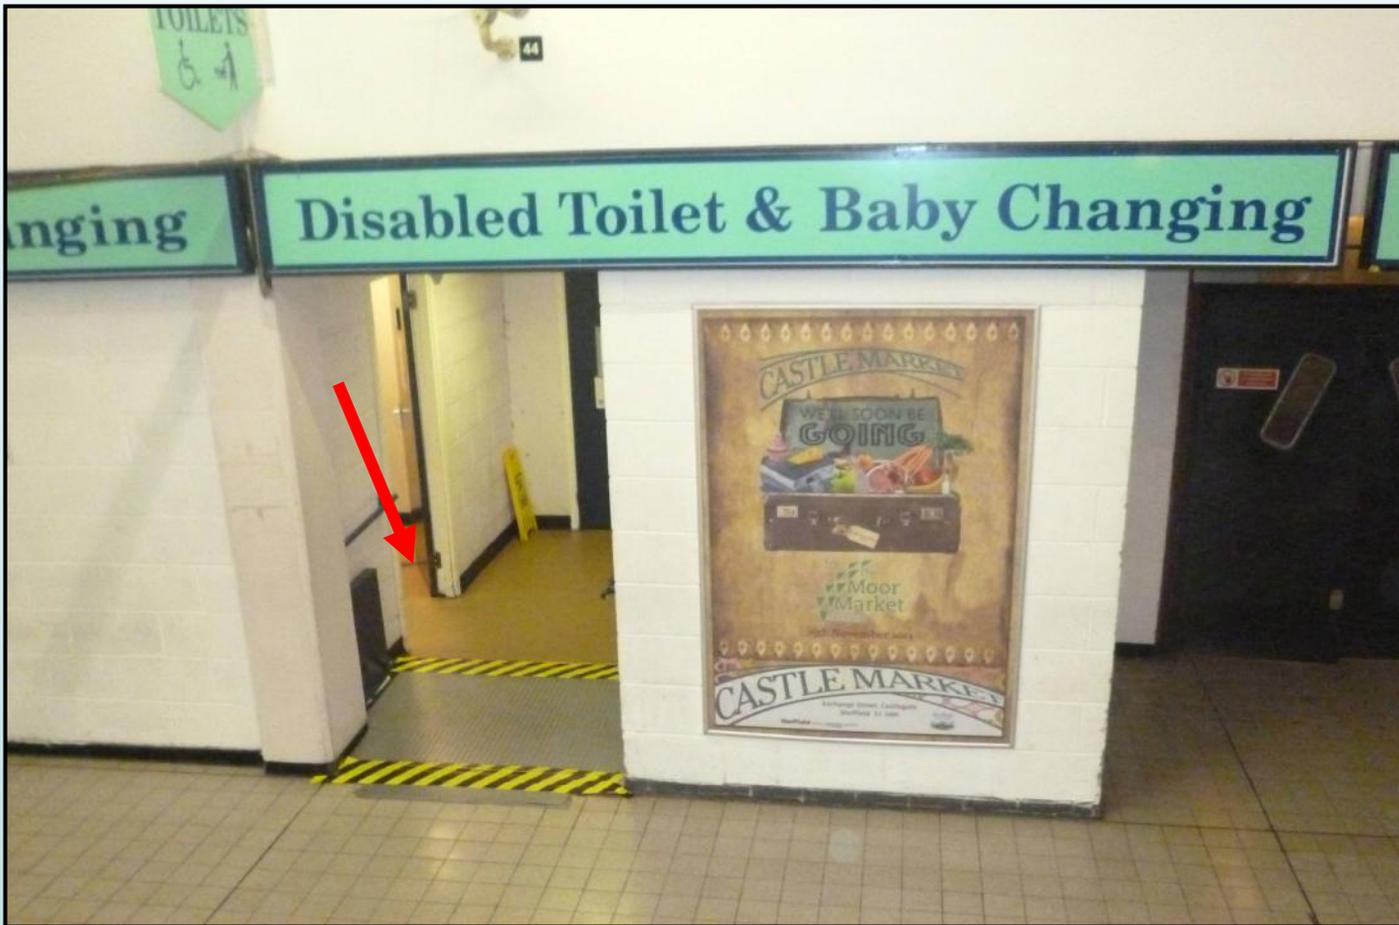
To view these remains is now slightly more complicated than with the other larger part of the castle. Access is through a manhole on the north side of the lowest level of the New Market Hall/Low Block. When the cover is raised, a metal ladder leads down onto a small raised platform at the south-west corner of the chamber, which is currently unlit.

Entrance cover to gate structures chamber, Castle Market, 2013
