Re-investigating Sheffield Castle

Shaun Richardson

Ed Dennison Archaeological
Services Ltd

Presentation to South Yorkshire Archaeology Day,
November 2013. Edited by
South Yorkshire Archaeology Service

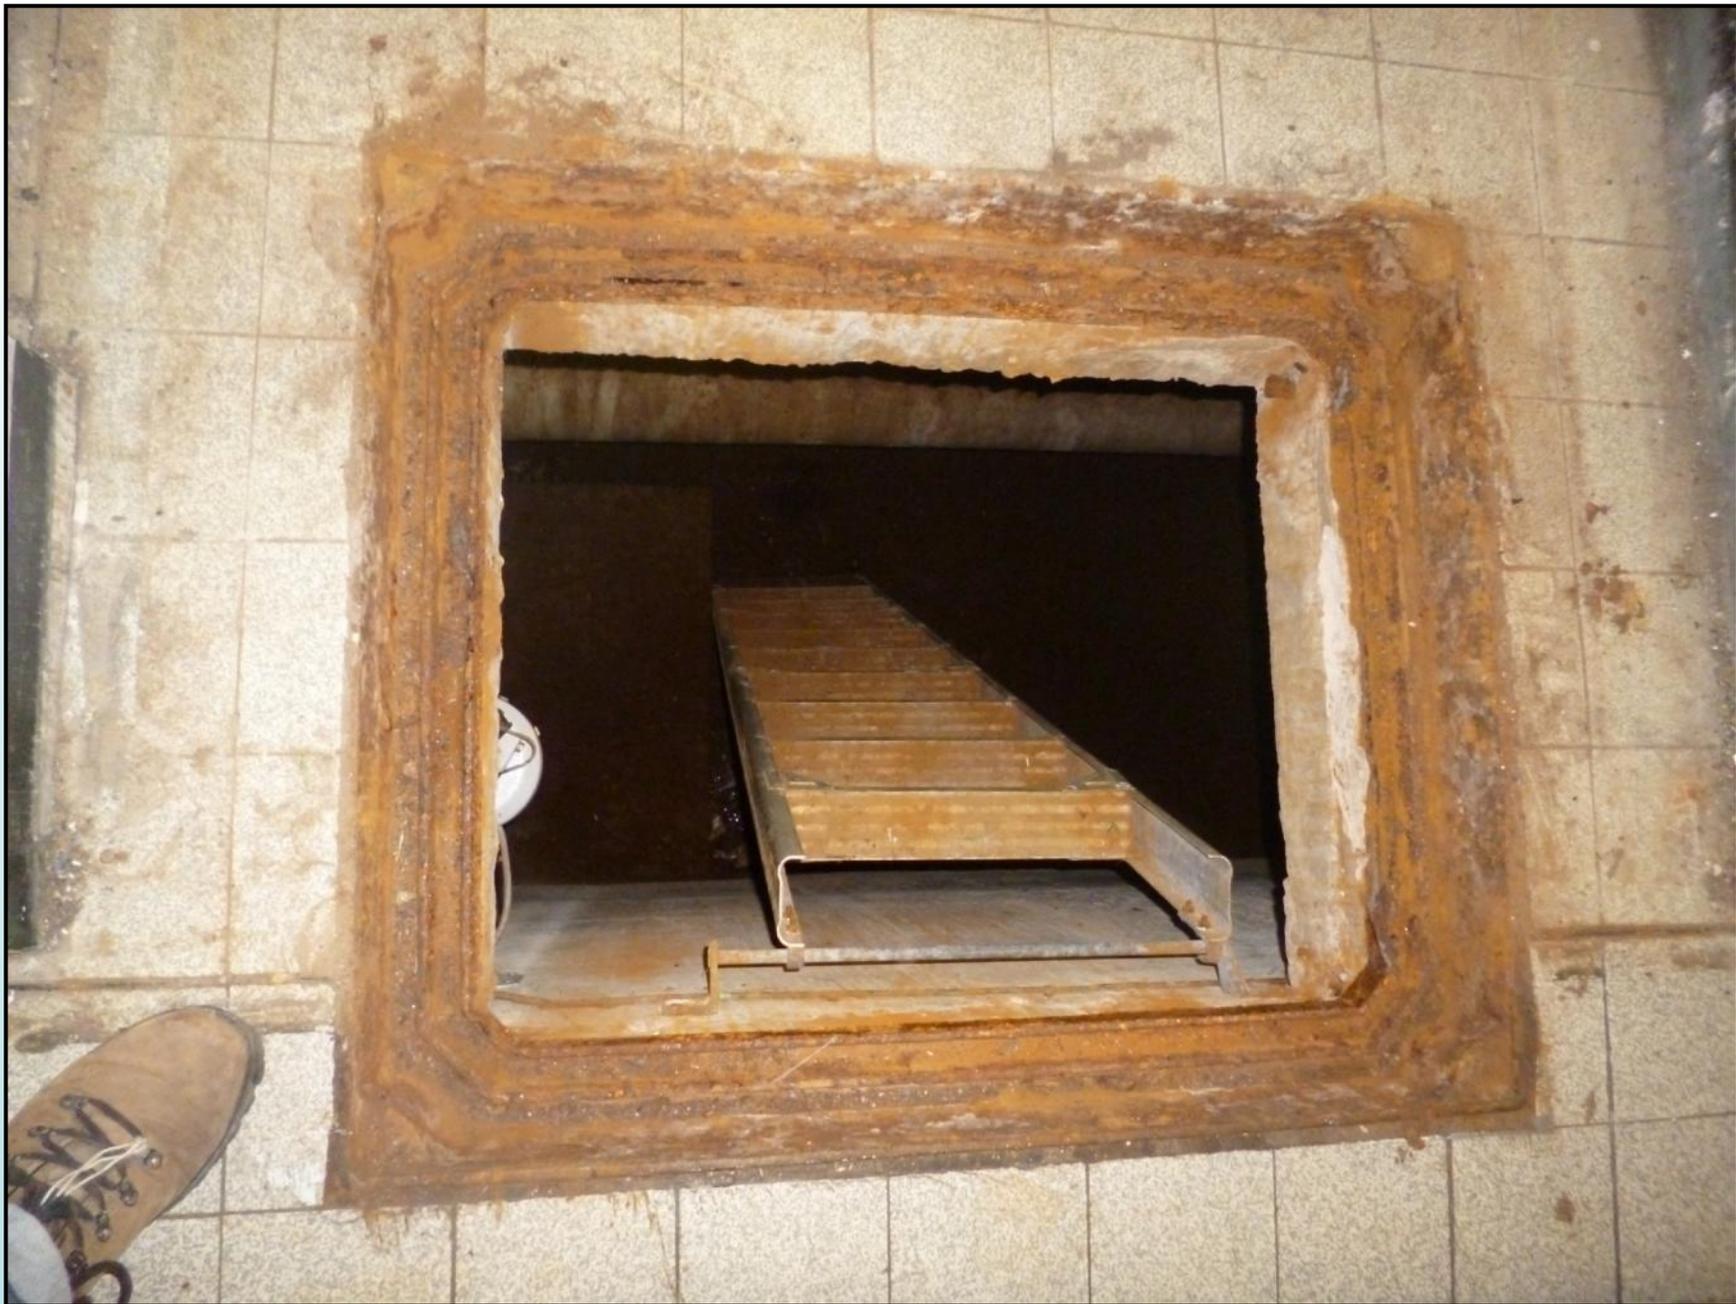
The castle is still there, aptly described by Peter Ryder as resembling a fossil in a vault and, despite having been heavily repointed, it is in a reasonable condition. Comparison between what remains now, and the slide from the 1960s, demonstrates that there is now considerably less visible than there once was. Unfortunately, there is a good reason for this.

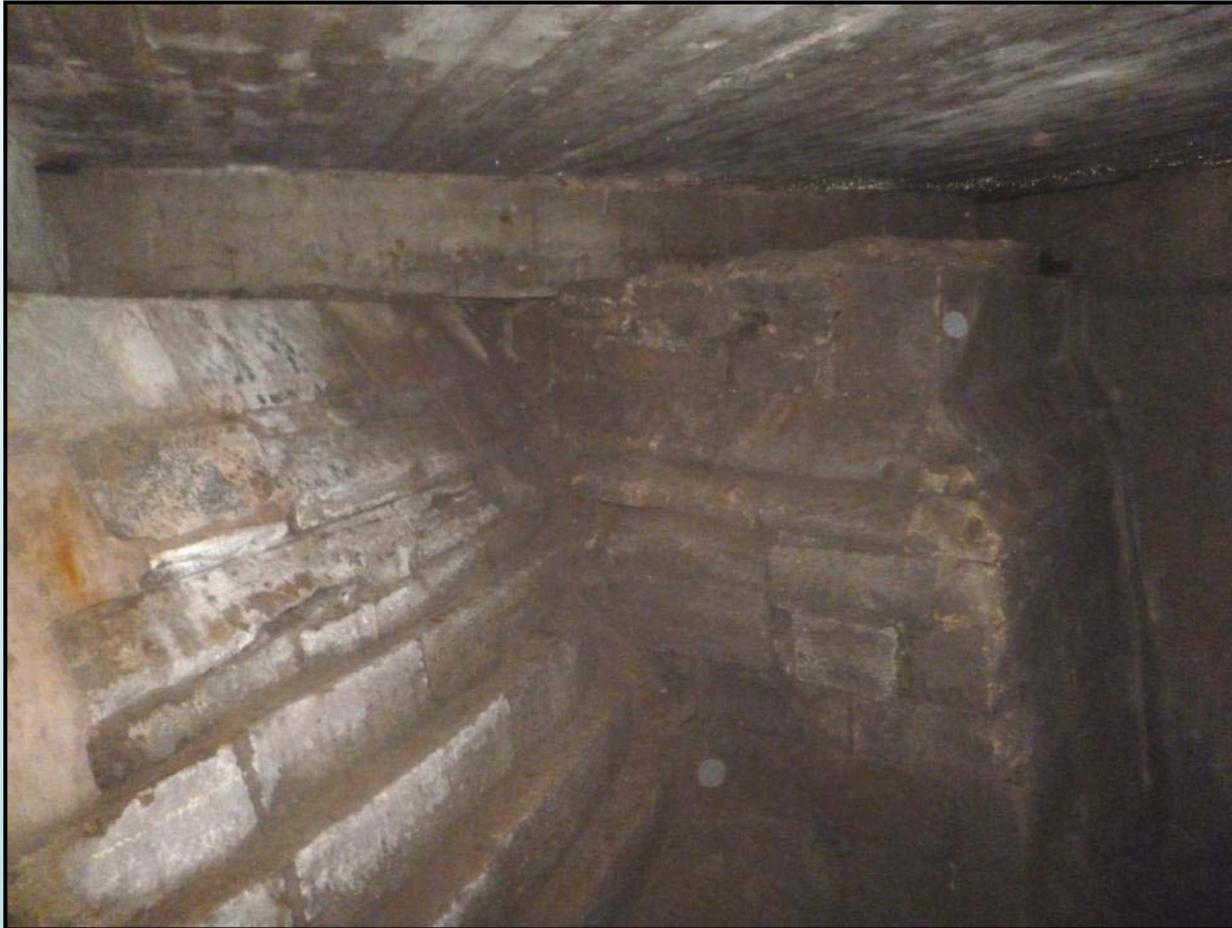
Castle gate structures within chamber, looking north-east, 2013

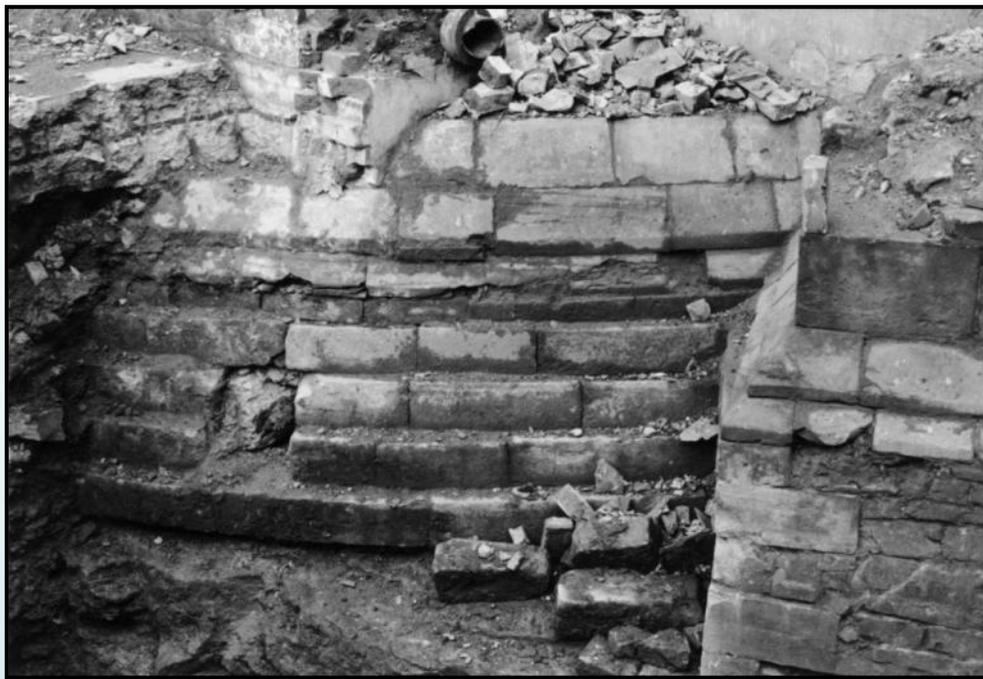
Castle gate structures during insertion of new chamber wall, looking north, taken by Leslie Butcher, in 1958 (Museums Sheffield)

Leslie Butcher noted that the chamber surrounding this part of the castle had been reduced in size in 1958, and his photographs (in the next slide) demonstrate graphically how this was done. The upper photograph was taken before the chamber was reduced in size and the lower one afterwards. As can be clearly seen, **a large slot was simply cut through the western tower.**

A contemporary engineer's drawing states that outside the chamber, the general levels of the castle walls should be reduced overall by a foot in height or "***lower locally as required***". So until the concrete floors of the market are taken up following the demolition of the complex, it will be impossible to properly assess to what extent this part of the castle still survives. In this case at least, the rather robust preservation techniques of the 1950s must count amongst the aspects of destruction that the evaluation strategy has to consider.

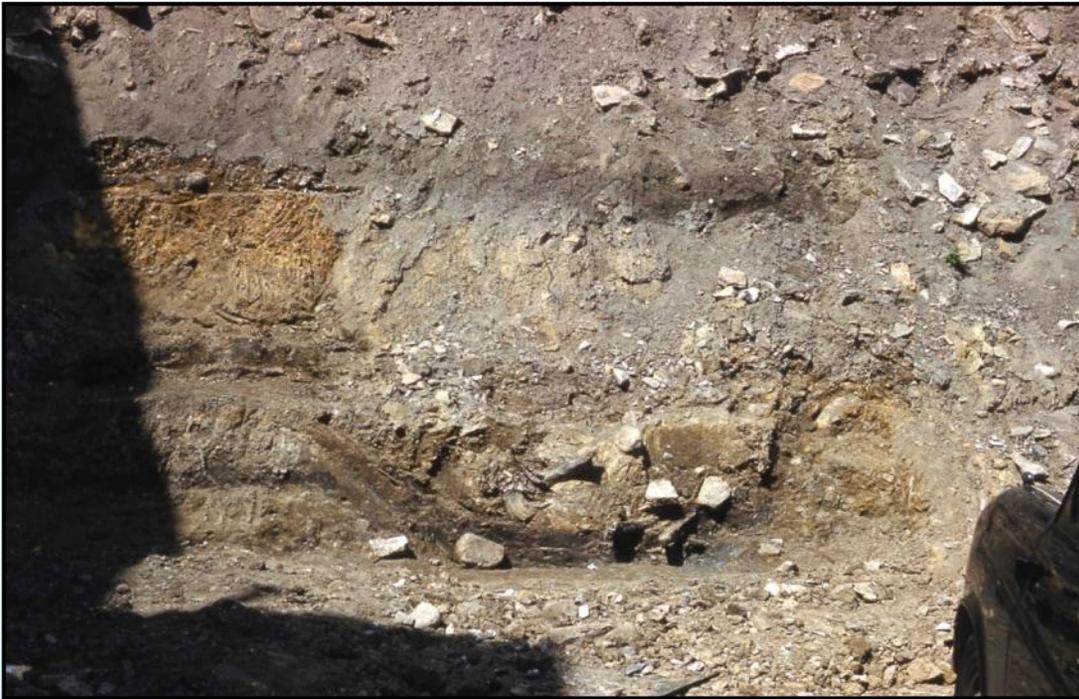
‘Early’ pit, south of current spiral loading ramp, photograph and drawing by Leslie Butcher, c.1961 (Museums Sheffield)

It is well known that during the 1920s the remains of a timber structure were uncovered within the area of the castle's inner court, which was interpreted as being Saxon in origin. More recently, this interpretation has been questioned, and the possibility raised that the remains were in fact of 12th or early 13th century date, and so belong to the earliest phase of the castle complex. This, of course, does not rule out the possibility of a pre-Conquest centre in the same area as the castle, and indeed the timber structure is not the only possible pre-castle element of the landscape that has been excavated. Leslie Butcher recorded at least three or four features, generally sub-circular pits containing wattle-work or brushwood that were cut into the surface of the natural clay, which he classified as "early" without committing himself to a firm date. The example on the next slide, recorded by Butcher using both photography and drawing, was exposed when the sloping ground to the south of the spiral loading ramp was cut back to a vertical section.

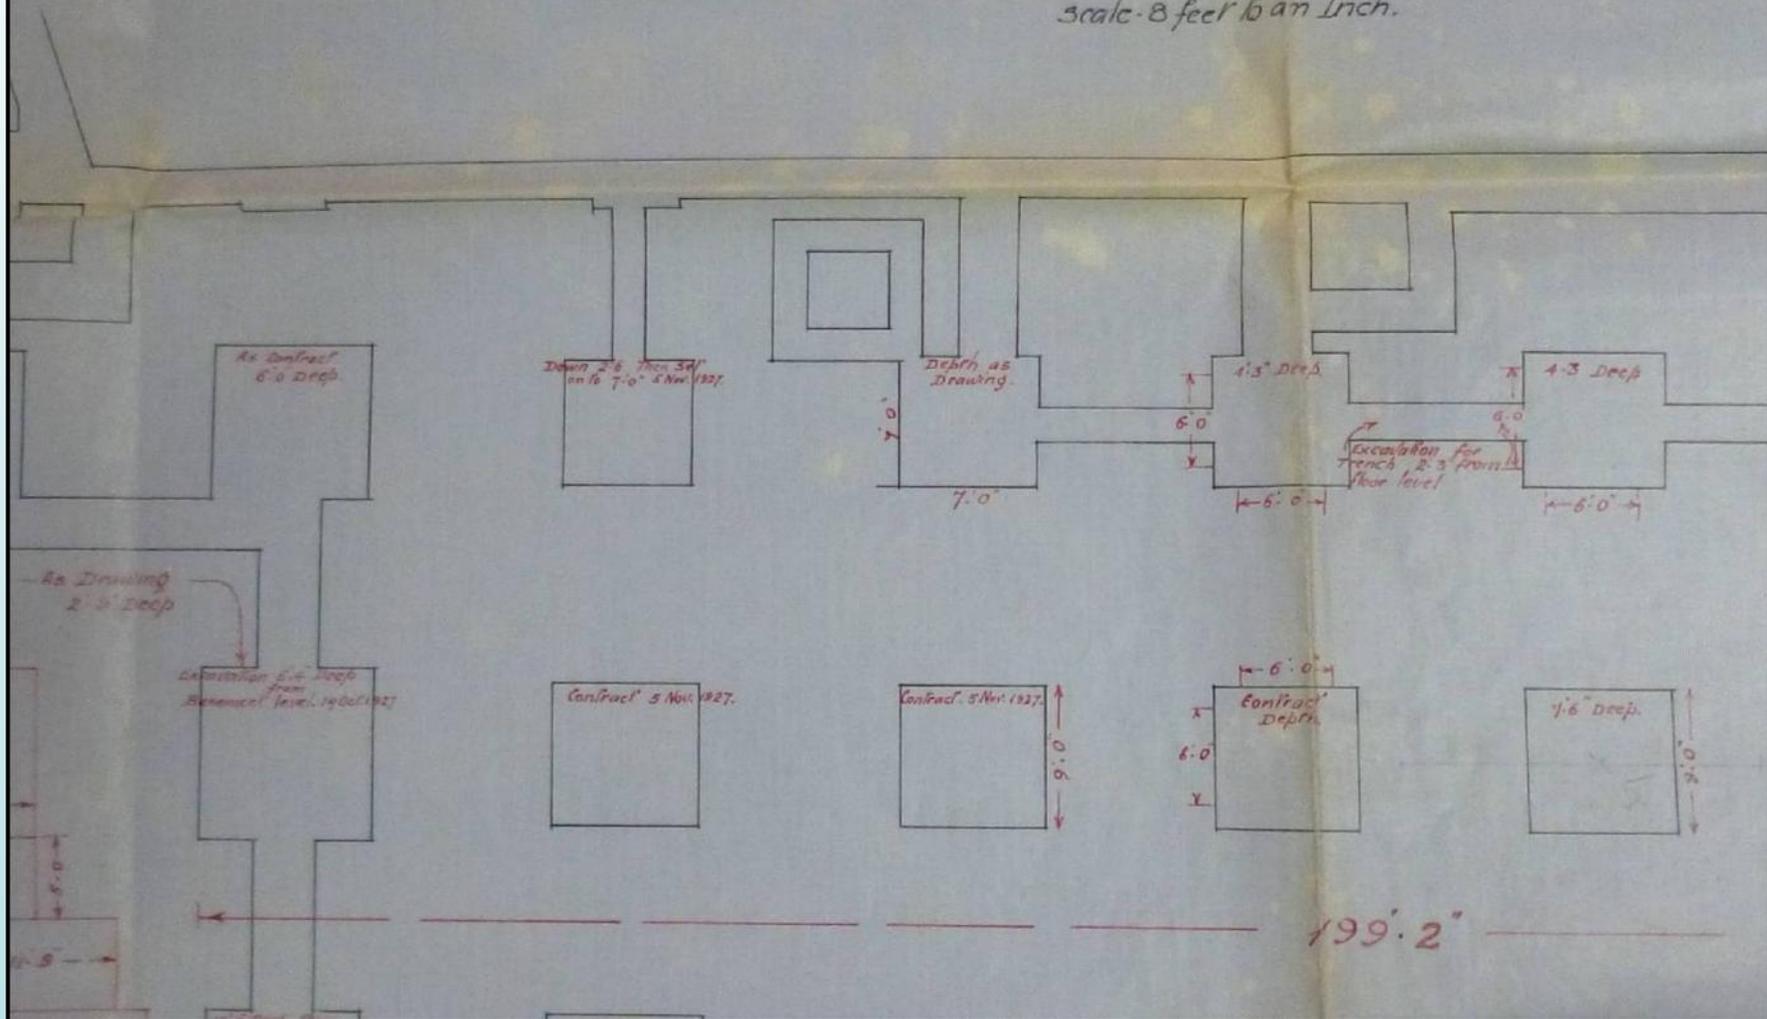
FOUNDATION PLAN.
Scale - 8 feet to an Inch.

This is one such example, an extract from the basement foundation plan for the Co-operative Stores. Although perhaps not the most visually exciting document, this type of material has proved extremely useful in developing the evaluation strategy, as the plan gives details not only of what depth it was planned to excavate the foundations to, but also the actual depth that was reached during construction.

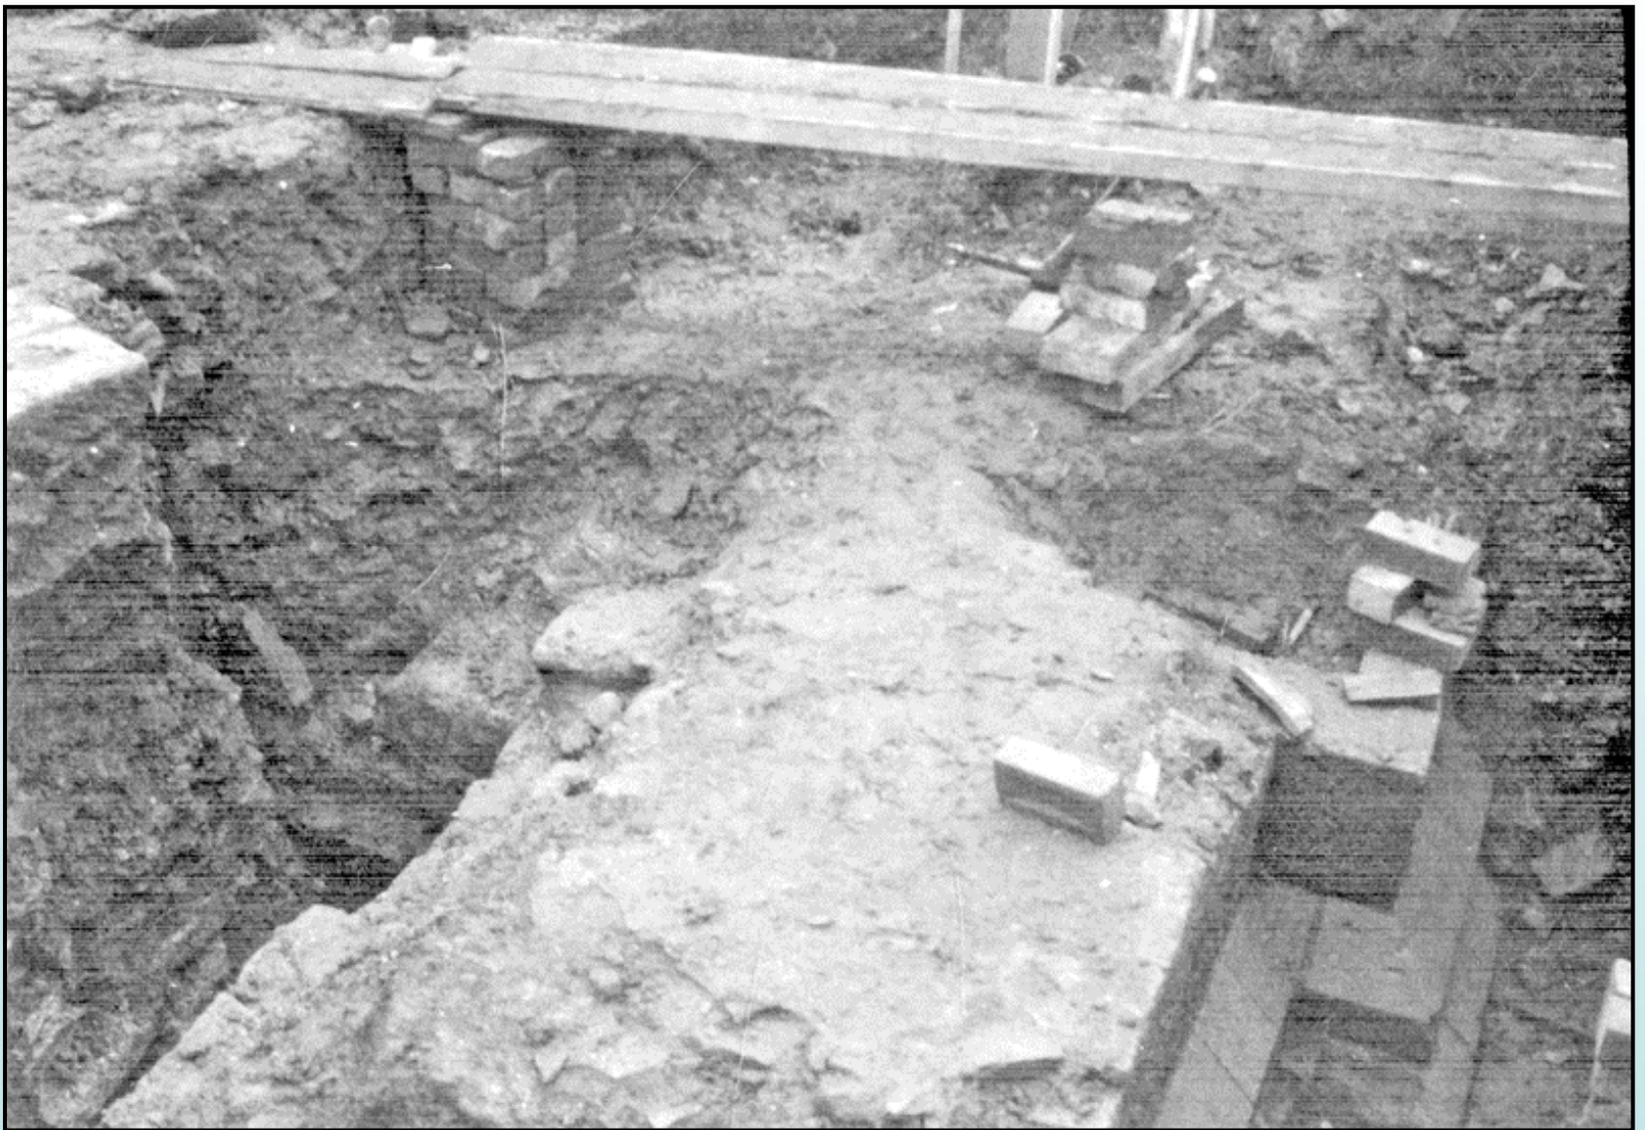
Fragment of castle beneath north-east part of Castle Hill Market,
looking south-east, taken by Himsworth 1928-1929
(Museums Sheffield / www.picturesheffield.com)

Nevertheless, despite their problems, between them the two men amassed a great deal of useful information. Armstrong was the first to see the two larger parts of the castle that have already been described, as well as making the earliest record of the moat. Furthermore, **he, and the wider membership of the Hunter Archaeological Society, played an important part in getting these castle remains preserved.**

Armstrong stated in several newspapers that between £50 and £100 would be needed to secure the remains, and that indeed they would be an asset to the Co-operative Store as people would need to pass through the shopping areas to see them; the Society might even install a café nearby, he remarked. The possibility of removing the remains stone-by-stone and re-erecting them in a public park was apparently also considered, but thankfully never took place. It was originally planned to have the gate structures overlooked from the circulation area leading to the ladies lavatory, but ultimately they were preserved within a chamber and their position indicated by means of lines on the floor.

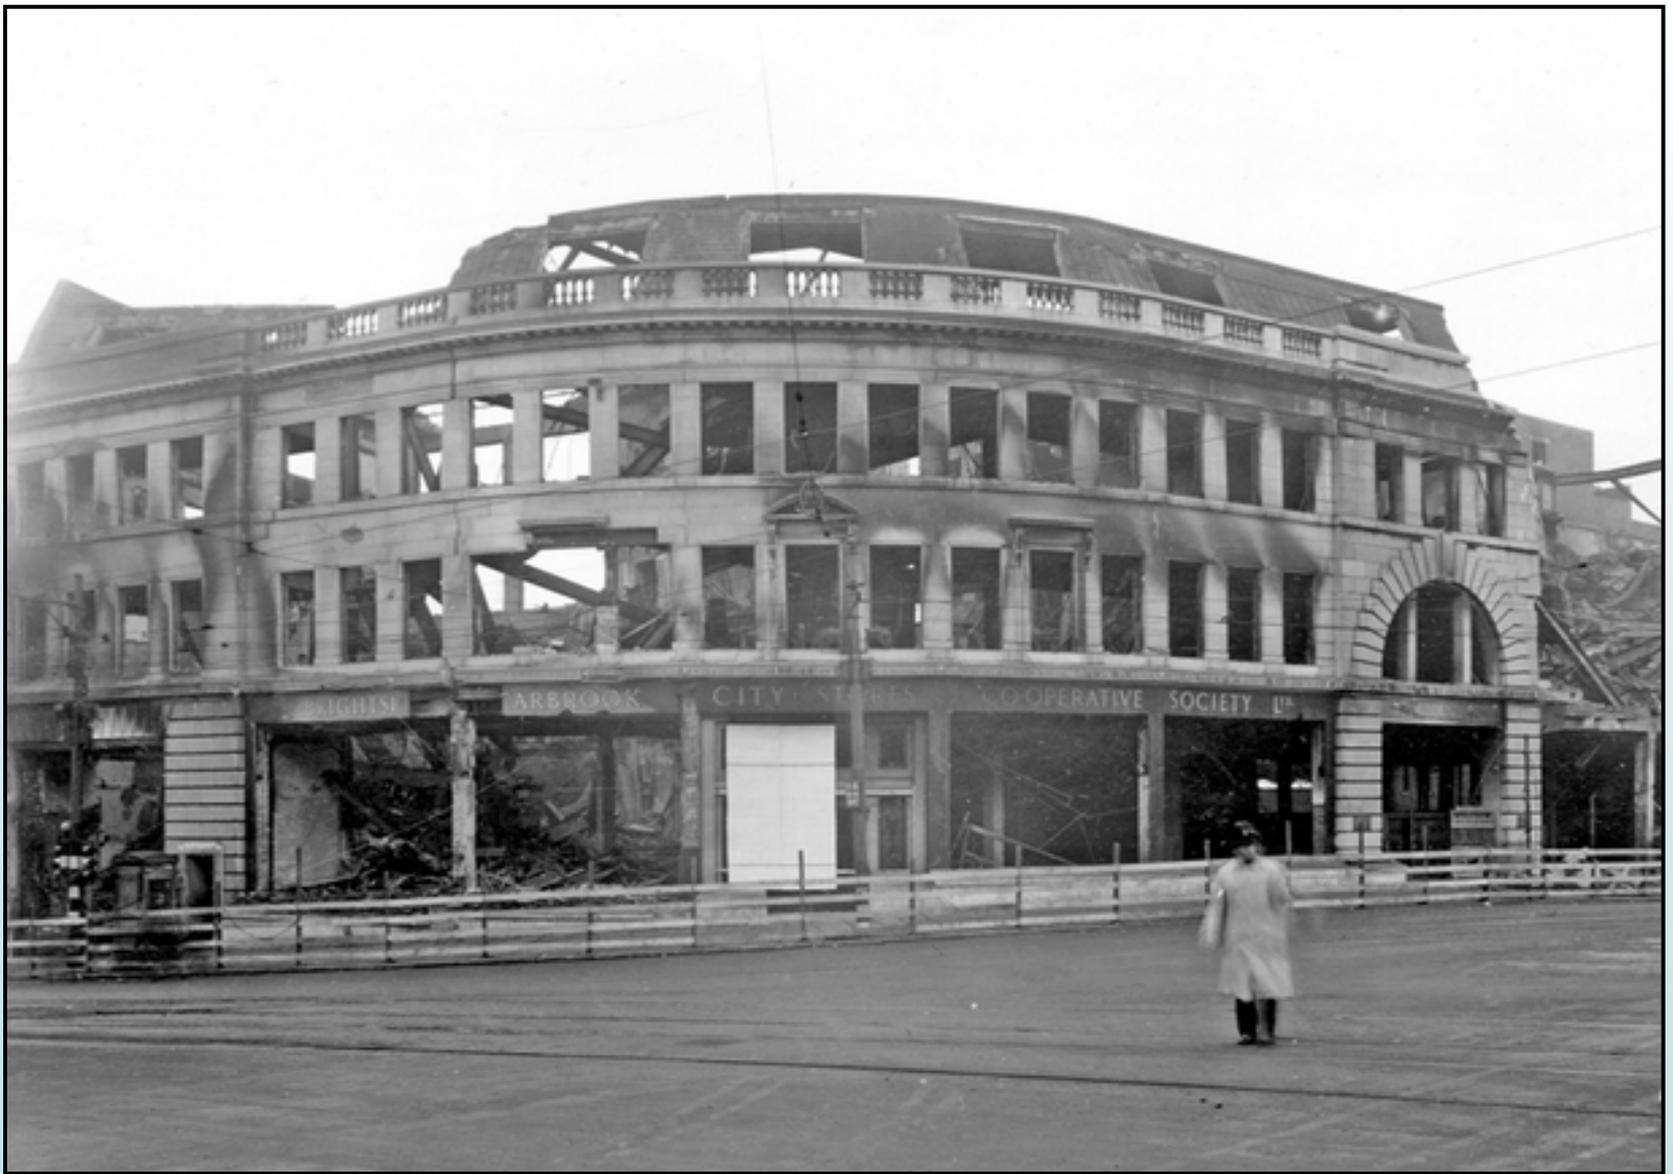
Co-operative Stores after bombing, December 1940
(www.picturesheffield.com)

The incorporation of these remains into the chamber turned out to be fortuitous, as on the night of the 12th/13th December 1940, **the Co-operative Store received a direct hit** from a German bomb. Himsworth visited the site about a year later when the bomb debris had been partly cleared, descended into the chamber and found the castle remained in good order. However, what Himsworth described as *“the large flat showcase full of small objects retrieved from the Castle site”* had disappeared.

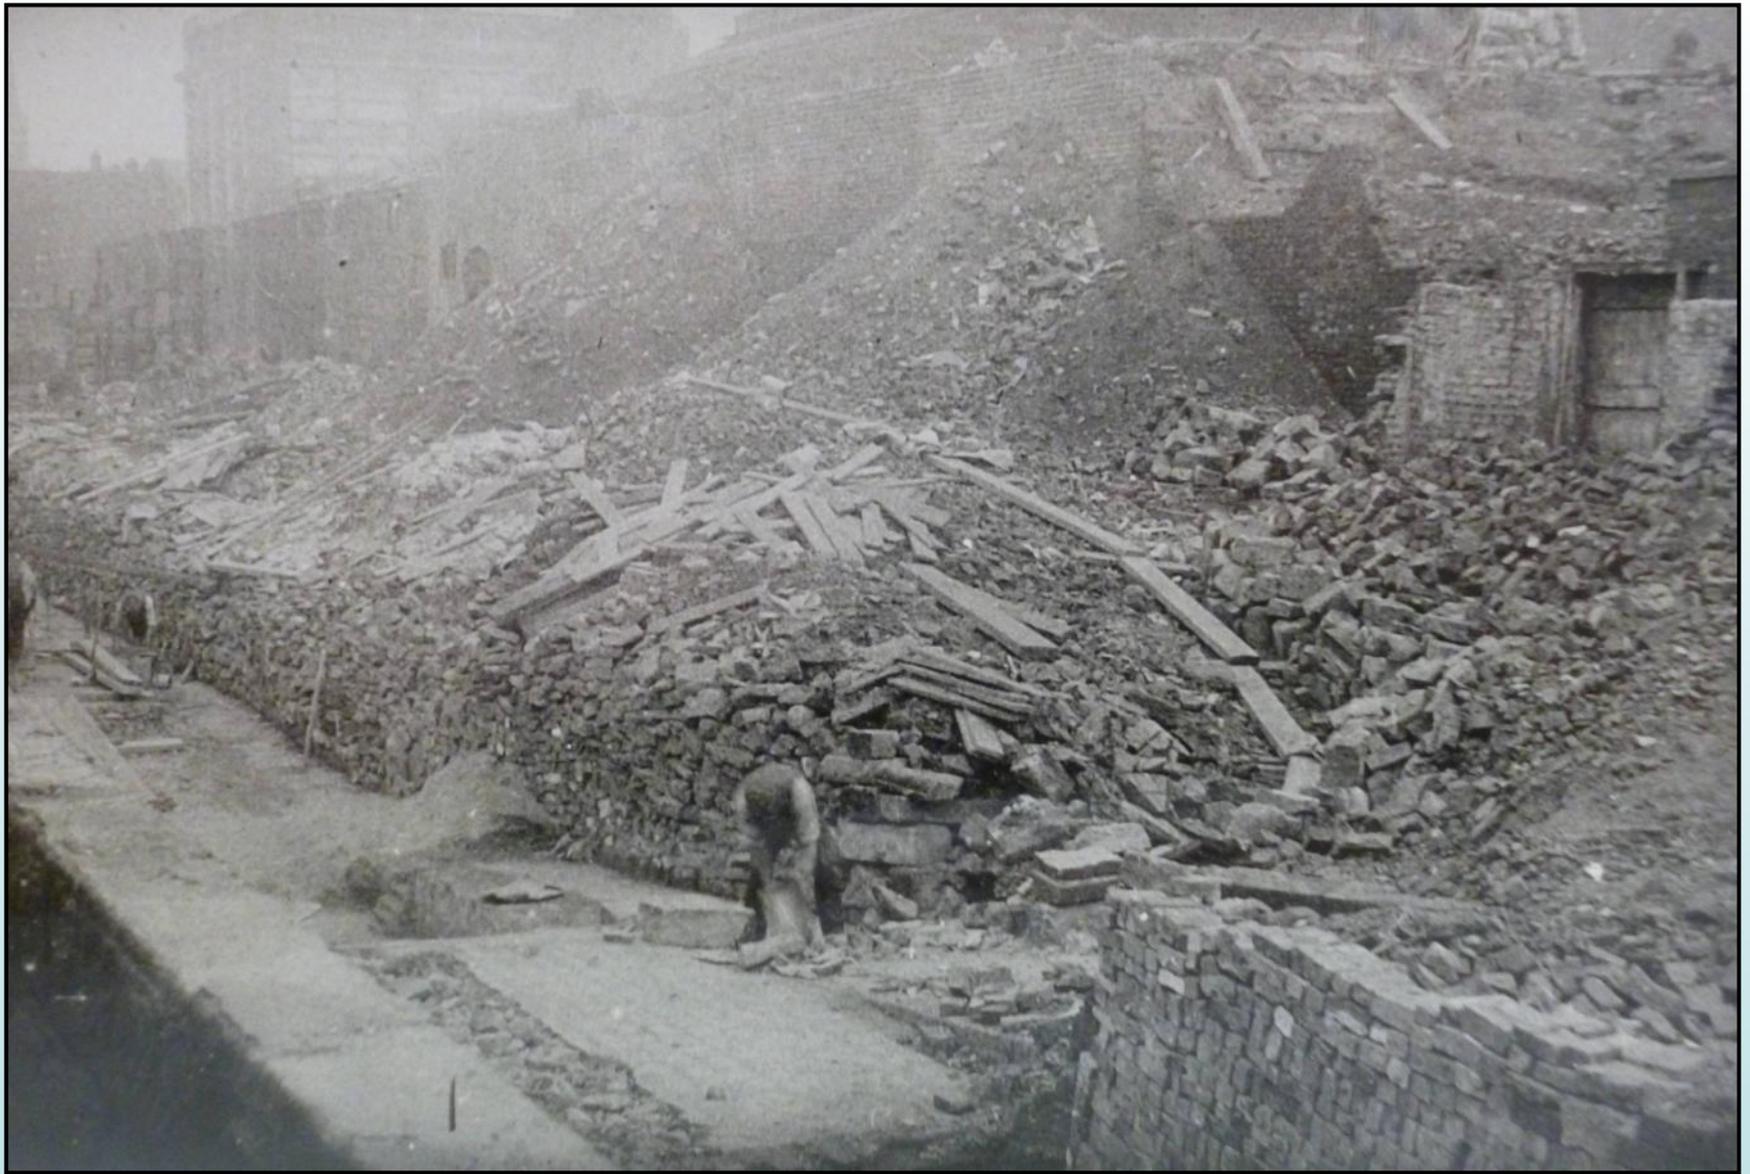
Demolition of Shambles and Chandlers Row for Castlegate, looking east, unknown photographer (Museums Sheffield)

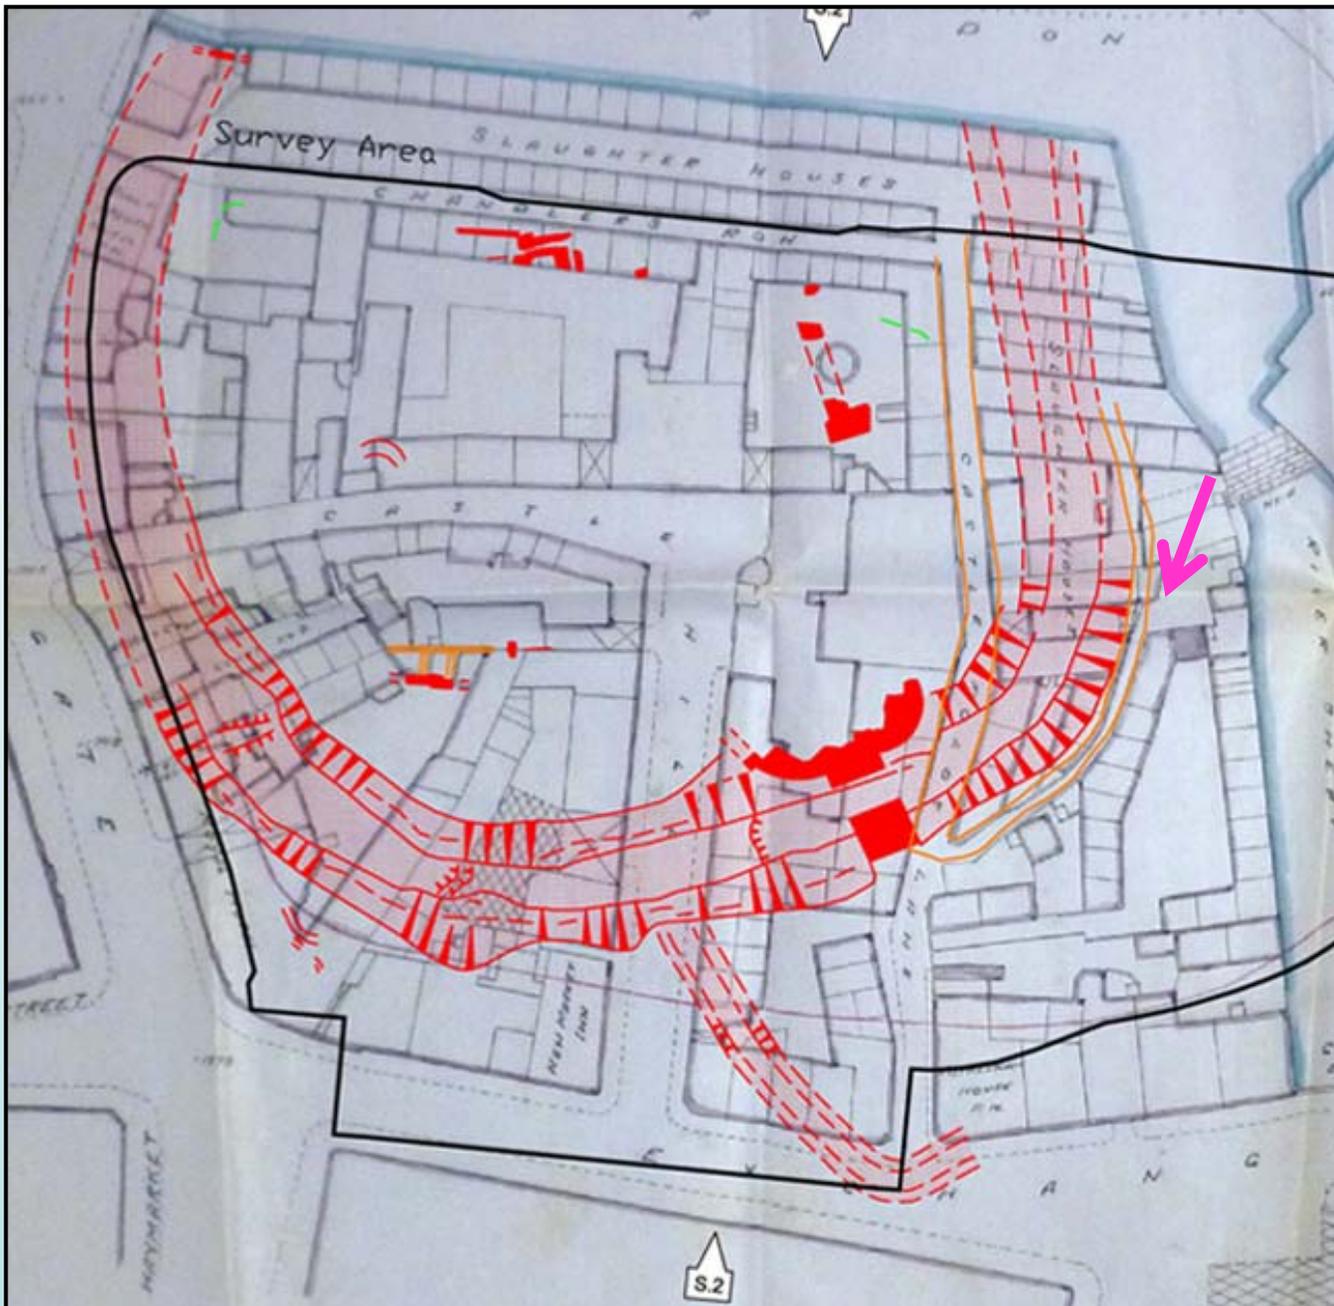
Draft plan of
known
archaeology,
superimposed
on a map
extract c.1900
(EDAS Ltd)

For example, in the upper right-hand part of the next slide, the large circular feature lying at the centre of a courtyard has clearly disturbed that part of the castle recorded by Armstrong in the 1920s and excavated much more recently by ARCUS. Such an exercise can also inform as to what parts of the castle's layout may still have exerted an influence on built structures during the 19th century. The pink arrow on the right-hand side of the slide points to a curving lane or passage that seems to be at odds with much of the surrounding layout, and which **appears to closely follow the outer line of the eastern moat.**

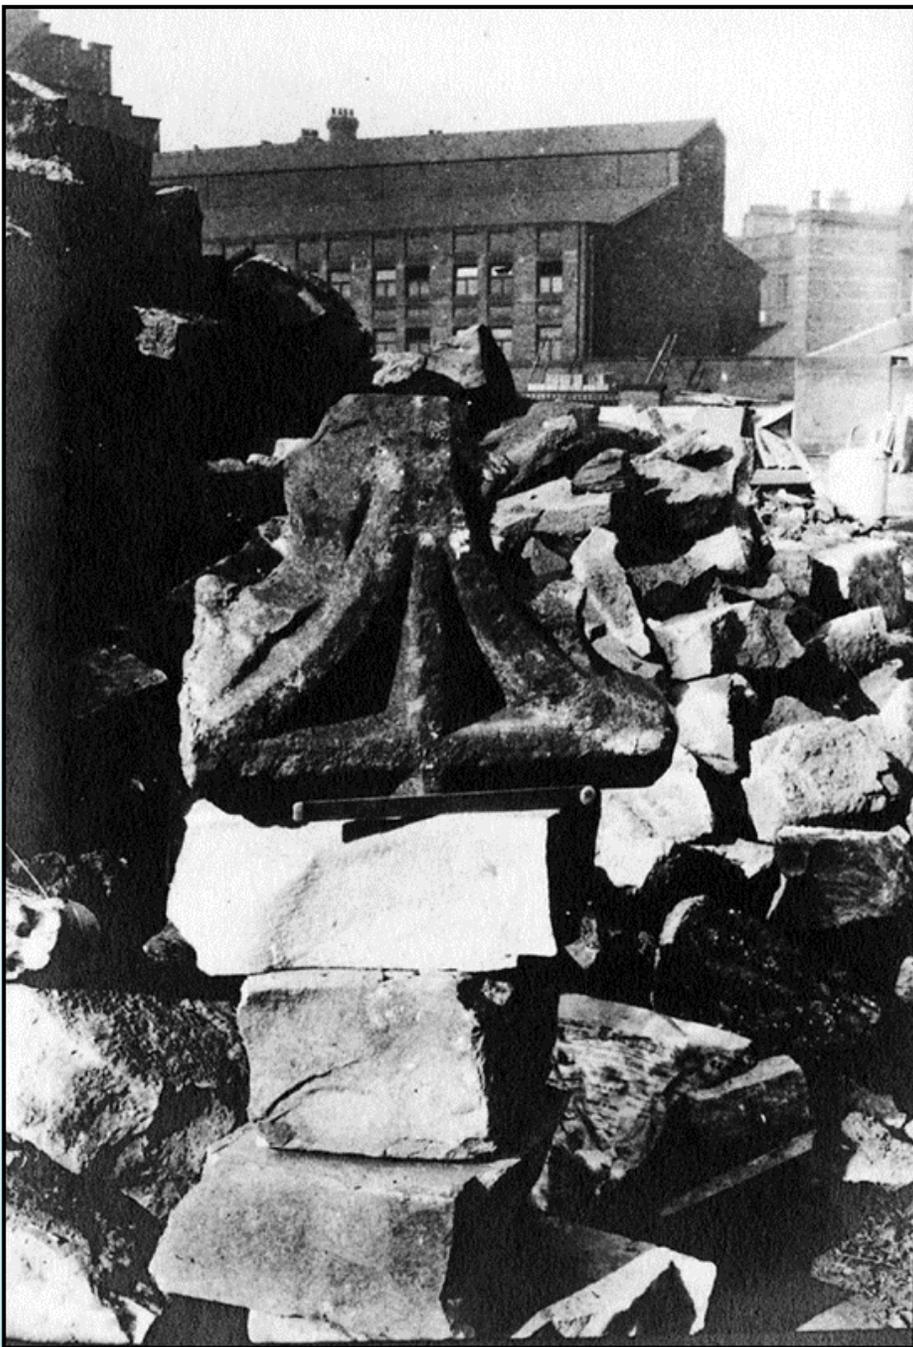
Masonry recovered during
demolition works, taken by
C Lea, c.1929
(www.picturesheffield.com)

Additionally, **such demolition material could well provide a greater context and understanding of other *ex situ* items that may have come from the castle**, such as the plasterwork and other building materials in Bishops House in Sheffield, and contribute to ongoing studies of the motives of those who undertook dismantling, slighting, salvage and demolition at castles during and after the English Civil War.

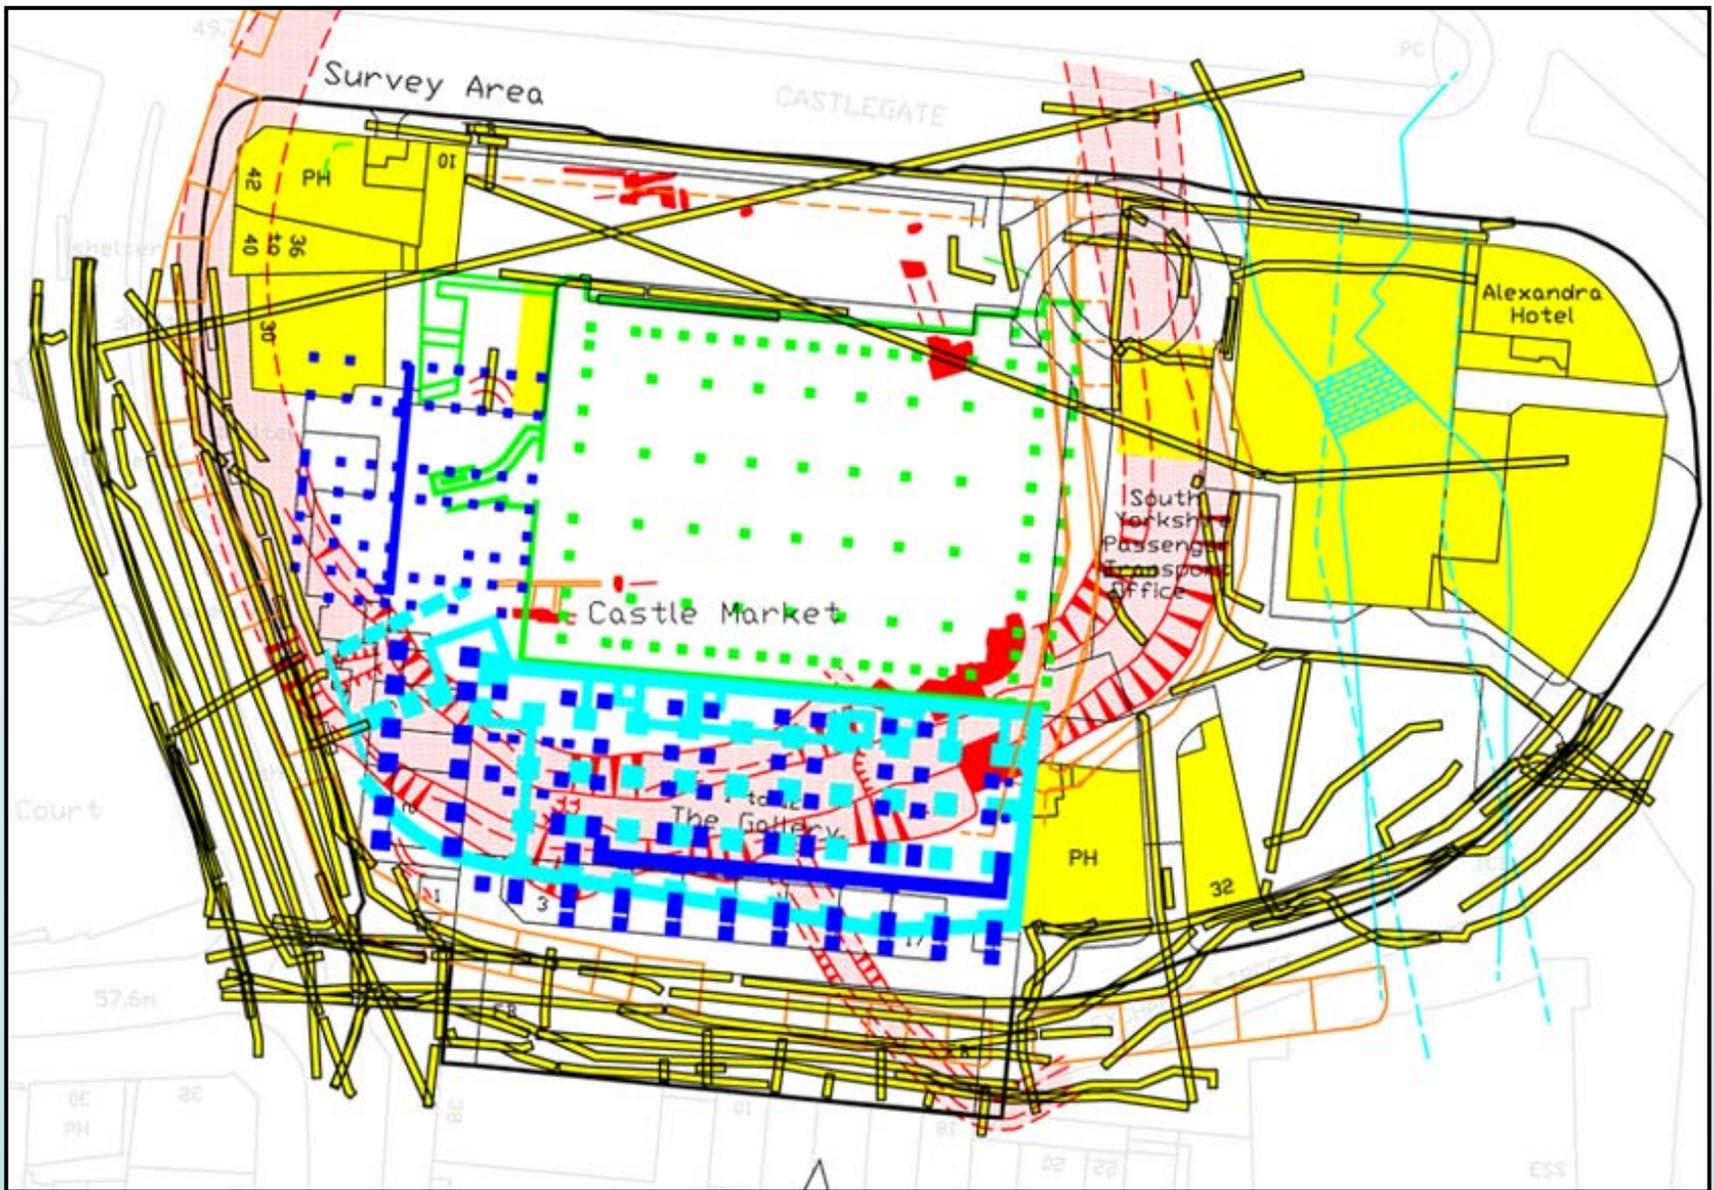
Extract from draft 1:500 scale plan showing known development on the site, 1900-2010 (EDAS Ltd)

However, lest, like Himsworth, the reader begins to despair that very little may actually be left of the castle, **it should be emphasised that in all likelihood important and locally extensive archaeological deposits remain in place across parts of the site.** The careful mapping of foundations shows that windows of opportunity may well still exist in even the most crowded locations, and crucially, the evaluation strategy has to deal in three, rather than two, dimensions.

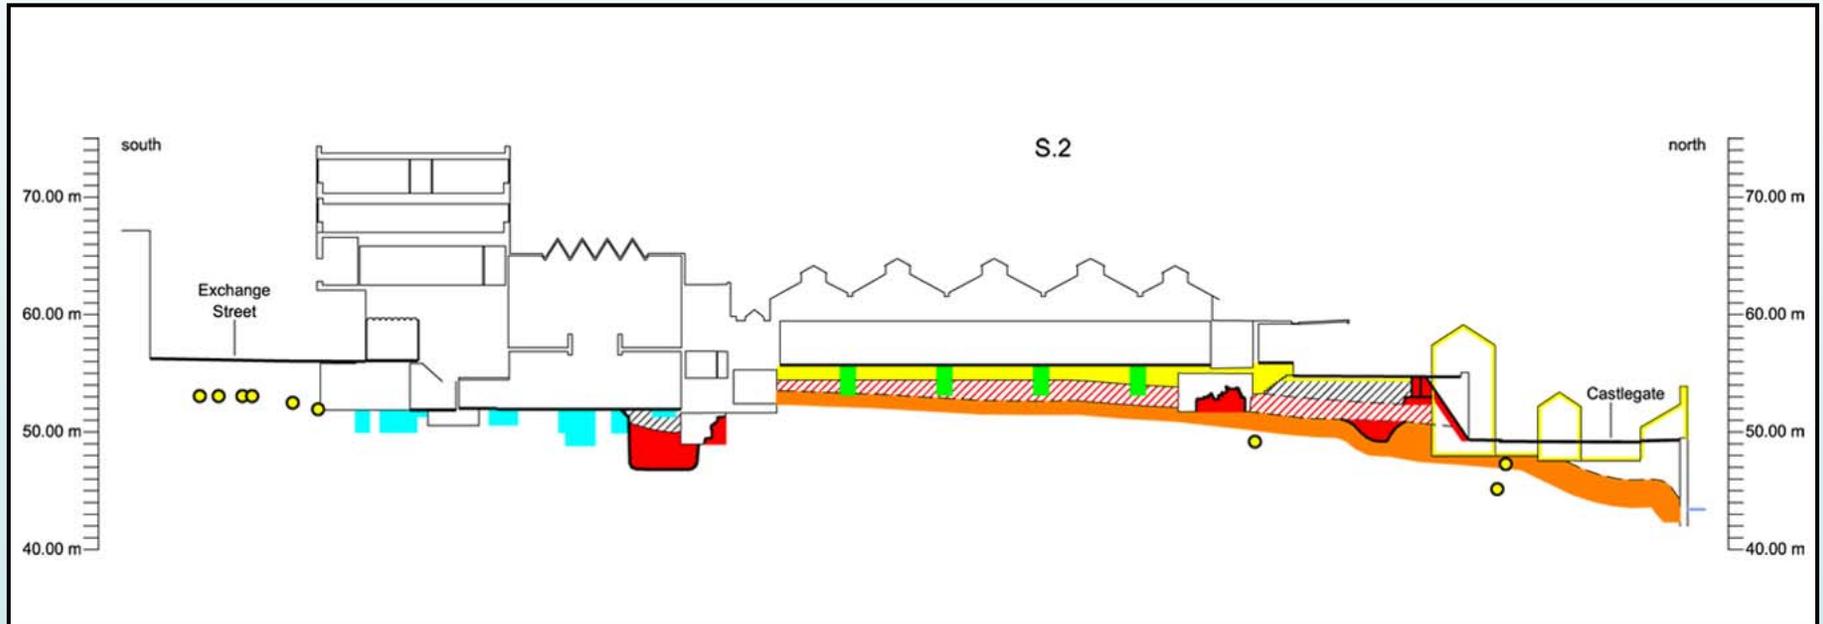
Draft section looking north / south through Castle Market area,
1:500 scale (EDAS Ltd)

The construction of archaeological sections across and through the Castle Market area, such as that shown on the next slide, demonstrates the relationship between known depths of deposits and the foundations of 20th century developments. The section, running north/south through the east side of Castle Market, depicts what Butcher plotted to be the original level of the natural ground surface (brown). Known features (solid red) include from south to north (left to right), the south moat, the larger parts of the castle preserved in the underground chambers, and the 'early' pit recorded by Butcher near the spiral ramp. The depth of probable medieval deposits associated with the castle are cross-hatched in red, possible demolition material cross-hatched in grey towards the north end, and relatively recent deposits in solid yellow. The various 20th century foundations are shown in green and blue.
