## STRUCTURAL REPORT ROSE GARDEN CAFÉ, GRAVES PARK, SHEFFIELD S8 8LJ

**Client:** Sheffield City Council  
**Project Name:** Rose Garden Café, Graves Park, Sheffield S8 8LJ  
**Report Title:** Structural Inspection Report  
**Document ref:** 00.22225-ACE-ZZ-ZZ-RP-S-0001  
**Date:** 8<sup>th</sup> August 2022

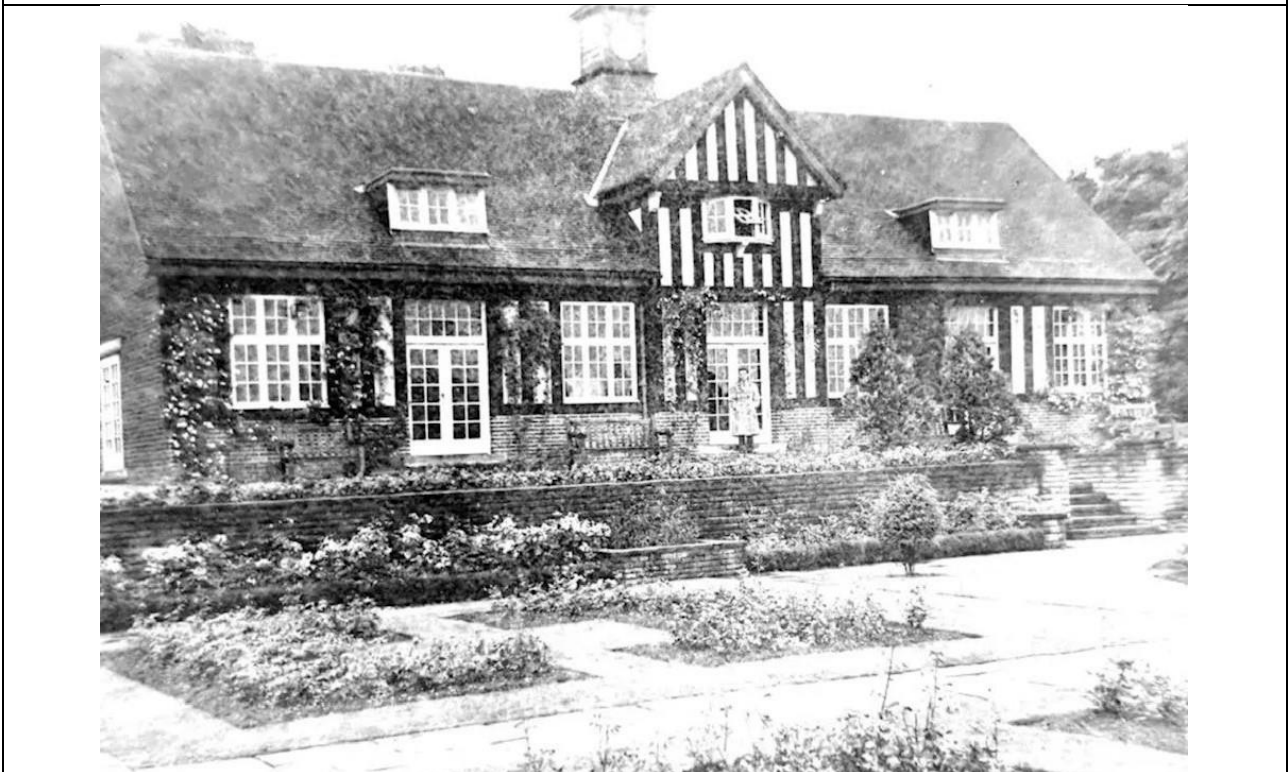
Photo 8  
Historic view of the café building

- 3.1. The previous report notes that the café building was built in 1927, an old photo is given in photo 8.
- 3.2. The main open plan café area would appear to be a load bearing masonry structure,
