Street Tree Appraisal Report

Resurfacing roads and footways whilst retaining street trees

December 2021

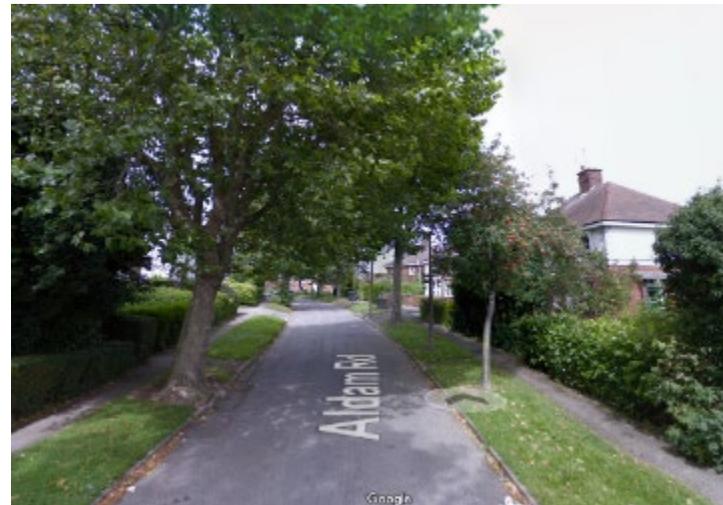
- Photo on the left outside property 22: tree buttress roots have displaced the kerbs with a significant root between the kerbs extending into the carriageway. The remaining kerbs have been absorbed by the tree.
 - Photo on the right outside property 25: the defects associated with the kerb line have been concluded previously, however the footway has been narrowed and surface is uneven and in poor condition due to the tree roots.
-

- The options available to address the displaced kerbs and rooting into the carriageway are limited as removing the existing kerbs is likely to result in significant damage to the tree which is in a fair condition overall;
- Therefore, the option is limited to the installation of a built out, 600mm in width. Bollards are not considered to be a requirement, therefore minimising impact on the street scene;
- The footway requires 60mm reconstruction throughout the length of the street and in proximity to the trees, hand excavation is required. Regarding the tree outside 25, removing historic asphalt patching will enable the new surface to be laid to rectify the ramping, but in retaining the tree there is a compromise to the current width of the footway where no restrictions exist on the footway on the opposite side of the street.

To ensure the trees are retained and a permanent solution implemented, the construction of a build out is recommended, accepting that for the tree outside 25, a reduction in footway width will be required.

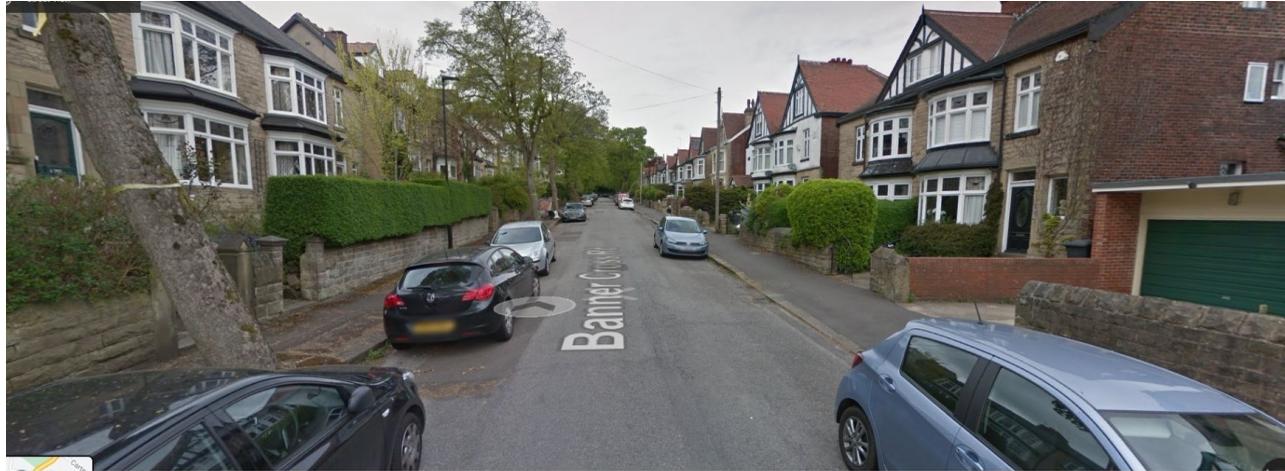
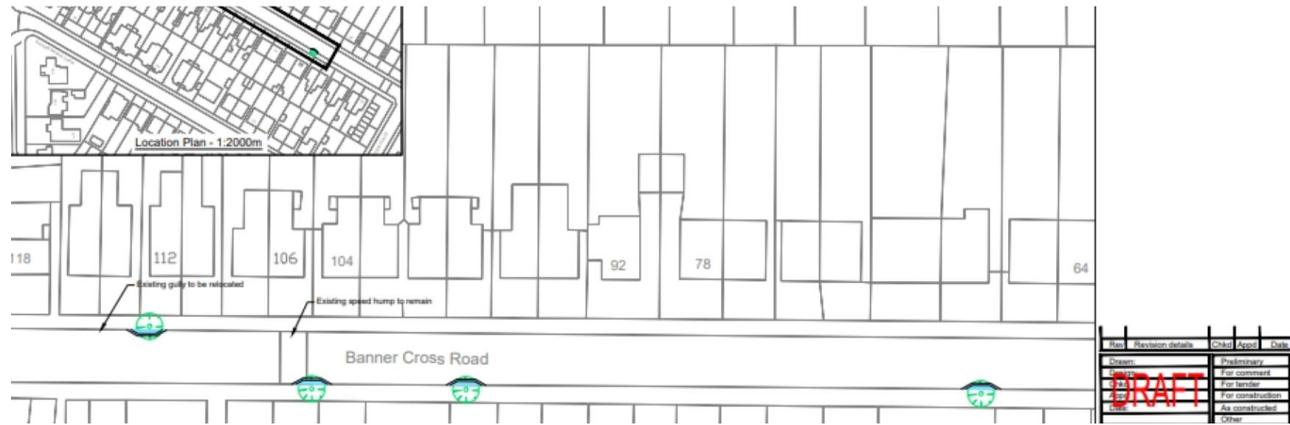
Current layout and outline design drawing

- Nine (9) trees were identified for replacement due to missing kerbs, evidence of rooting in the carriageway, with footway surfacing lifted creating uneven and ramped surfaces. Trees were identified for replacement to enable defects to be addressed;
 - Improvement work including resurfacing is planned for 2021. Defects associated with two (2) trees have been addressed previously, and in addition the tree located outside property 106 was removed in April 2021 following a routine tree inspection due to disease *Meripilus*.
-

Making changes to the highway by introducing four (4) buildouts will have an impact on residents and the highway user by reducing the availability of parking and changing the street scene.

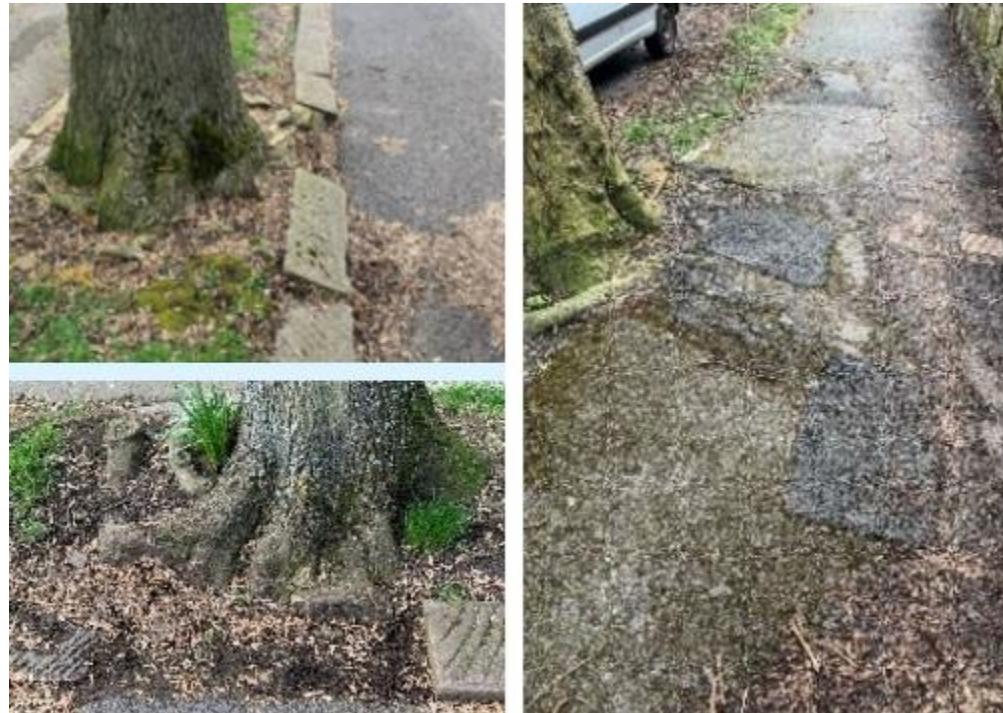
- There are thirty-seven (37) trees along Milden Road, of which seventeen (17) are Ash trees. All were assessed in 2020 for Ash Die Back (ADB) with minor evidence visible at the time, therefore deemed to be in fair condition. However, the trees will need to be subject to annual monitoring and are likely to deteriorate to a point of replacement in the coming 5 years;
- The carriageway was resurfaced in the early investment stage, accepting that along the length of the road, several mature trees have displaced kerbs (natural stone) which are no longer present (photos on the left);
- The footway resurfacing remains outstanding, with evidence of roots present in the footway (photo on the right) causing surface defects and ramping.

- The key factor is the tree species. With mature Ash, due to Ash Dieback (ADB) the remaining life expectancy of the trees is limited to approximately 5 years. The trees will continue to be assessed annually and removed at the point the extent of ADB is deemed to be a risk to public safety. ADB is well understood by all stakeholders in the management of street trees;

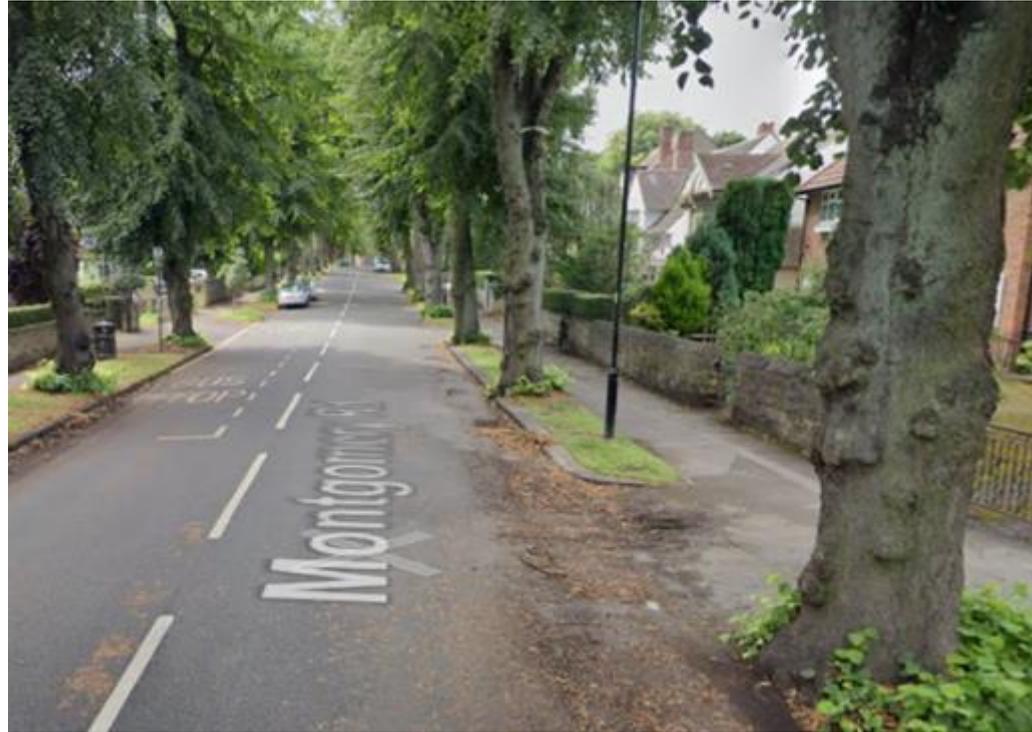
- Sixteen (16) trees originally due to be replaced to enable early investment improvements to take place with various footway defects including missing and displaced kerbs;
- The carriageway resurfacing has been completed, although kerb replacement remains outstanding. Footway resurfacing to be due to be completed in 2021;

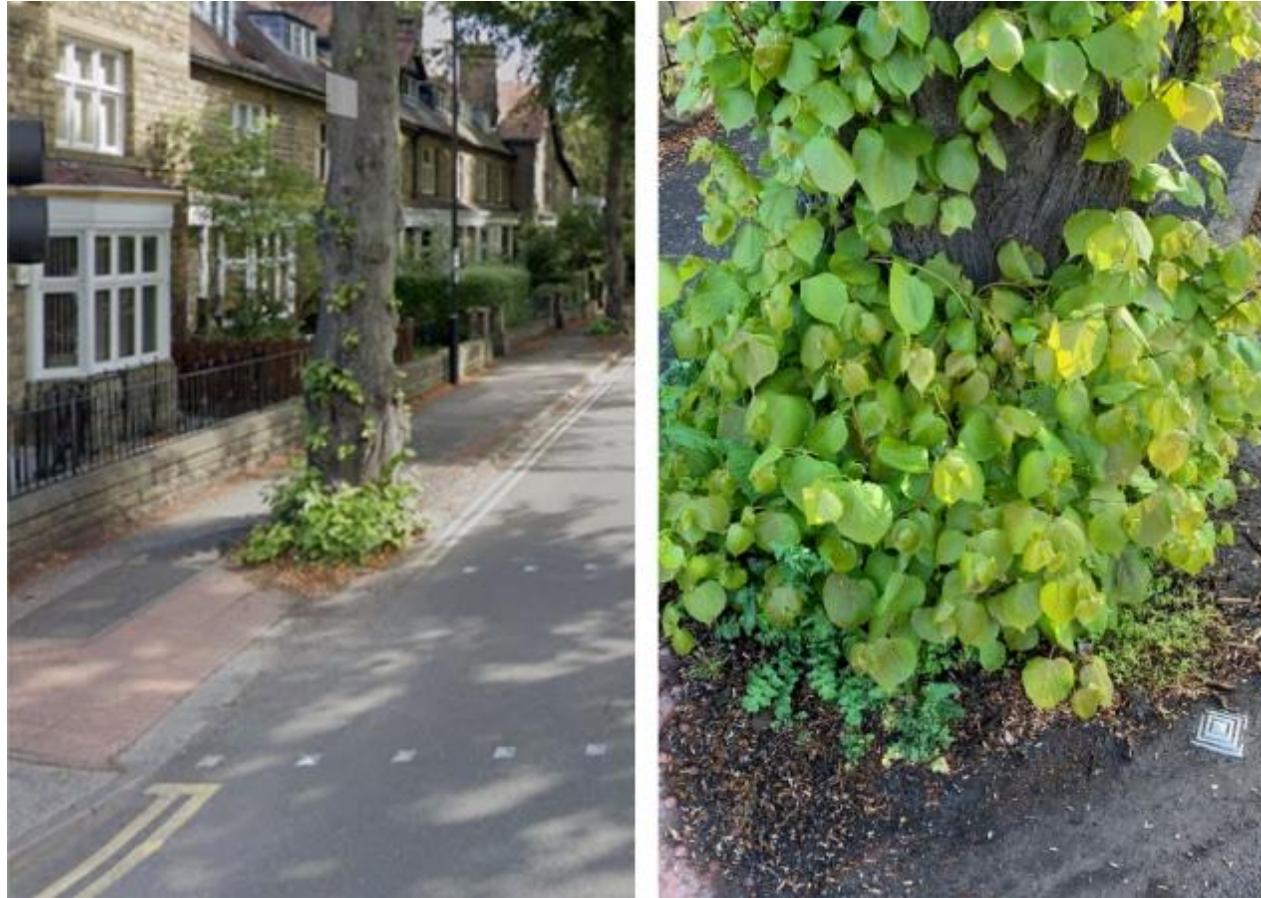
- The carriageway was resurfaced during the early investment stage, though the kerbs remain displaced at the tree originally identified for replacement at the junction with Cowlshaw Road, adjacent to number 136.
-

- The Lime tree, in a fair to good overall condition, is located adjacent to the crossing point on a main throughfare. The kerb has been displaced by the tree and cannot be reinstated. This has not impeded the resurfacing work previously completed and no drainage issues have been identified;
- The options are limited to the tree being replaced, a build out or accepting the missing kerb and continued compromise of current standards.

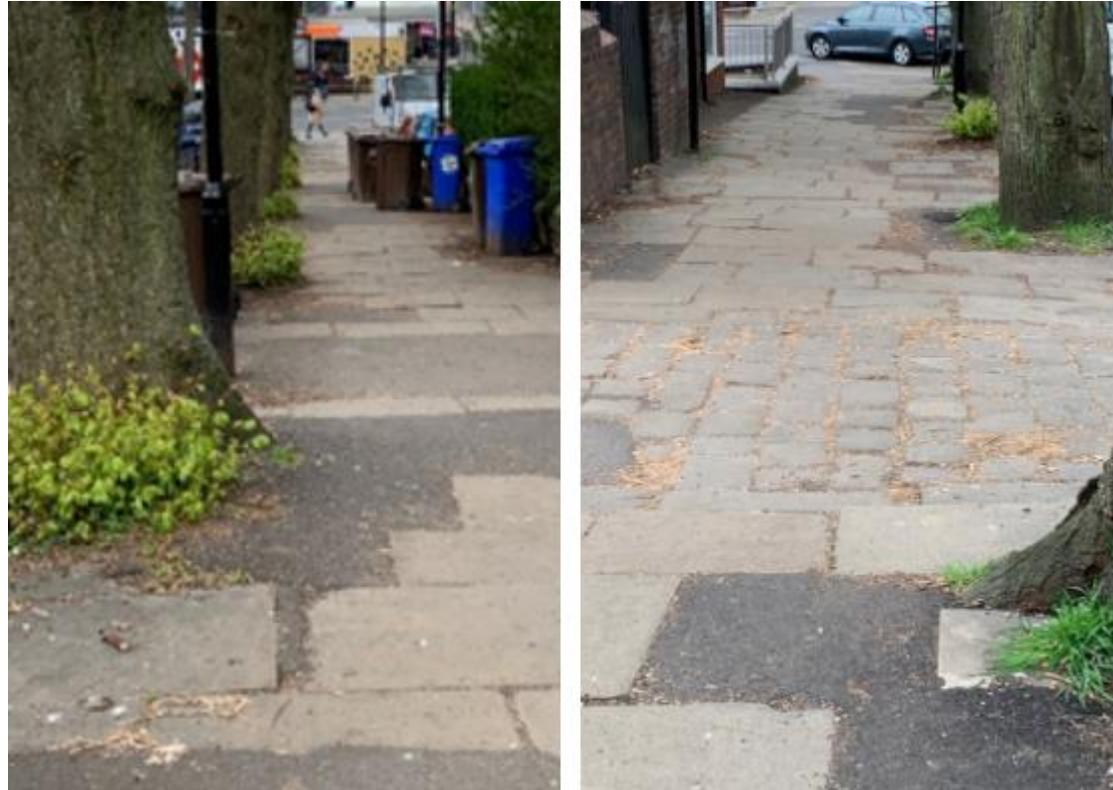
- Above photos of the tree located at the park entrance where kerbs have been displaced and there is significant root in the kerb line. The gully has also been buried by the displaced kerbs;
 - Photos below show the damage to the footway due to the presence of tree roots which have raised the flag stones. To rectify the trip hazards, the flag stones have been lifted and replaced with an asphalt surface path.
-

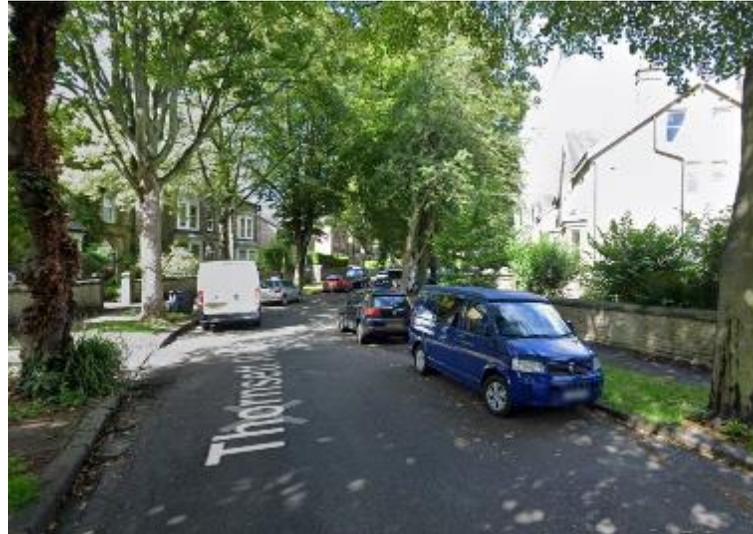
- Thornsett Road is lined with mature trees, predominantly in verges therefore minimising the risk to footway though there are defects associated with the tree where the footway is raised extensively in places;
- The carriageway has kerbs displaced and missing with evidence of root intrusion.

- Further investigations were carried out in May 2021 to identify the extent and depth of roots within the carriageway and inform the final design solution which to due to be concluded in August 2021. No trees are considered for replacement.
