# **REPORT ON WESTERN ROAD**

## Report on Western Road:

## REPORT ON WESTERN ROAD – TREE PROPOSALS

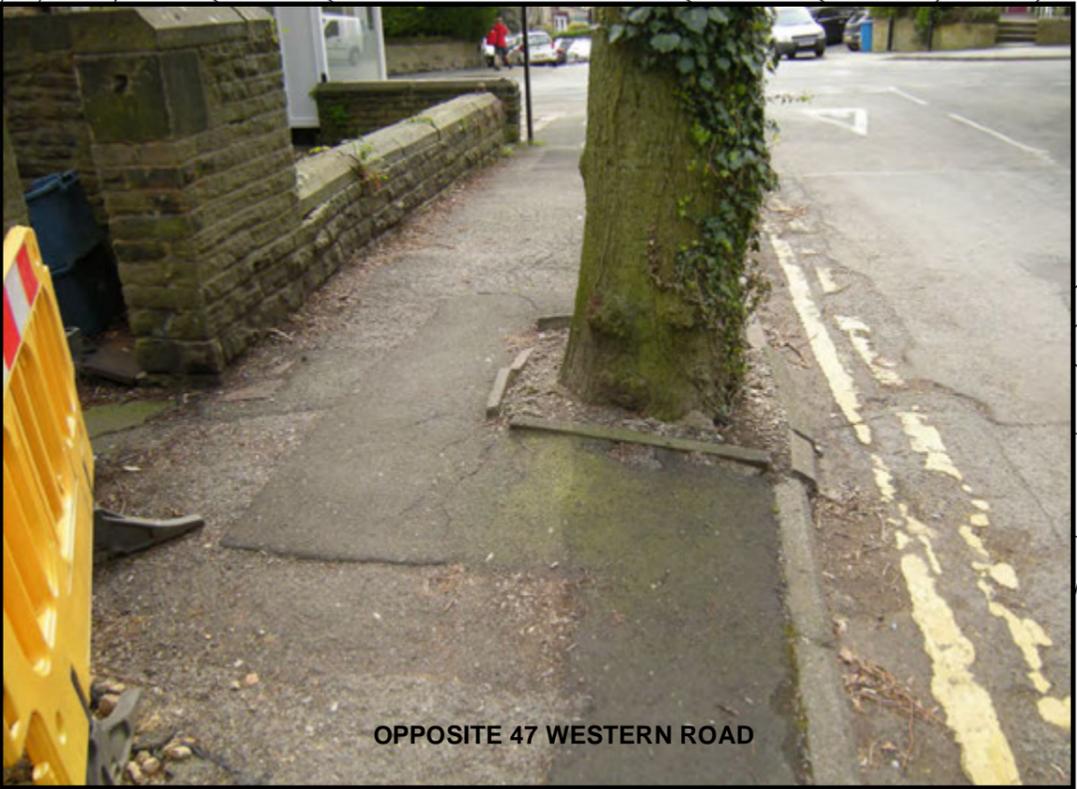
OPPOSITE 47 WESTERN ROAD

**Opposite No 47: SA. Recommend Replacement: ITP in Agreement:**

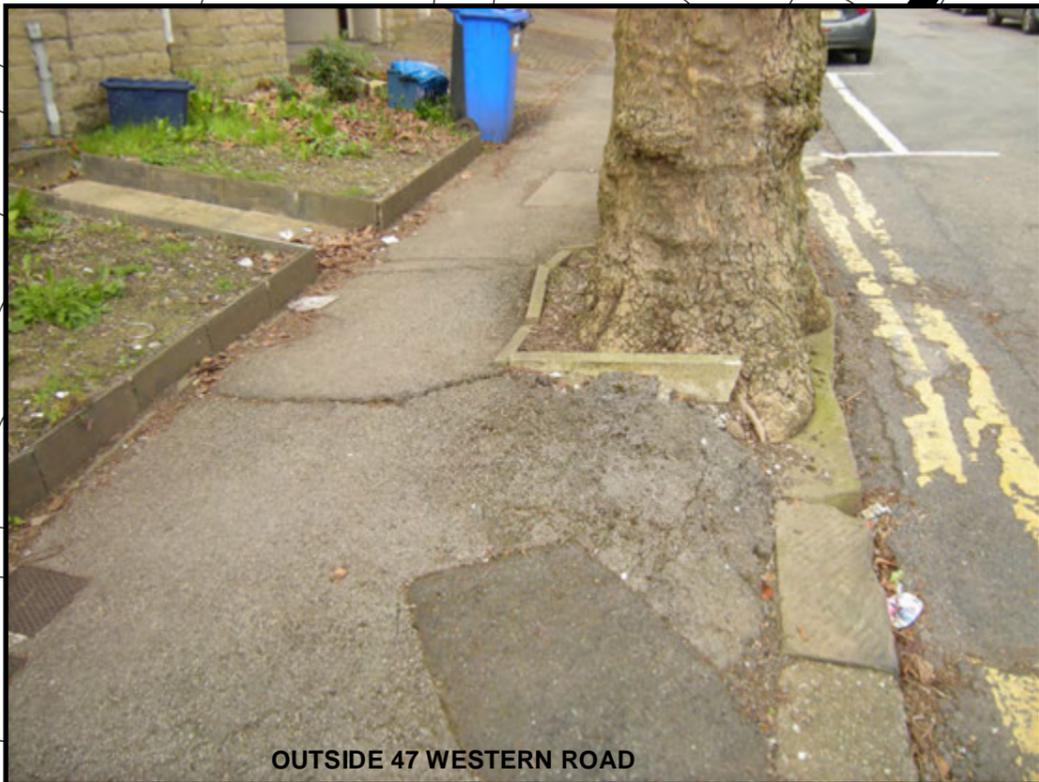
OUTSIDE 47 WESTERN ROAD

**Outside No 47: SA. Recommend Replacement: ITP in Agreement:**

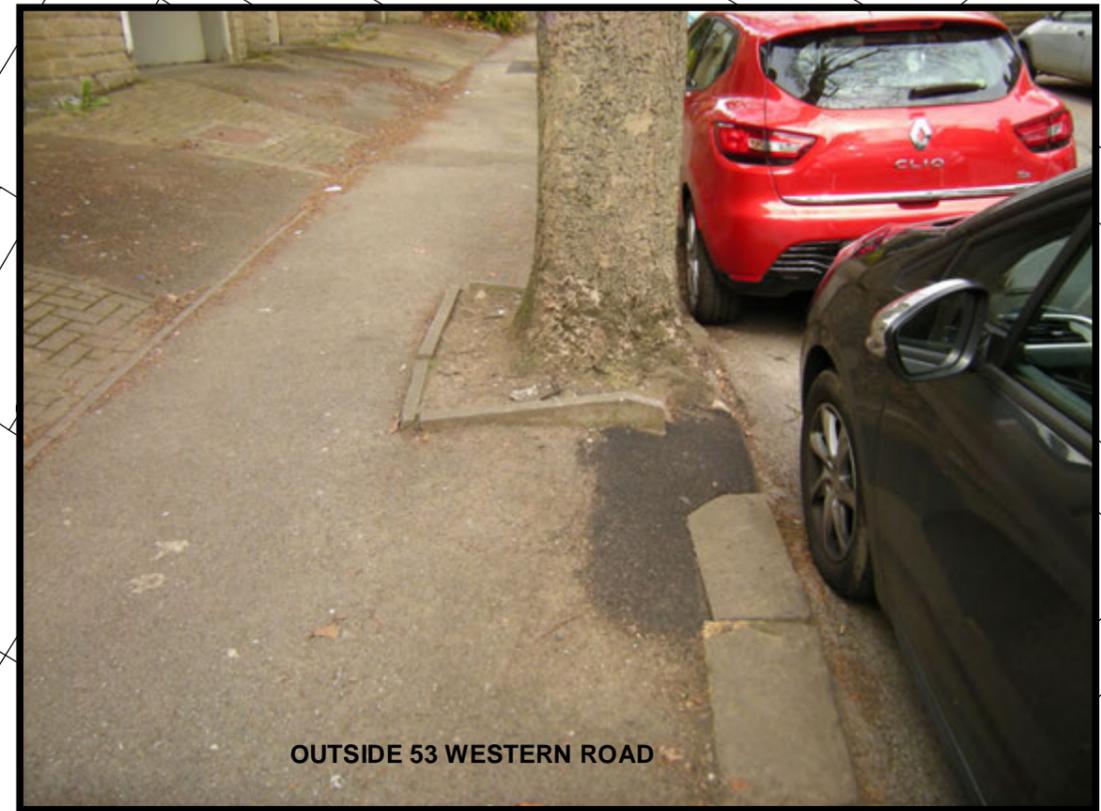
OUTSIDE 53 WESTERN ROAD

**Outside No 53: SA. Recommend Replacement: Airspade In Agreement**

Cannot install full or half kerb due to buttress which was suggested by ITP. Risk of vehicle strike damaging existing wounds allowing entry of pathogens: Independent Airspade report recommends replacement.

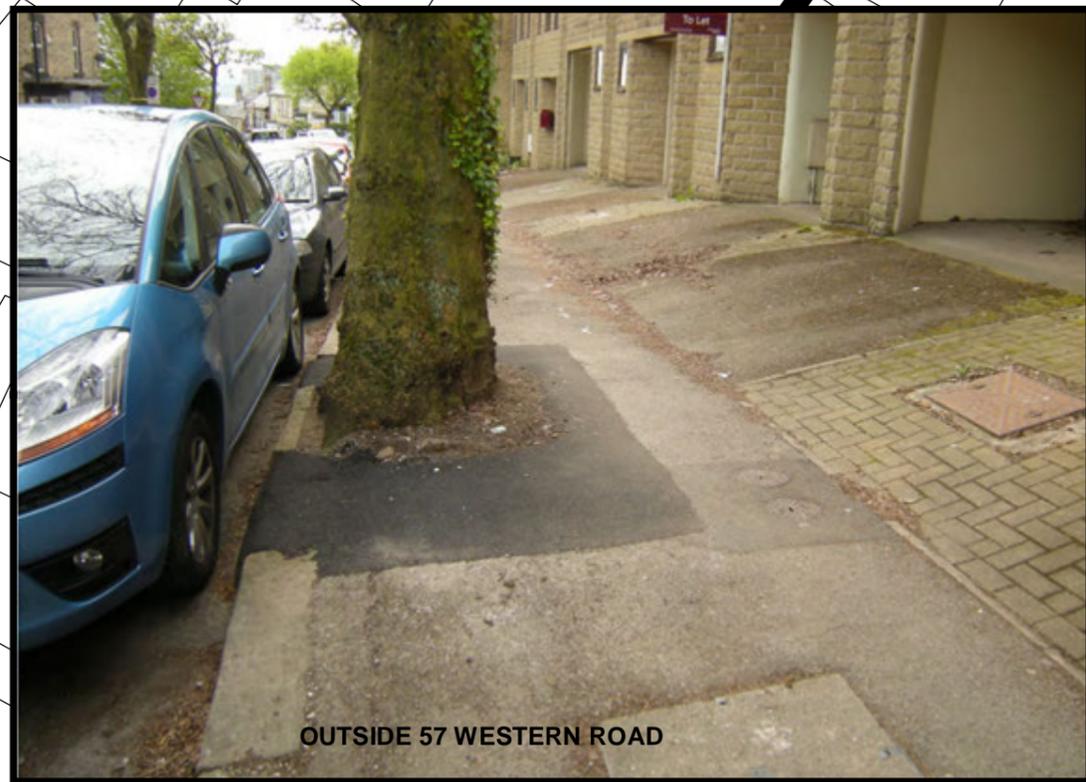
OUTSIDE 57 WESTERN ROAD

**The root continues to grow into the carriageway and will get damaged when surfacing is completed. Proceed as planned with replacement**

## **Outside 57: SA. Recommend Replacement**

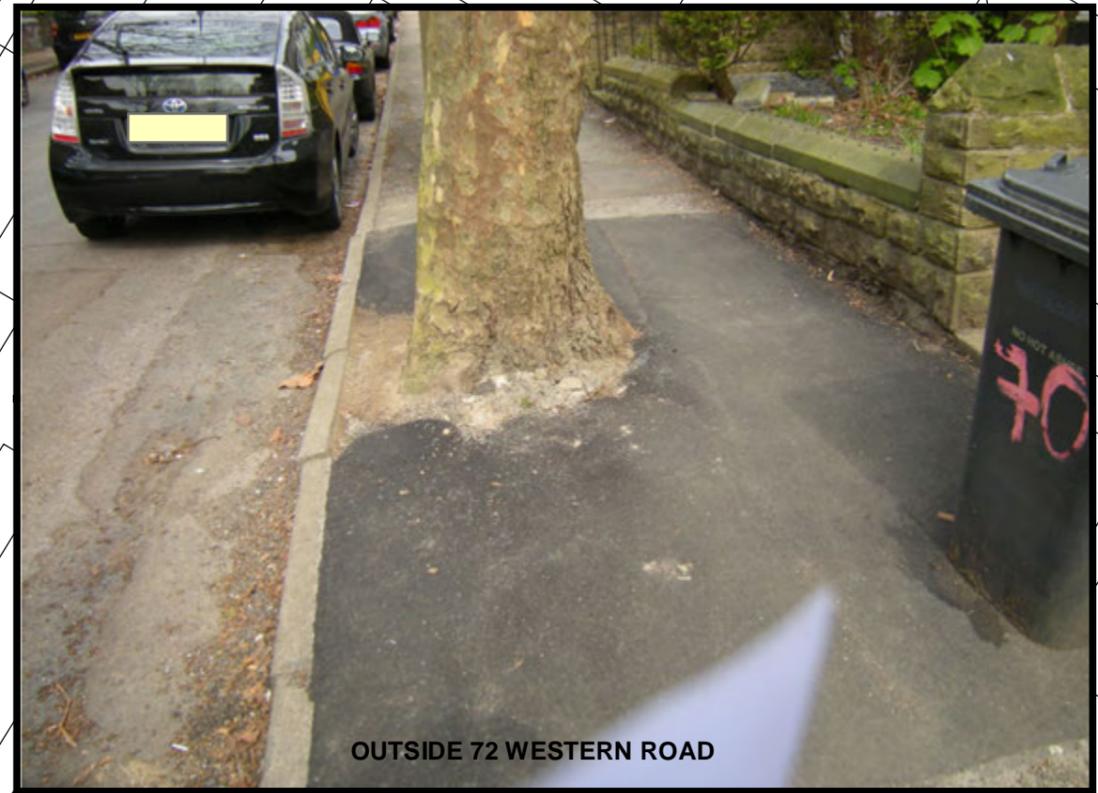
OUTSIDE 72 WESTERN ROAD

**Outside No. 72: SA. Recommend Replacement: ITP in Agreement:**

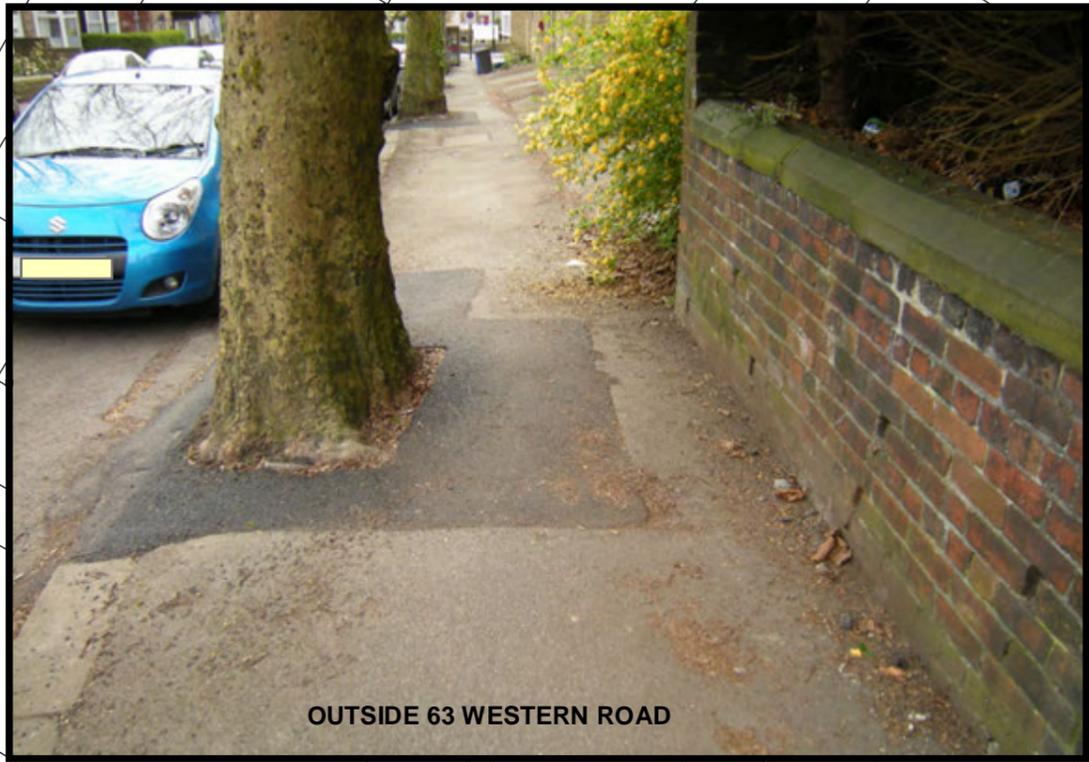
OUTSIDE 63 WESTERN ROAD

## **Outside No. 63: SA. Recommend Replacement: Airspade in Agreement:**

Replacement only option - Kerb displaced, unable to reset or provide half kerb. Roots continuing to trace under carriageway causing significant structural damage. Footway already ramped and damaged by shallow roots.

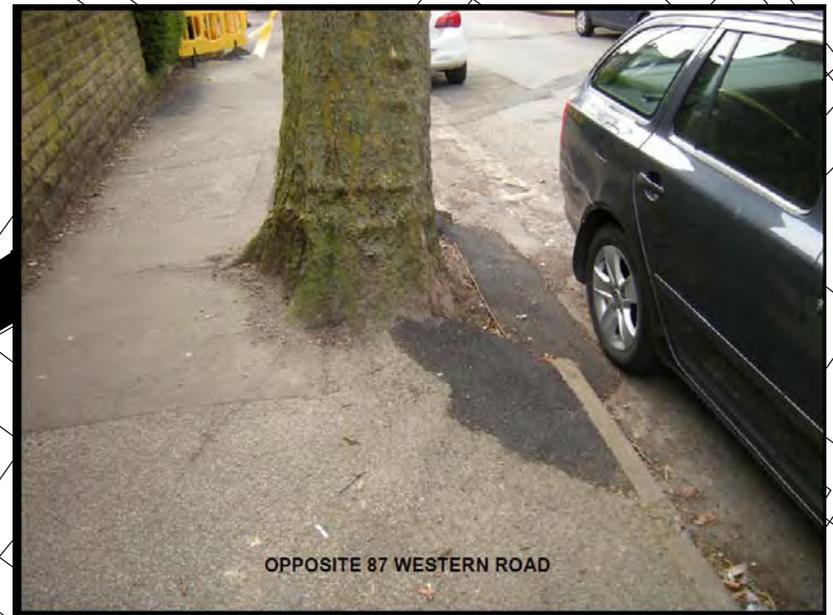
OPPOSITE 87 WESTERN ROAD

**Opposite 87: SA. Recommend Replacement**

**Temporary repair in Bitmac to cover roots into carriageway. Evidence of roots tracing towards property. Previous thin kerb already failed and removed due to roots, unable therefore to replace half kerb .**

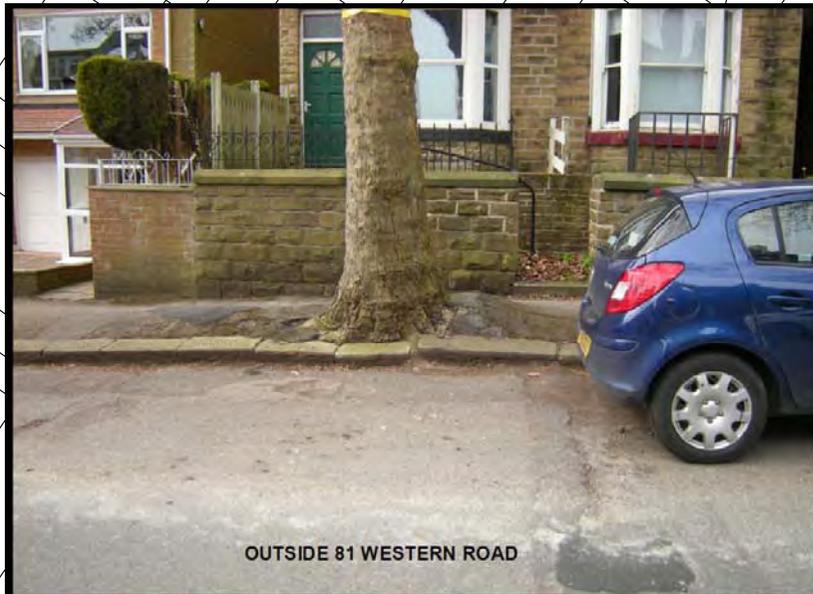
OUTSIDE 81 WESTERN ROAD

**Outside No 81: SA. Recommend Replacement: ITP in Agreement:**

Footway already significantly ramped by roots tracing to boundary wall: Kerb pushed out into channel line: Photo also showing recently repaired wall to the property

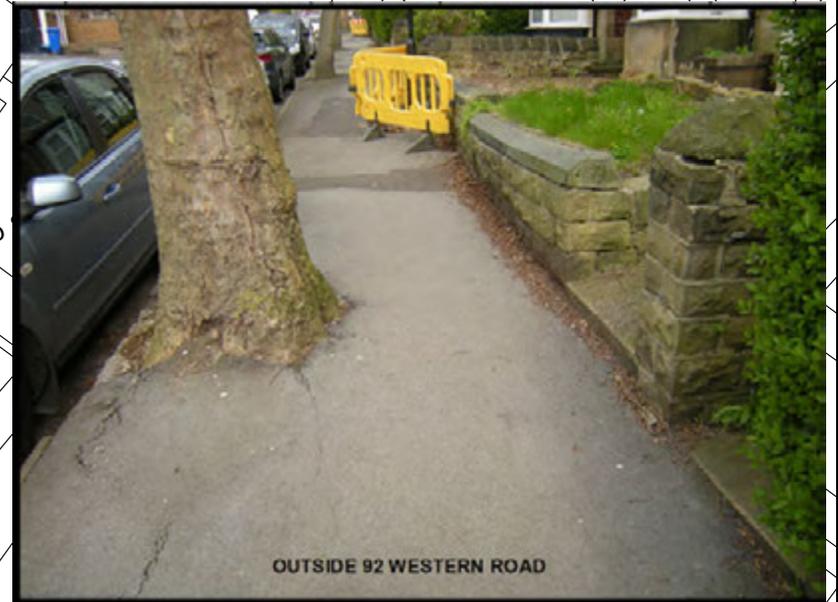
## **Outside No. 92: SA. Recommend Replacement**

**Evidence of slight bowing to wall: Cannot install full kerb at this location as it would encroach channel line. Kerb already missing due to be pushed out by roots. Roots would therefore prevent half kerb suggested by ITP**

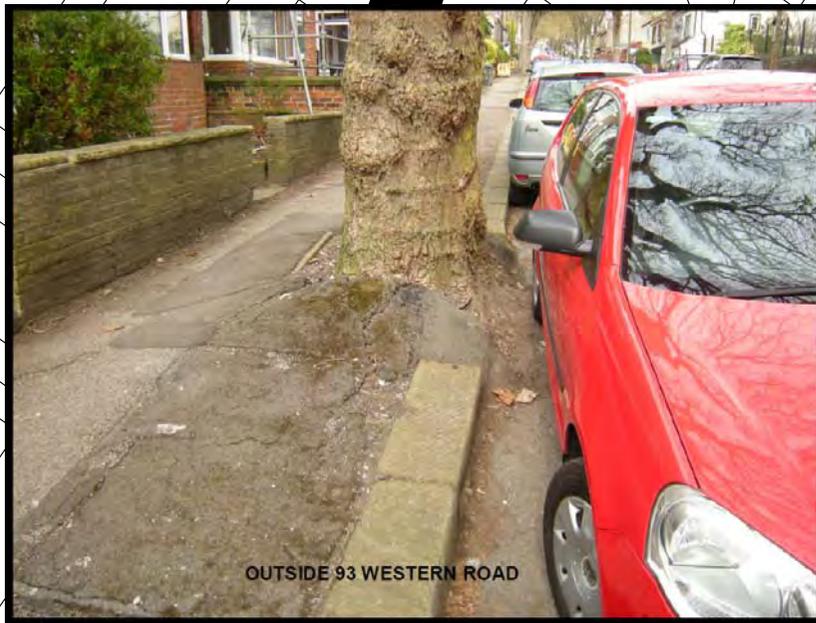
**Outside No. 93: SA. Recommend Replacement: ITP in Agreement:**

Root/buttness in carriageway causing damage and preventing any further kerb placement. Roots also in channel line of traffic and tracing towards third party boundary wall near gate.

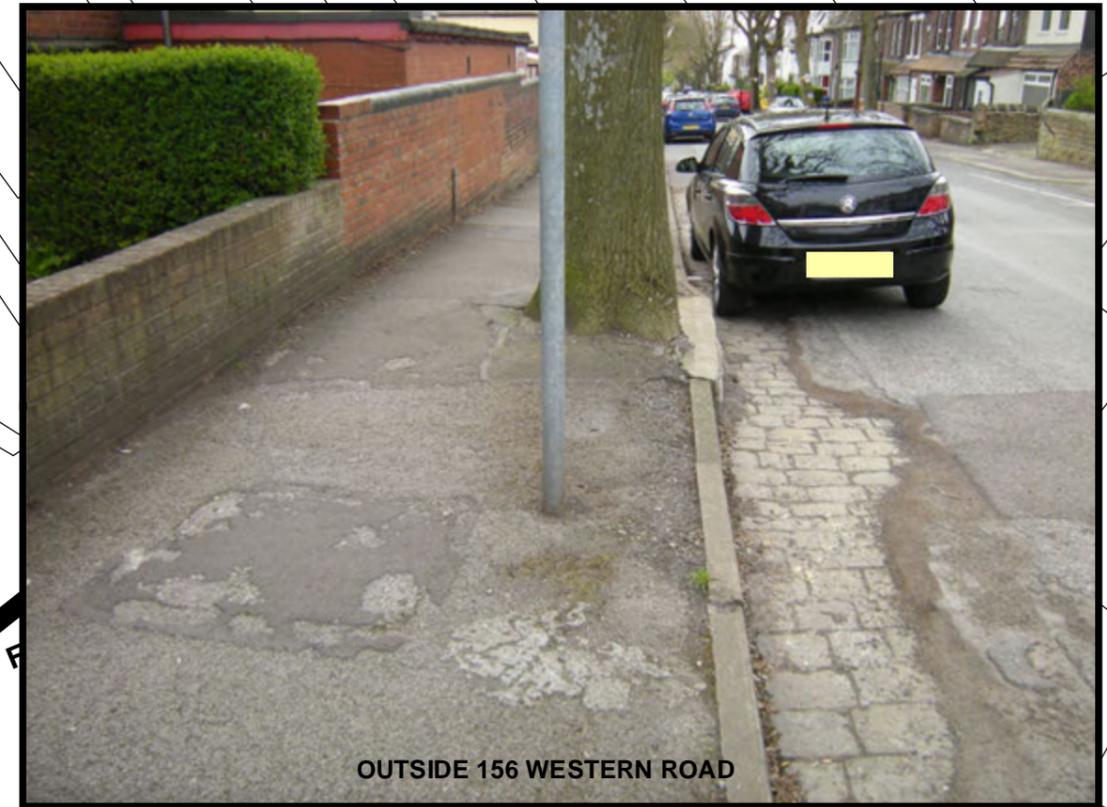
OUTSIDE 156 WESTERN ROAD

## **Outside No. 156: SA. Recommend Replacement**

**Decay at topping points and poor structural condition: Concrete frontage in place of kerb is only temporary as roots will displace into carriageway causing further distortion to the alignment.**

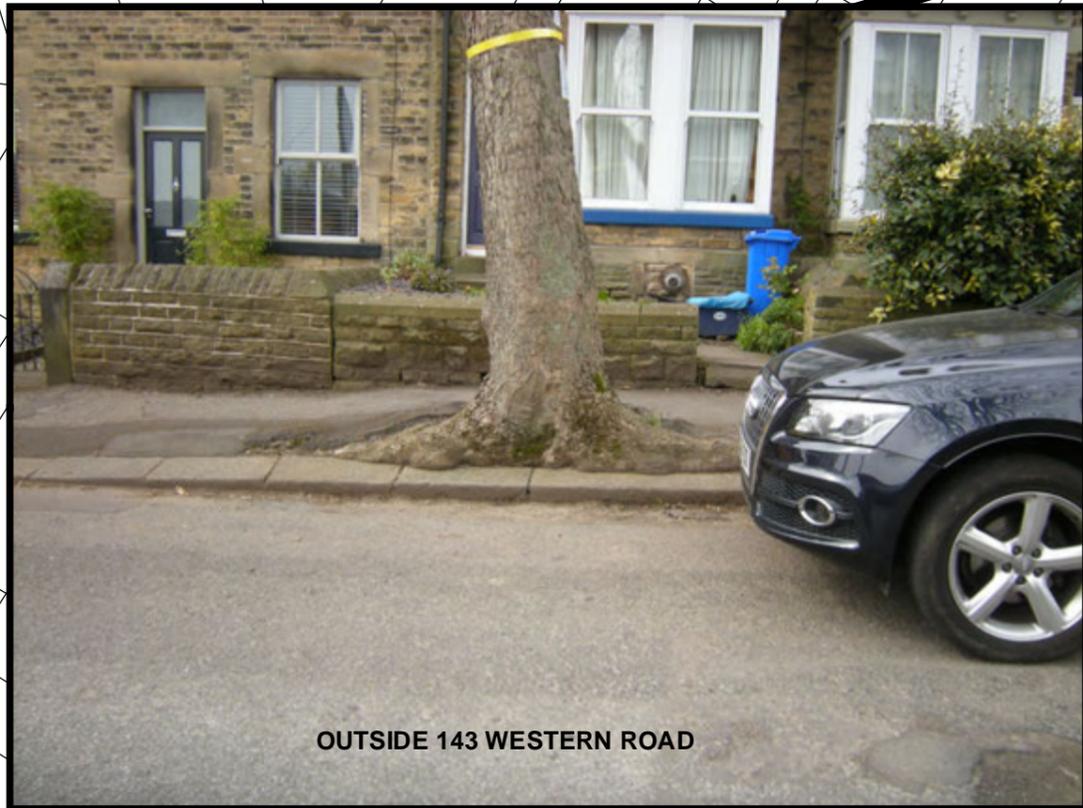
OUTSIDE 143 WESTERN ROAD

**Outside No. 143: SA. Recommend Replacement: ITP & Airspade in Agreement:**

Roots overgrowing kerb and causing trip hazard. Footway damage severe. Potential 3<sup>rd</sup> party wall damage Felling and replacement, due to decay. Basel Ganoderma. Sp. fungal fruiting body.

The tree is now showing signs of major health issues. It was agreed on site that due to its condition further investigation was not required, Continue with replacement

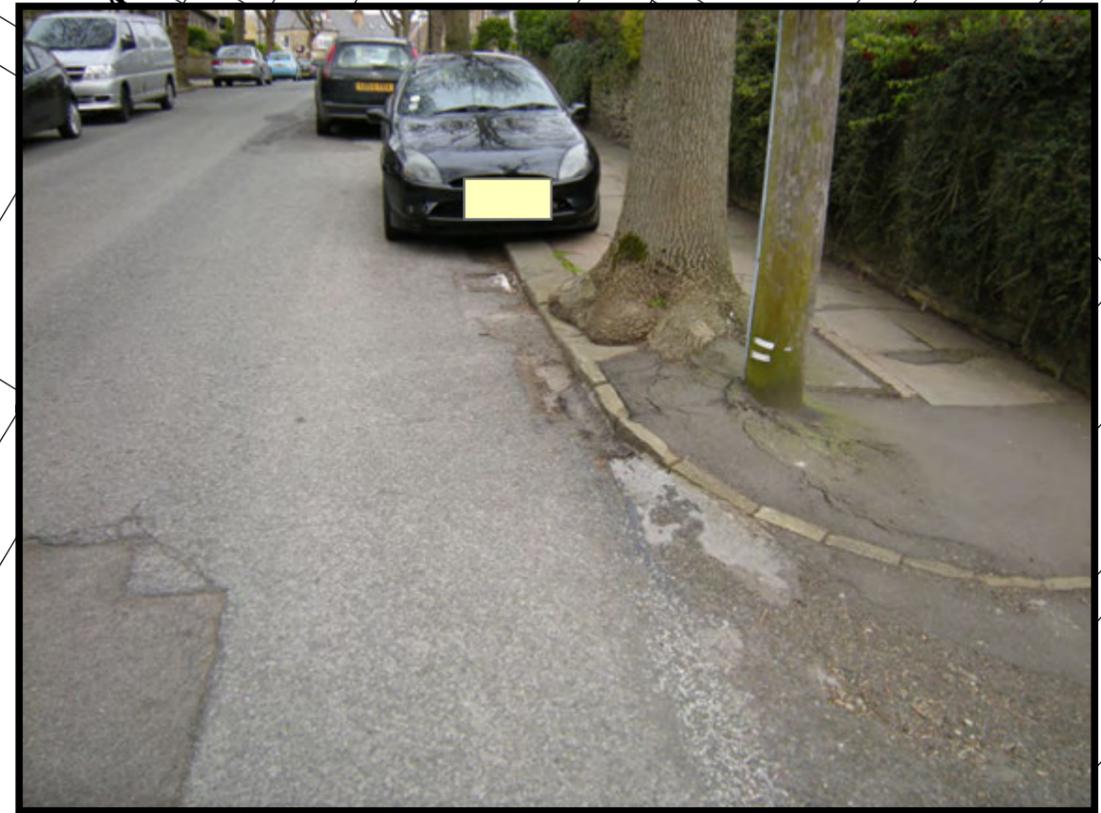
**Opposite No. 239: SA. Recommend Replacement: ITP in Agreement:**

Buttress enveloping kerbs and preventing access to service cover. Unable to provide half kerb.
