## PROBLEMS, THREATS, OPPORTUNITIES AND CHALLENGES

**Fig.33** Problematic development within Nether Edge.

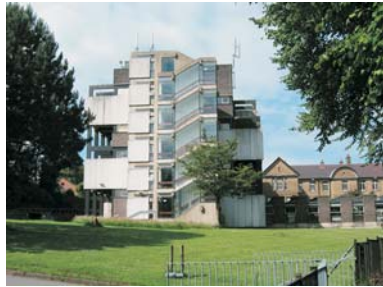
**(a)** Sheffield Hallam University - ugly modern extension to attractive Edwardian former school.

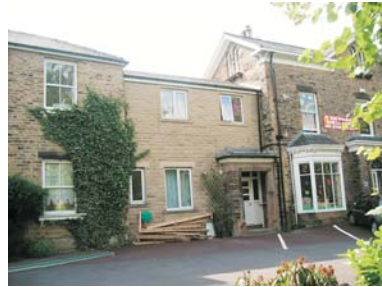
**(b)** Infill between two fine villas damaging their "separate" character. Note the poorly proportioned and detailed windows.

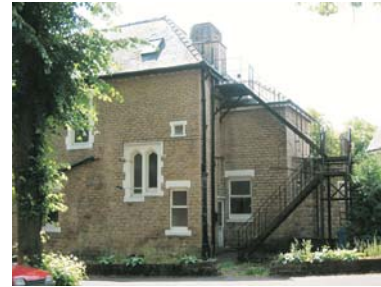
17.1 Many large properties have also been sub-divided into flats or let for multiple occupancy, or changed use to hotels and care homes. The proliferation of such uses has tended to erode the external character of some properties, with increased prominent forecourt parking, intrusive fire escapes (Fig.33c), dormer windows and poorly maintained gardens. There has been a slow reversal of this trend as many properties return to use as houses as demand for housing close to the city centre increases.

**(c)** Flat conversions of large houses often create the need for intrusive fire escapes.

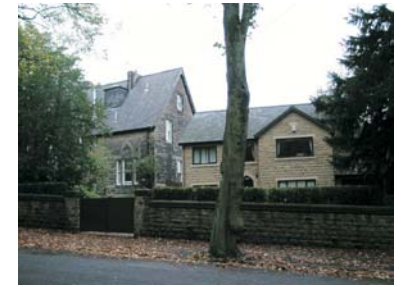
20.1 More recently, however, new development has sought to mimic the existing Victorian architecture without a rigorous understanding of its principles and lacking the detailing and craftsmanship in its execution. The resulting pastiche has tended to simply dilute the existing character of the area instead of either preserving or enhancing it in a positive sense (Fig.33j). Infill development often fails to respect the scale, vertical emphasis and hierarchical character of villa development (Fig.33d).

**(d)** Modern infill with different scale, roof pitches and window proportions to neighbouring Victorian Villas. The close proximity of the new house also impinges on the setting of the villa.

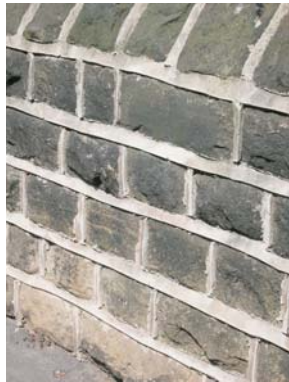
**(e)** Strap pointing - offensive in appearance and damaging to stonework.

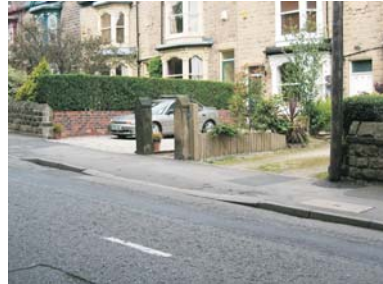
**(f)** Creation of vehicular accesses can break the continuity of boundary walls and isolate gate posts.

21.4 Finally, the hardsurfacing of front gardens, removal of planting and the intrusion of car parking is an ongoing problem which does not currently require planning permission yet seriously erodes the green character of the conservation area Fig.33(f). In the absence of statutory controls it is recommended that the implications of establishing an Article 4(2) direction be considered (see "Floorscape and boundaries" below for a fuller discussion of the issues and

22.1 In the current absence of statutory controls it is recommended that the removal of permitted development rights for the demolition of such walls be included within an Article 4 Direction. The incremental nature of such development means that damage can be done by permitting apparently small-scale development which cumulatively erodes the character of the area over time. It is particularly damaging in terrace or semi-detached housing where new accesses would result in the loss of a significant proportion of the walled frontage. The construction of poor quality timber fences or walls in styles unsympathetic to the area is also highly damaging.

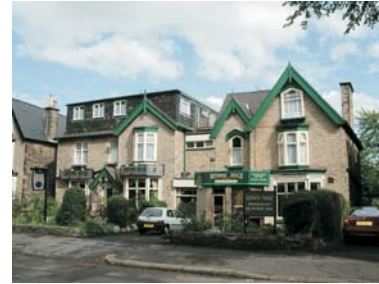
**(g)** Roof dormers which damage traditional roof forms.

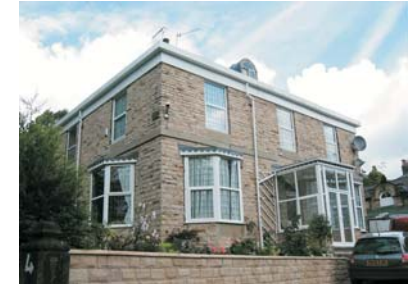
20.4 Many properties are well maintained with original features intact or being restored, to the credit of their owners. However, the incremental loss of original materials and detailing continues to erode the character and appearance of the area. The replacement of timber sash windows and timber doors with Upvc alternatives has been especially damaging to the integrity and appearance of many villas (Fig.33h and i).

**(h)** The replacement of timber windows, doors, porches, soffits and barge boards with UPVC affects the traditional character & appearance of historic buildings.

20.6 However, to prevent further incremental damage to the proposed Conservation Area, a major objective is the introduction of an Article 4(2) Direction restricting permitted development rights for alterations to buildings fronting highways (i.e. areas visible from a public point of view). This would mean that changes such removal and replacement of sash windows, decorative barge boards and slate roofs, would require planning permission.

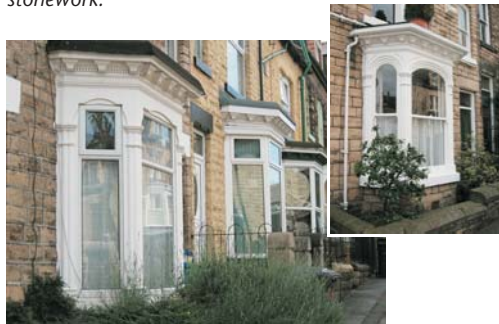
**(i)** Bay windows altered to Upvc (above). Compare an original timber bay retaining its fine decorative mouldings & sash windows (inset).

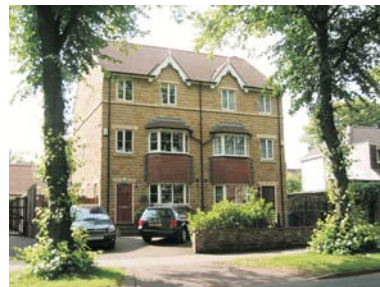
**(j)** The proportion of floor heights, bay windows and dormers are at odds with the local character despite attempts to copy the local style.

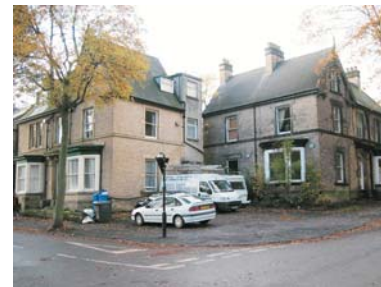
**(k)** Some aspects of the Victorian street layout were far from ideal and have occasionally resulted in the close relationship of villas and unattractive space in between.

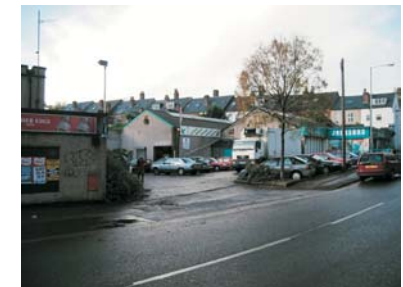
**(l)** The area around the former tram terminus, now occupied by a shop and garages, would benefit from environmental improvement works.
