# VERIFICATION REQUIREMENTS FOR COVER SYSTEMS

Technical Guidance for  
Developers,  
Landowners and  
Consultants

**Yorkshire and Lincolnshire  
Pollution Advisory Group**

Version 4.1 – June 2021

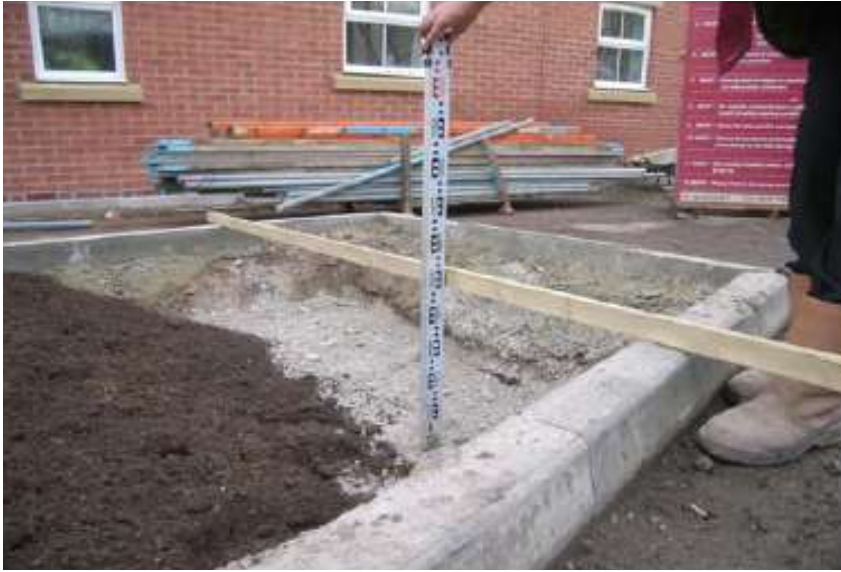
Photograph 1:  
Depth check of inert  
cover within area of  
public open space.  
Physical break layer  
and topsoil visible.
